GROUND WATER ASSESSMENT

WEST SIDE QUARRY LLC

6655 SW Hergert Road
Cornelius, Oregon 97113
Washington County Tax Lot 1S3200000405

November 25, 2020
EVREN NORTHWEST, INC.
Project No. 1350-20001-05

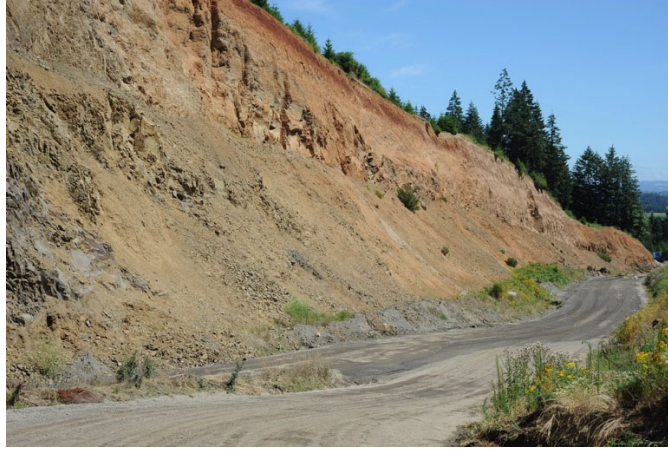
The top of the basaltic lava, deeply weathered and moderately eroded, forms the surface in the upland slopes of the Chehalem Mountains. These red paleosols are visible along the northern slope of the quarry and are about 10 to 15 feet thick.

(July 16, 2020)

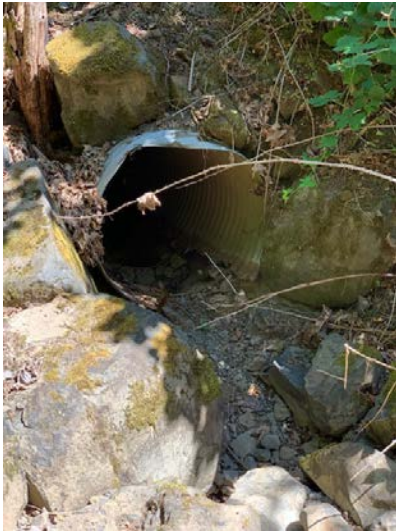
The outlet of culvert C1 (reported by DOGAMI to be full of sediment) emerged at a vegetated hillside approximately 175 feet to the northeast. Counter to DOGAMI's report, the culvert was elevated above a rocky creek bed and neither the pipe nor creek bed had any visible sediment buildup.

View of culvert inlet C1, hydraulically down-gradient of impoundment structure, showing absence of sediment and iron staining. (August 7, 2020)

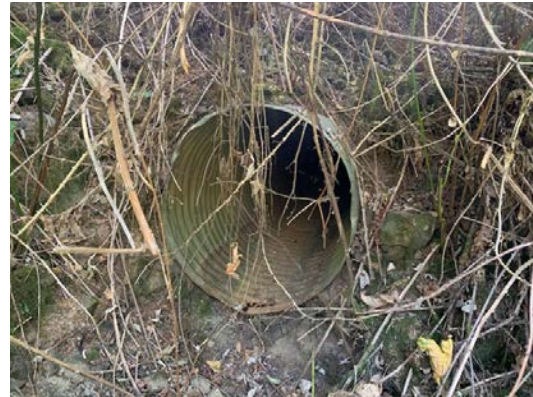
View of outfall of lower culvert showing absence of sediment and iron staining. (August 7, 2020)

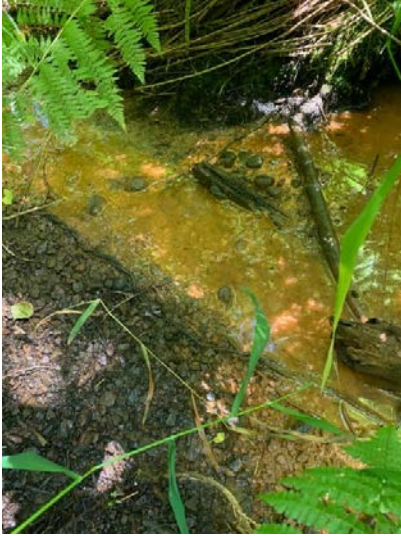
Approximately 100 feet down slope of outfall C3 the embankment expanded into a broad swampy area covered by wetland vegetation. The area where DOGAMI had previously observed bubbling water coming from the ground was dry and stained (iron oxide); however, approximately 75 feet further northeast, ENW noted several active ground water seeps coming from the ground with associated rust-colored sediments. The channeled water from the quarry drainage joined the unnamed creek approximately 600 feet northeast of the impoundment structure. No evidence of oxidizing iron deposits was noted within the sediments of the unnamed creek bed.

Approximately 100 feet down slope of outfall C3 the embankment expanded into a broad swampy area covered by sword fern and wetland vegetation. The area where DOGAMI had previously observed bubbling water coming from the ground was dry and stained (iron oxide). Approximately 75 feet further northeast, ENW noted several active ground water seeps coming from the ground with associated rust-colored sediments.

View of typical rust-colored seeps emerging from the boggy area below the storm water impoundment feature (July 16, 2020)

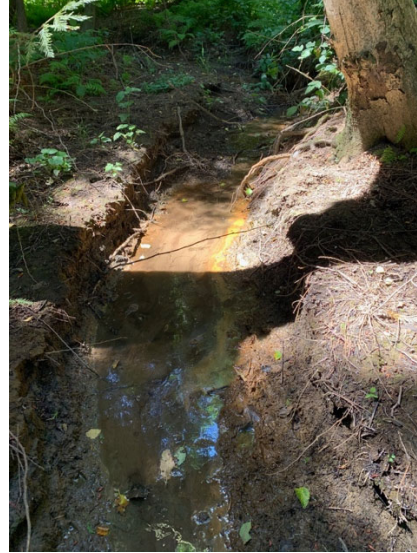
Channel below seeps (July 16, 2020)

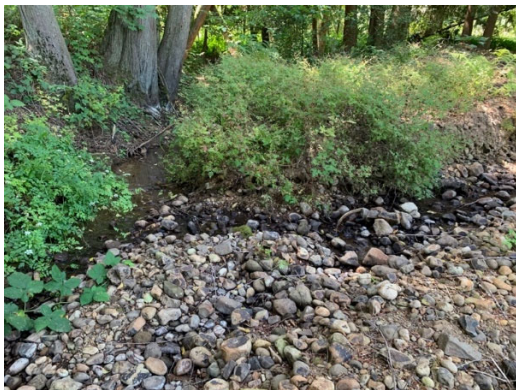
The channeled water from the quarry drainage joined the generally eastward-flowing perennial creek on the Husin Property approximately 600 feet northeast of the impoundment structure. A culvert below the confluence of drainages was noted about 40 feet downstream. This culvert reportedly discharges to a roadside ditch along Hergert Road at the end of the Husin's driveway. No evidence of oxidizing iron deposits was noted within the sediments of the Husin creek bed.

View of confluence of quarry runoff and a stream on adjoining property. (August 7, 2020)

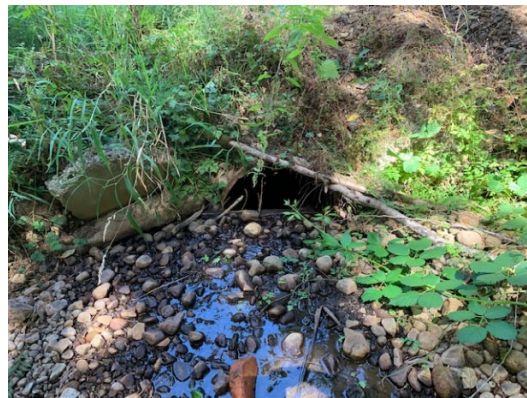
View of culvert below confluence of two drainages. (August 7, 2020)

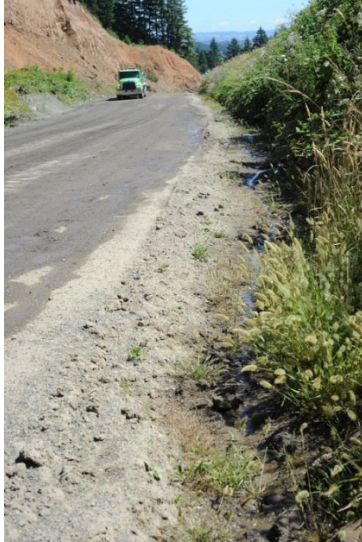
During both visits, ENW observed two seeps (SEEP2 and SEEP3 on Figure 2) collecting in a shallow ditch along the haul road, below the middle bench. SEEP3 was on the lower switchback at an elevation of approximately 425 feet amsl, and SEEP2 was directly upslope of SEEP3 on the upper switchback of the main haul road at an elevation of approximately 450 feet amsl. A platy, iridescent film was noted on both seeps typical of organic residue from iron-oxidizing bacteria. No obvious source of water was found in the hydraulically up gradient direction above the seeps; therefore, ground water was the suspected origin.

On the August 7, 2020 visit, ENW observed two seeps (SEEP2 and SEEP3 on Figure 2) collecting in a shallow ditch along the haul road, below the middle bench. SEEP3 was on the lower switchback and SEEP2 was directly upslope of SEEP3 on the upper switchback of the main haul road. No obvious source of water was found in the hydraulically up gradient direction above the seeps; therefore, ground water was the suspected origin.

View of lower switch back of haul road and SEEP3
(July 16, 2020).

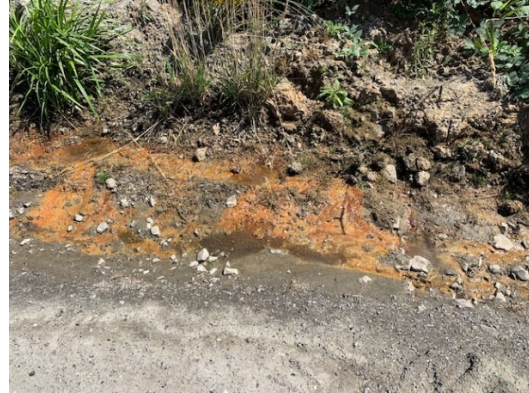
Close-up view of SEEP3 next to haul road
(August 7, 2020).

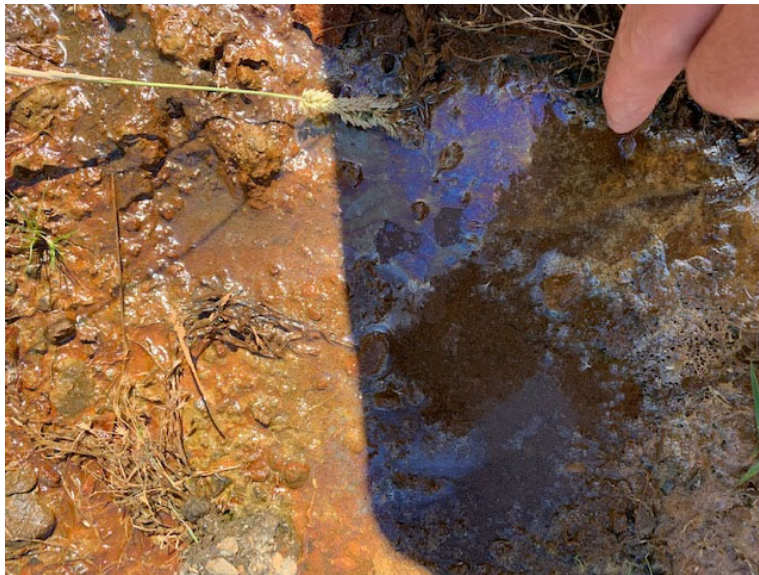
The presence of seep water emerging during a dry period when no water is present in the storm water impoundment feature, and presence of seeps above the storm water impoundment feature are evidence that seeps are more likely a result of emergent ground water from basalt interflow zones exposed in the quarry. The upper seeps at 425 to 450 feet above mean sea level lie above the productive aquifer at nearby Finley well and may receive contribution from infiltration through overlying weathered soil and rock materials. ENW concludes that high iron precipitation due to bacterium is likely naturally occurring.

A platy, iridescent film was noted on both seeps typical of organic residue from iron-oxidizing bacteria.

Close-up view of organic 'sheen' associated with iron oxidizing bacterial (August 7, 2020)

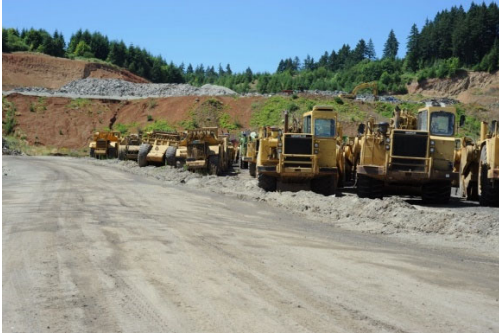
At the middle bench above the seeps, there were numerous quarry trucks parked on gravel surfaces. However, no evidence of rust surface staining was noted beneath the trucks, leading ENW to conclude that seep water staining in the haul road ditch was more likely due to iron-oxidizing bacteria.

View of quarry trucks parked at the middle bench level of the quarry. (July 16, 2020)

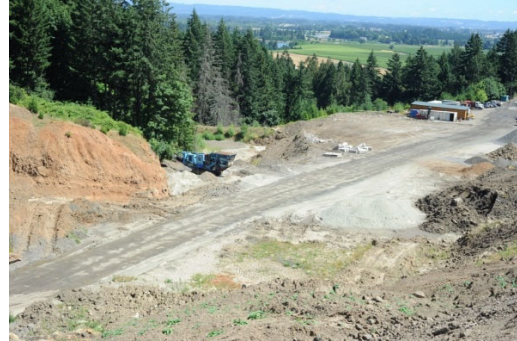
View northeast from the middle bench level of the quarry, showing storm water impoundment feature in distance. (July 16, 2020)

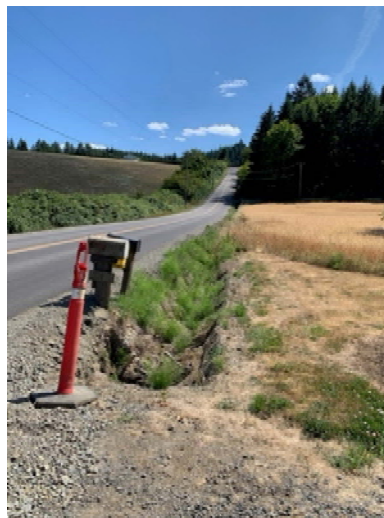
The ditch along Hergert Road was inspected from the quarry entrance north to the Husin property driveway where it converged with the combined flow of Outfall B and the perennial stream. Outfall A and Outfall B converge at a point just north of the Husin driveway. Inspection of the ditch along Hergert Road did not reveal any flowing water, nor any significant sediment buildup from the quarry. It was noted that the ditch had just recently been cleaned and new gravel placed. The perennial stream from the Husin property was observed flowing into the Hergert road ditch just north of the driveway. No significant turbidity was noted in the perennial stream at its convergence with the ditch.

View south along Hergert Rd ditch from the Husin Driveway entrance. (August 7, 2020)
