Culvert Repair Programmatic Agreement 2022 Annual Report

**Oregon Department of Fish and Wildlife | Oregon Department of Transportation
April 2023**

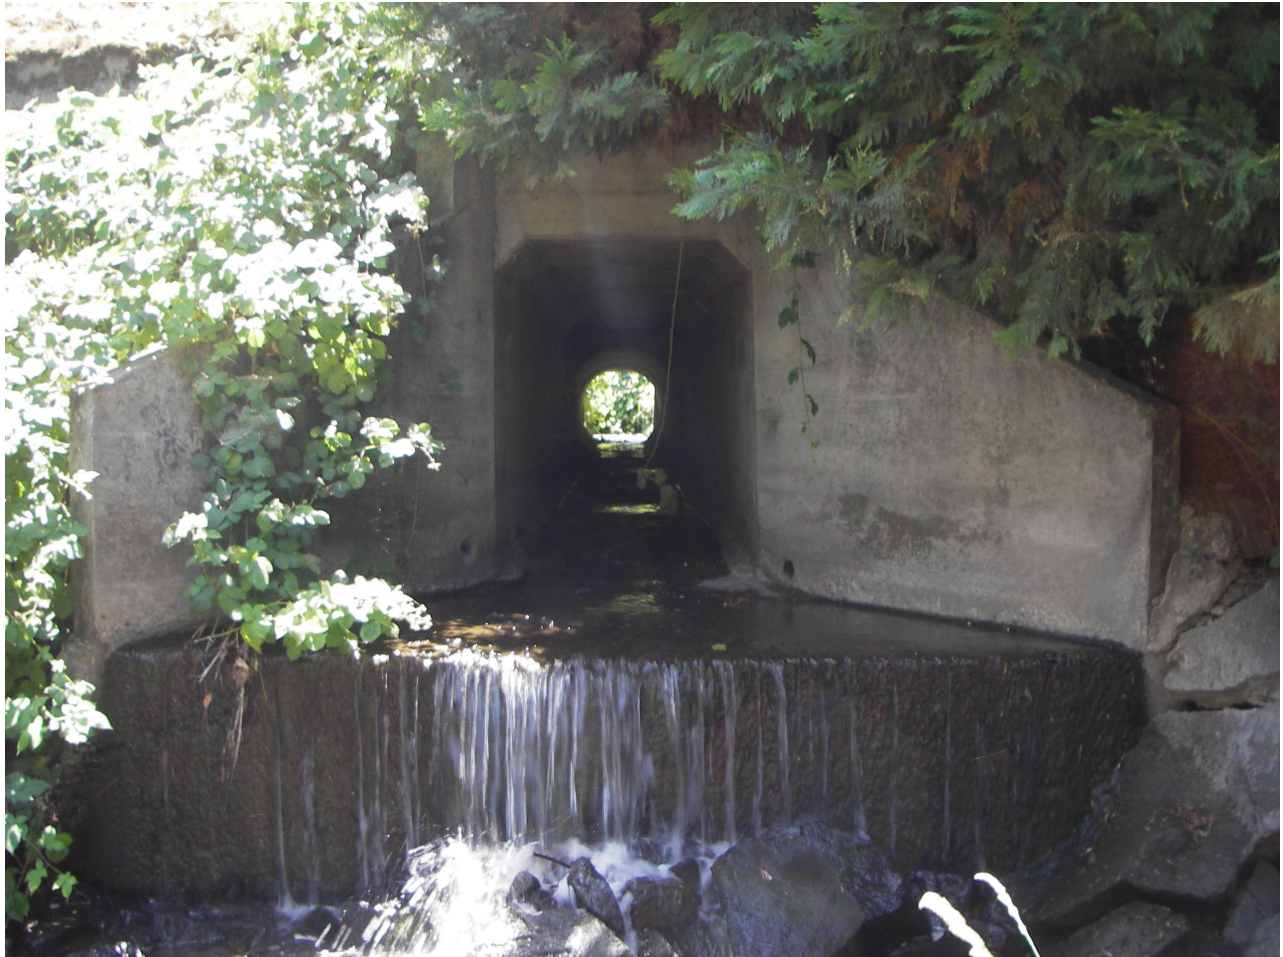
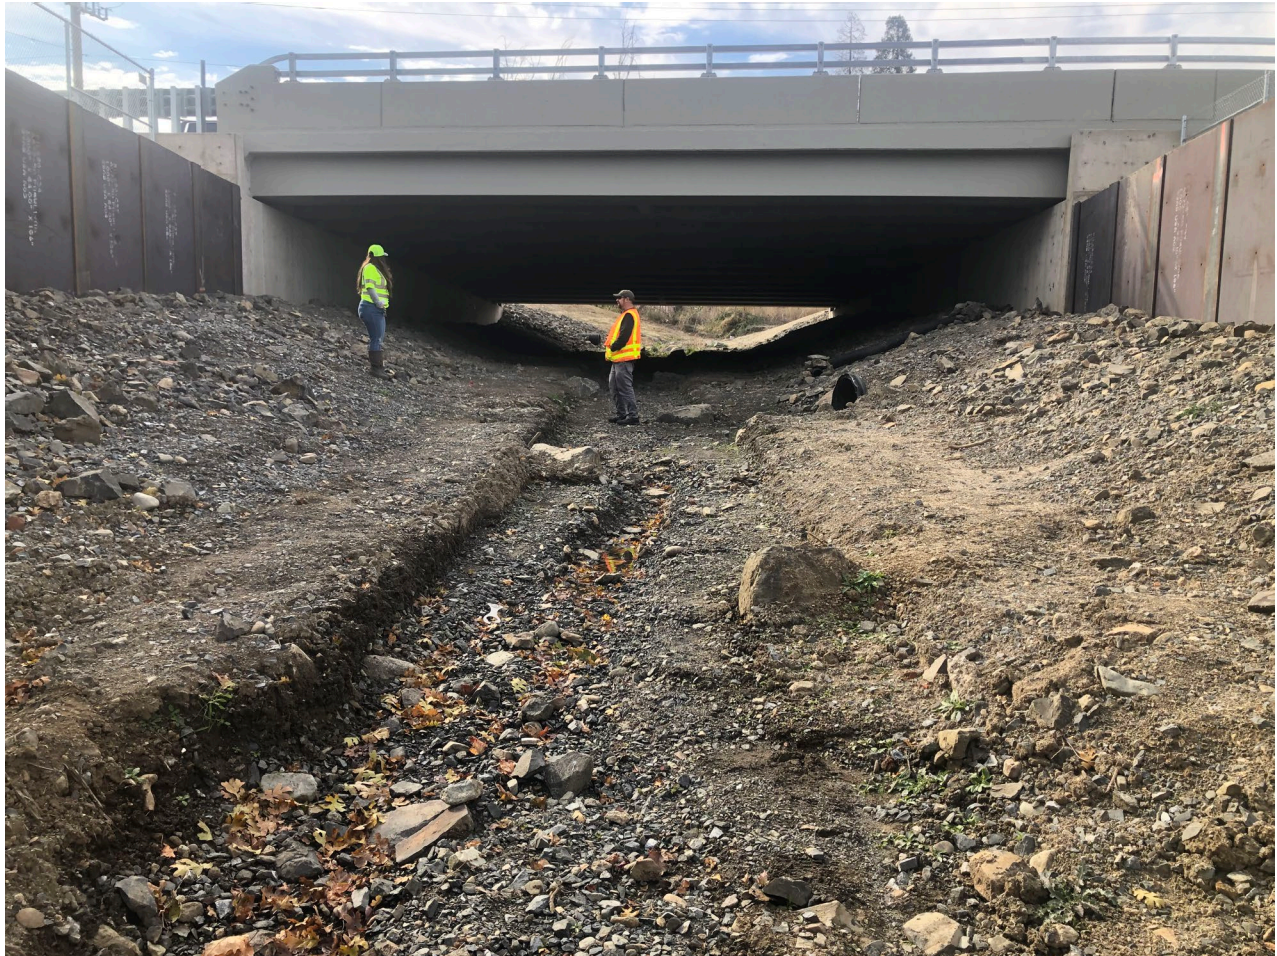
Figure 3: OR 99W Coleman Creek Culvert Replacement Project, Before and After

Description: The top panel of two photos shows Coleman Creek before the replacement. The photo shows the original culvert outlet with large perch, creating a fish passage barrier. The bottom photo is after the culvert replacement, showing a new 46-foot long bridge with the reconstructed stream channel under it.

The OR 99W Coleman Creek Culvert Replacement Project, Figure 3, completed by the ODOT Fish Passage Program, is one example of ODOT's commitment to improving fish passage and supporting the Oregon Plan for Salmon and Watersheds. The project replaced an undersized 4-foot by 6-foot concrete box culvert with a 46-foot-long bridge. The original culvert was undersized for the stream channel, causing channel scour and incision. The culvert also had a large perch at the outlet, which resulted in a significant passage barrier for both adult and juvenile NMF. The Coleman Creek fish passage project opened access to over 4 potential miles of high-quality spawning and rearing habitat for summer and winter steelhead, fall Chinook salmon, cutthroat trout, and lamprey species at a cost of \$5.3 million.

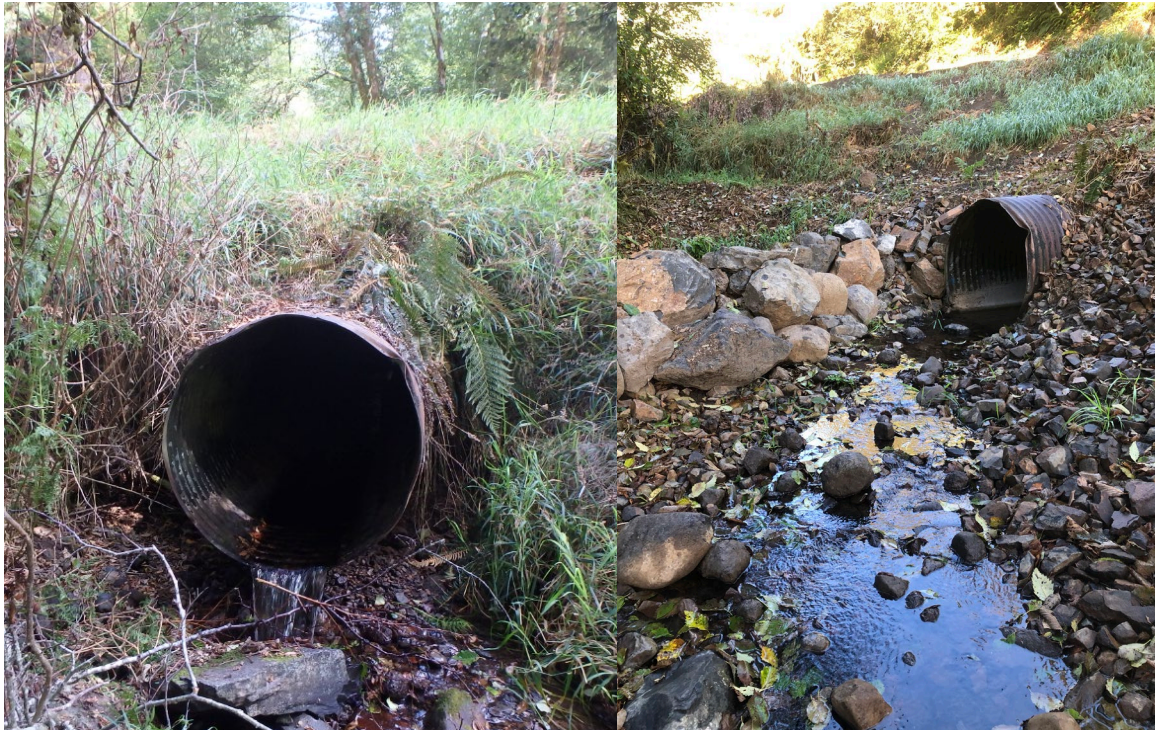
Figure 5: Small Creek Before and After

This culvert conveys Small Creek, a tributary of the Little Nestucca River in Tillamook County, Oregon. Small Creek has an estimated active channel of 10' and the current culvert is 54' long and 4' in diameter. The culvert had an 18" drop on the outlet near the confluence with the Little Nestucca River, causing significant fish passage issues, and was a complete barrier for Pacific lamprey. The culvert showed signs of invert and barrel damage, and was in need of repair.

Description: Two images, the first displays the culvert pre-repair from the outlet end with a perch creating a fish passage barrier. The second shows the culvert post-repair from the outlet end with a roughened riffle backwatering the outlet.

The culvert was repaired by paving the invert to cover the scour and seal the barrel. Fish passage improvements include a roughened riffle to the culvert outlet to eliminate the jump, and rounded cement corner baffles were installed to reduce velocities, and increase the depth in the culvert barrel.

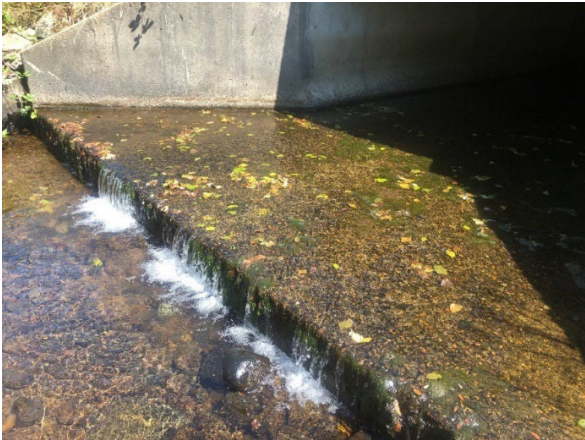
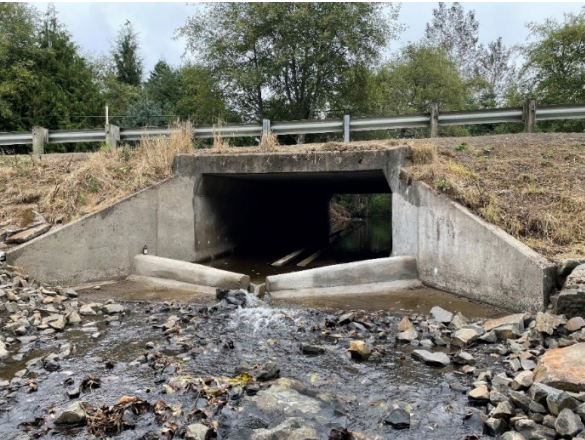
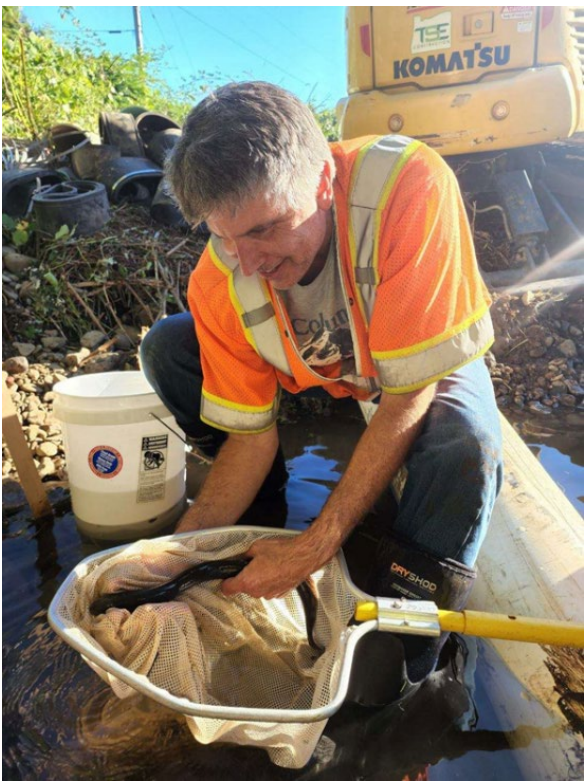
Figure 6: Munson Creek Culvert Repair Before and After

The box culvert had exposed rebar and concrete wear from scour on the invert and was in need of repair. Some small sections of the walls had some erosion as well. The active channel width is estimated to be 17'.

Description: Three images, the first is pre-repair looking at the culvert outlet and Apron. A 12" drop off of the apron can be seen. The second is post-repair looking inside the culvert from the outlet end with a roughened riffle backwatering the outlet, and rounded baffles on each side of a low flow channel. The third image shows Wade Holaday, Senior Major Culvert Maintenance Engineer, with an adult Pacific lamprey collected during fish salvage.

The repair included repaving of the invert of the culvert and covering erosion scour and exposed rebar. To address the perch on the apron, a 70' roughened channel was built up to the culvert outlet, eliminating the jump. Weirs were placed in the culvert to reduce the velocities and increase the depth. The weirs are rounded to allow for lamprey migration. In addition, a low flow channel was created in the barrel to further increase passage depth during low flows. Improved passage here will provide easier access to 4.73 miles of habitat for coast cutthroat trout, Pacific lamprey, winter steelhead, coho and fall Chinook. Prior to construction, the fish salvage captured 18 adult Pacific lamprey from below the culvert apron. These individuals were released upstream, and extended the known distribution of Pacific lamprey in the Tillamook River Watershed.

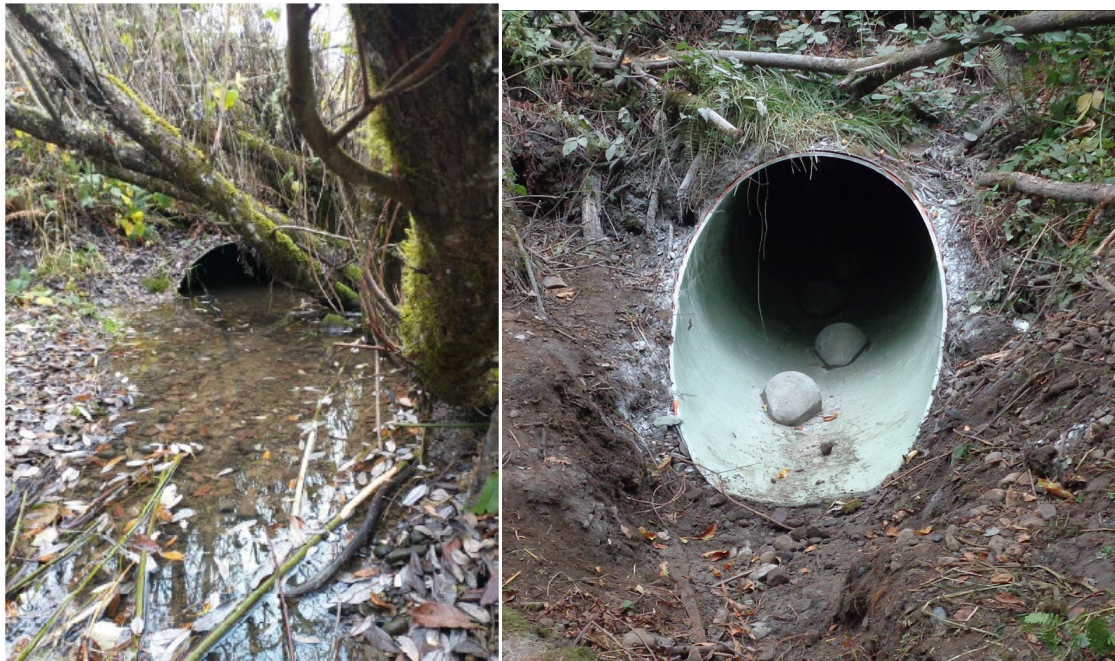
Figure 7: Unnamed Tributary of the South Fork Coquille River Culvert Repair Before and After

The culvert is deteriorating and has vertical and horizontal alignment breaks. The active channel width is estimated at 7' and is a seasonal stream, but provides coastal cutthroat trout habitat when it is flowing. The undersized culvert had velocity issues for fish passage at higher flows.

Description: Two images, the first shows inside the culvert from the outlet end pre-repair with water running through it. The second displays inside the culvert from the outlet end post-repair with fish blocks installed.

The structural condition of the culvert was addressed by installing a CIPP liner. Fish blocks were installed in the culvert to increase depth, increase hydraulic complexity and reduce velocities. The passage improvements will improve passage for coastal cutthroat trout to 0.56 miles of additional habitat upstream of Highway 42.

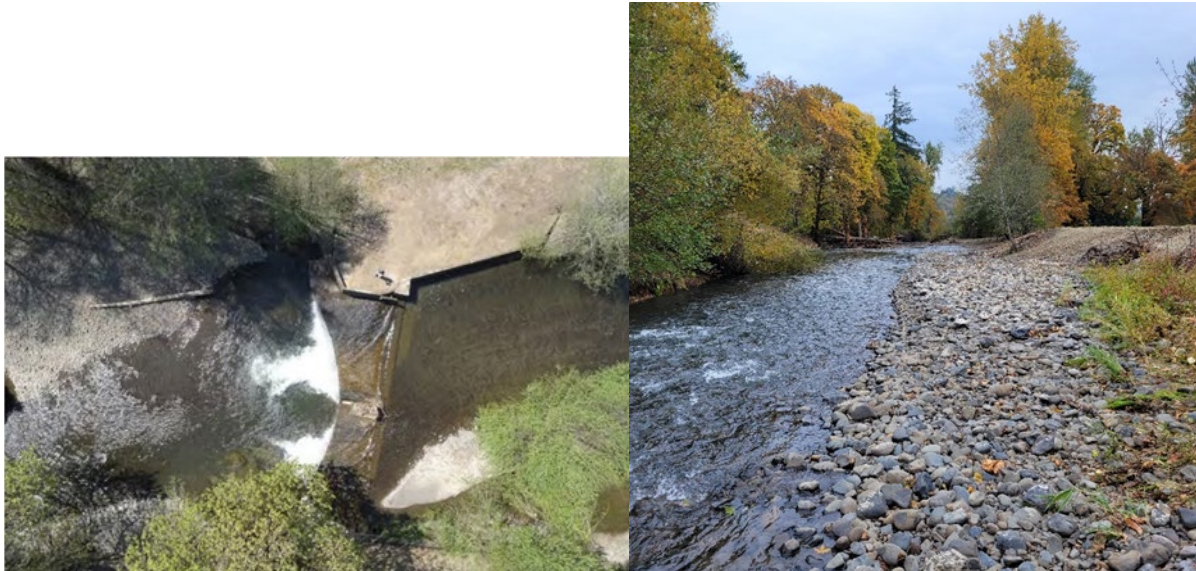
Figure 8: Balm Grove Dam Removal Project Before and After Photos

Description: Two images, the first shows an aerial view of the dam and spill way with water running throughout. The second displays the restored channel with a riffle running next to a channel bank.

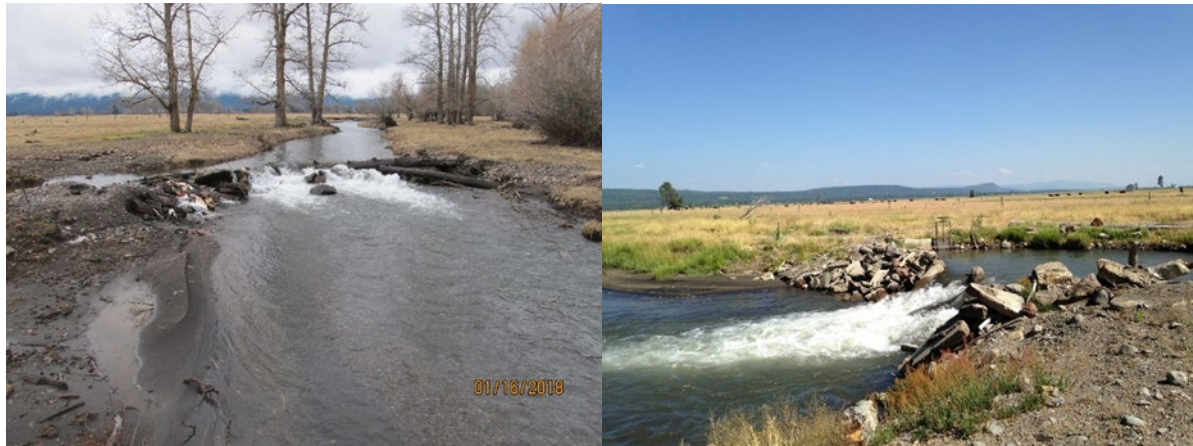
Figure 9: Annie Creek Irrigation Diversion Project Before and After Photos

Description: Two images, the first shows an upstream view of the push up dam with water running through it. The second displays a side profile view of the restored channel.

This project provided volitional fish passage at two irrigation diversion pushup dams on Annie Creek, a tributary to the Wood River in the Upper Klamath Basin. Both barriers were removed and a roughened riffle was constructed to provide volitional fish passage. Both diversions were combined and a new criteria fish screen was installed to prevent the entrainment of juvenile fish. Removing these barriers allows upstream and downstream volitional passage in the lower five miles of Annie Creek.
