# **Culvert Repair Programmatic Agreement 2019 Annual Report**

Oregon Department of Fish and Wildlife | Oregon Department of Transportation  
August 2021

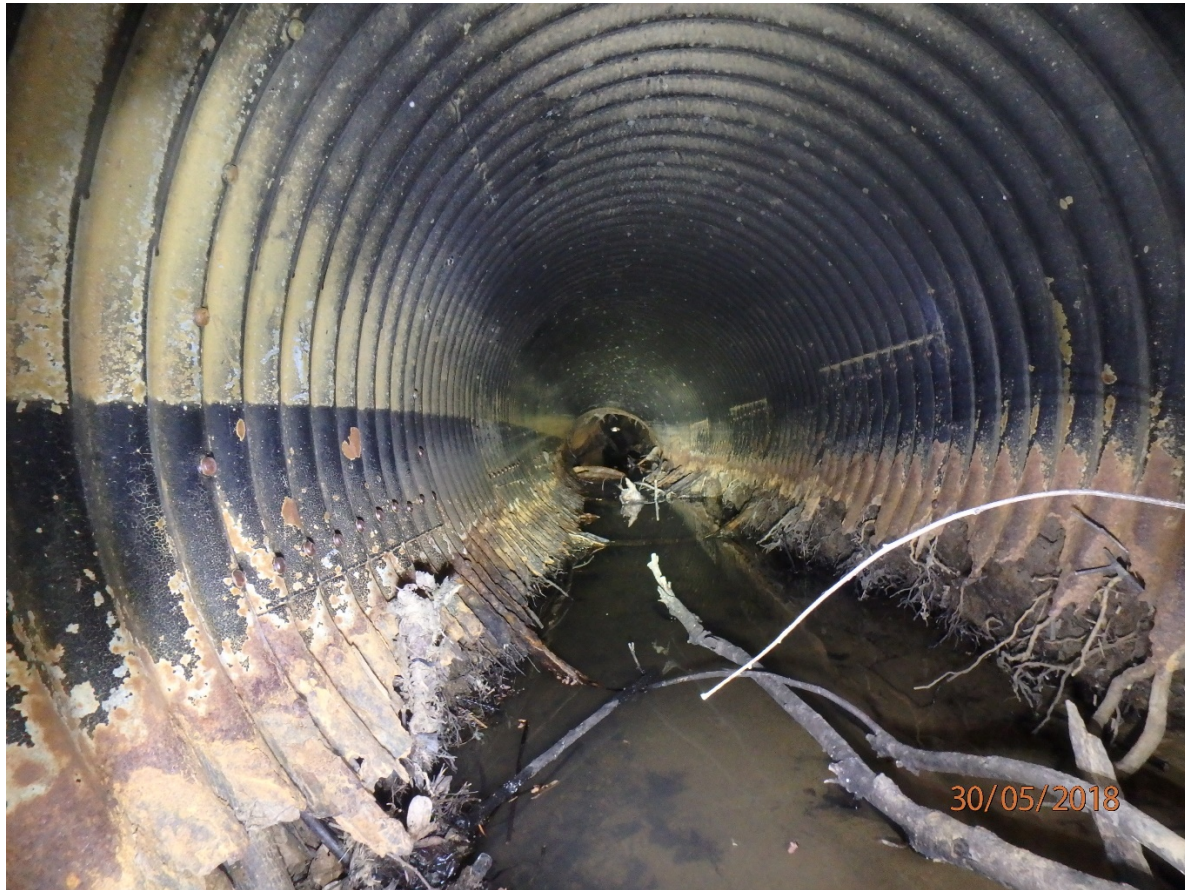
Figure 2: Photo of a critical condition corrugated metal pipe culvert with invert completely missing, rusted sides, and separated segments

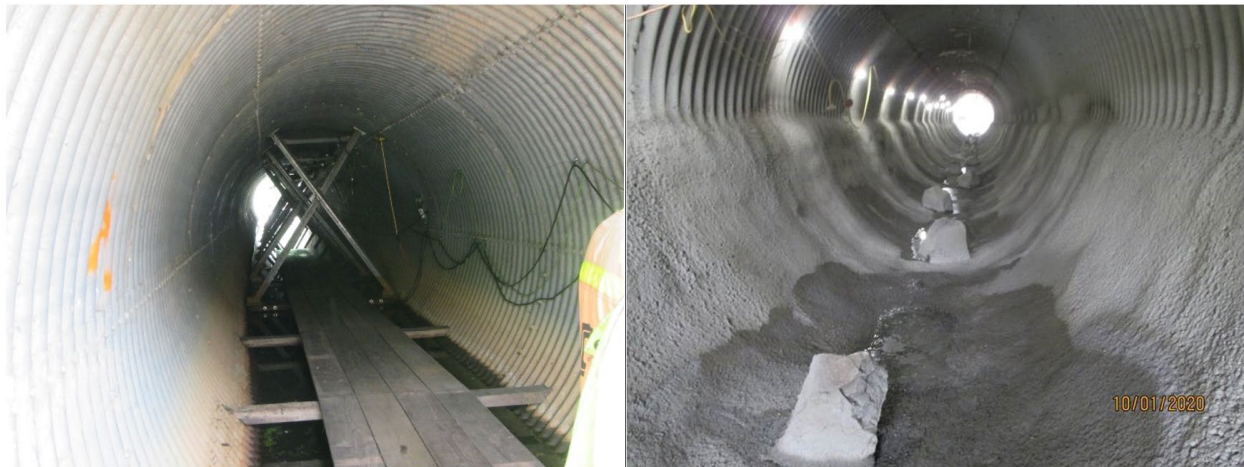
Figure 6: Johnston Creek Culvert Repair, Before and After

The structural conditions of these culverts was critical due to significant corrosion. The culverts were collapsing causing sagging and roadway cracking on the highway. A fatal accident occurred at this location due to a partial roadway collapse over the culverts. Significant repairs to the culverts would trigger Oregon’s fish passage rules, and in August of 2018 ODOT declared these culverts an emergency and began the process of planning to address fish passage at this location under the CRPA. Internal cross-bracing to support the culverts was completed in the spring of 2019, with fish passage improvements and further repair work were implemented in 2020.

Hydraulic calculations showed flow conditions at the culvert had velocities over 2 fps and flow depths as low as 4 inches (flows ranging between 5 percent and 95 percent of the daily

The degraded culverts were repaired with an invert pave that sealed and reinforced the failing corrosion and returned structural integrity to the culverts. Fish passage was improved with the addition of fish rocks in lower culvert. The repair work was completed in 2019, and the fish passage improvements were completed in 2020. These fish rocks were placed in the east culvert to decrease the velocities within the culvert and offer ample hydraulic variation for NMF. Post-treatment conditions were estimated to have velocities approximately 2.1fps, down from over 3 fps and flow depths of over 7 inches, thus improving access to the approximate 4.95 miles of upstream habitat.

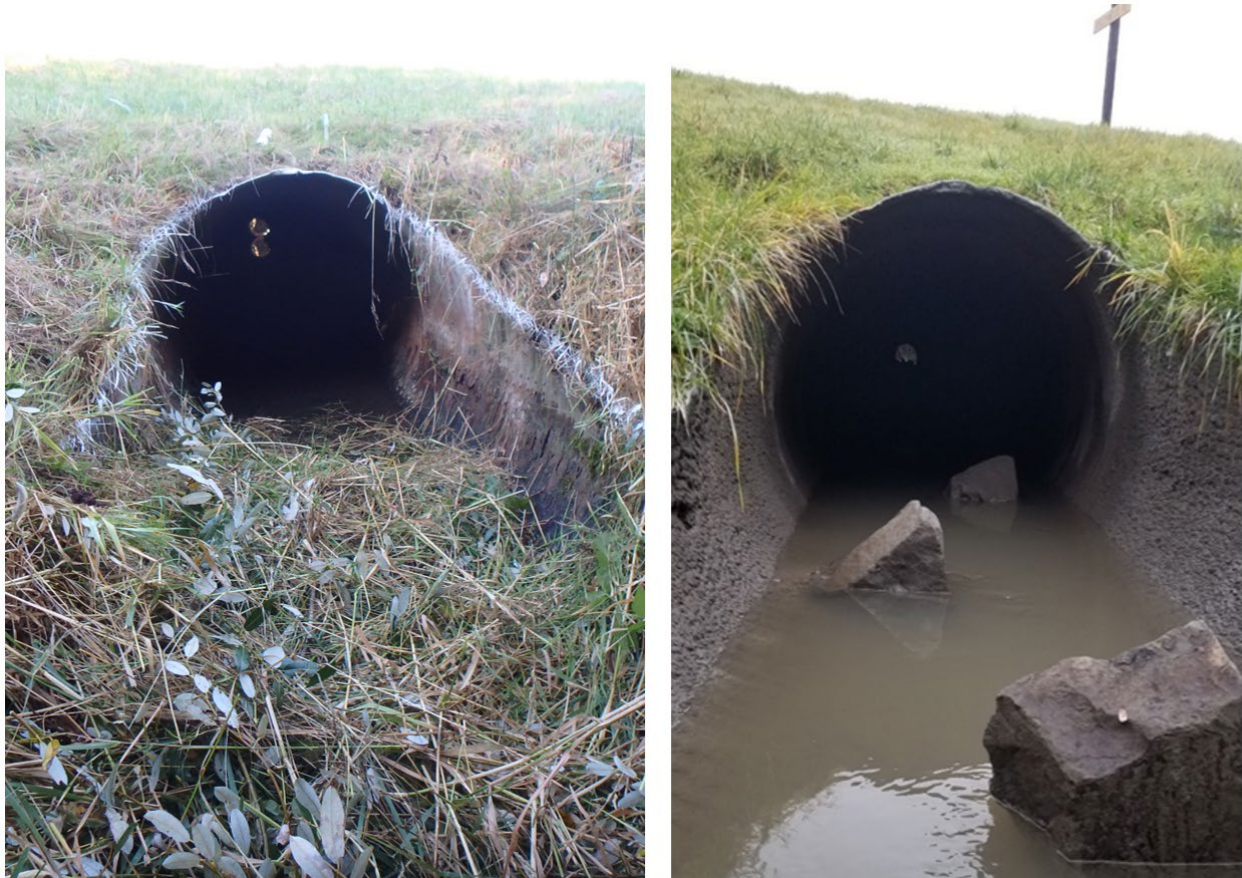
Figure 7: Unnamed Tributary to Mud Slough Culvert Repair, Before and After

Although the culvert was rated in fair condition following initial inspections, subsequent inspection efforts determined that the amount of invert rusting was enough to warrant repair. Degradation of a culvert invert allows water to saturate the soil surrounding the culvert. It also erodes away the soil beneath the culvert and can lead to settling. If left untreated, these issues can lead to the roadway becoming unsupported and unsafe.

The rusting culvert was repaired by a Centrifugally Cast Concrete to amend structural issues caused by rust. Fish passage was improved by the addition of fish rocks to slow water velocity, increase hydraulic diversity, and better facilitate fish passage during high flows. The fish rocks lowered the velocity in the culvert and allowed for variation of hydraulic conditions through the culvert to improve NMF passage conditions to the potential 5.05 miles of habitat upstream.

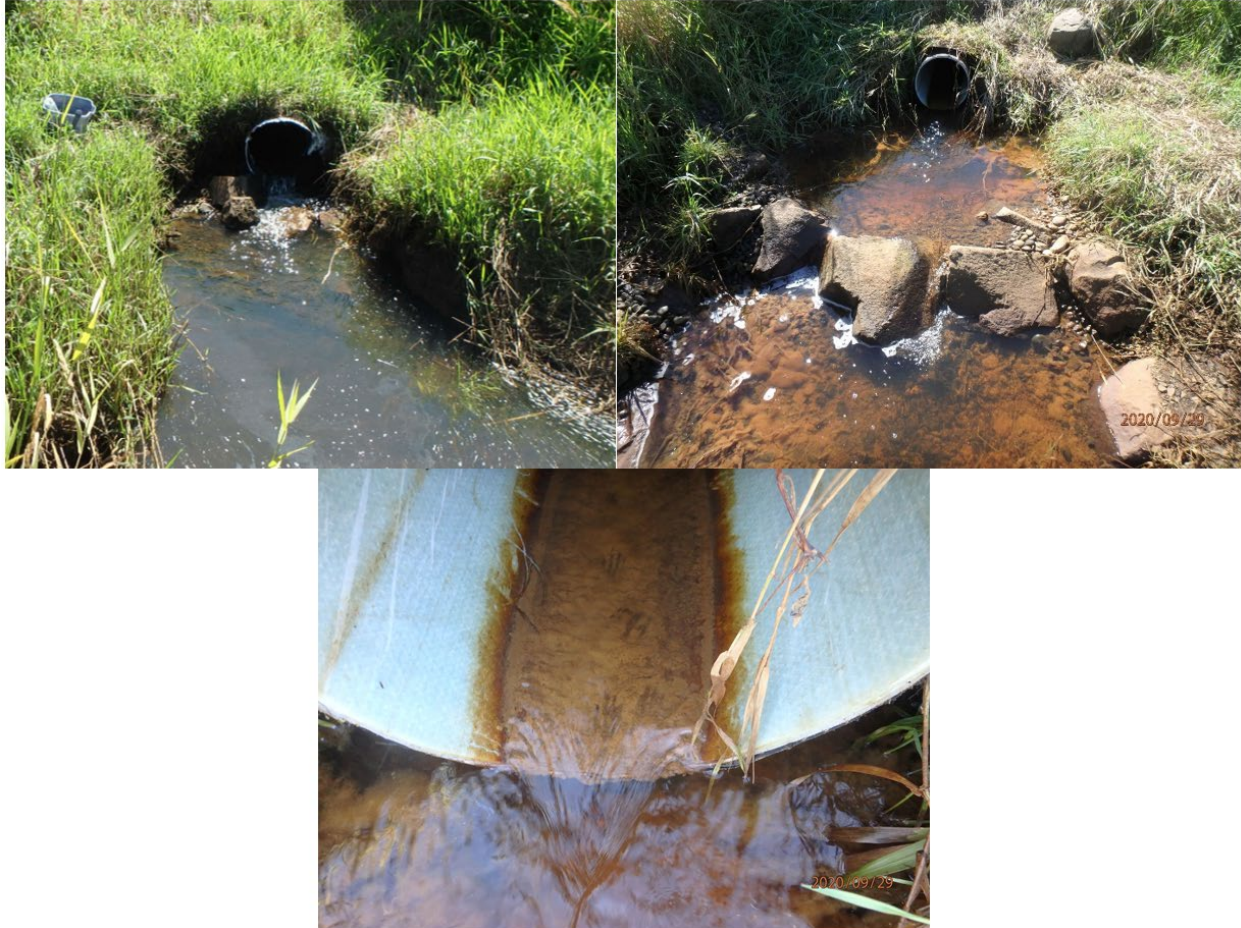
Figure 8: Unnamed Tributary to Westport Slough Culvert Repair, Before and After

The 18 inch diameter CMP is 95 feet long and drains an area of 1.55 acres of habitat and floodplain. The culvert's surveyed condition was considered critical due to corrosion. If left untreated, this could become a potential hazard to the traveling public due to water saturating and destabilizing the surrounding soil arch and roadbed, leading to settlement of the culvert that could leave the roadway unsupported.

Post-construction monitoring at this site determined that the boulder receiving pools did not fully seal and backwater the culvert to the designed plans. Adaptive management in 2020 included resealing the weir with fine material to backwater the culvert to designed condition. The site will continue to be monitored to ensure the weir functions as intended.

Description: Three images, the first shows the outlet end of the culvert pre-repair with water running through it, the culvert is perched ~4 inches. The second image shows the outlet of the culvert post-repair with water running through it, the perch at the outlet of the culvert has been improved. The third photo shows the conditions at the outlet following adaptive management work in 2020, where there is no longer a perch.

Fish passage was improved at the outlet of the culvert by building two boulder receiving pools. The culvert was repaired with a CIPP liner. This allowed for the degraded invert condition to be restored, keeping the water inside the barrel. Installing two downstream u shaped boulder receiving pools improved fish passage. These pools slow velocities during outgoing tides, backwatering the culvert for longer durations, and reducing the perched condition of the culvert at low tide. The resulting conditions improve fish passage and increase access to the 1.55 acres of upstream habitat.

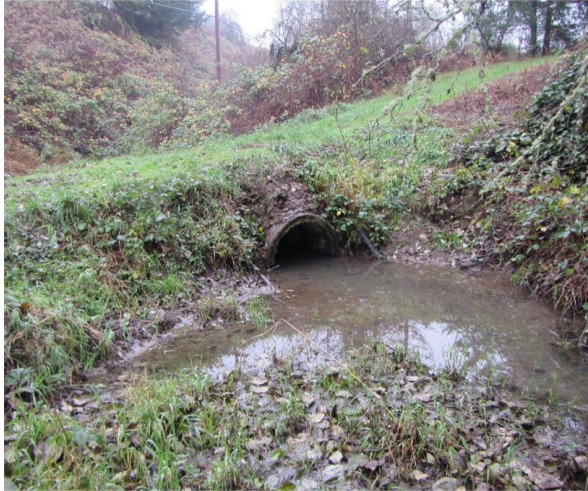
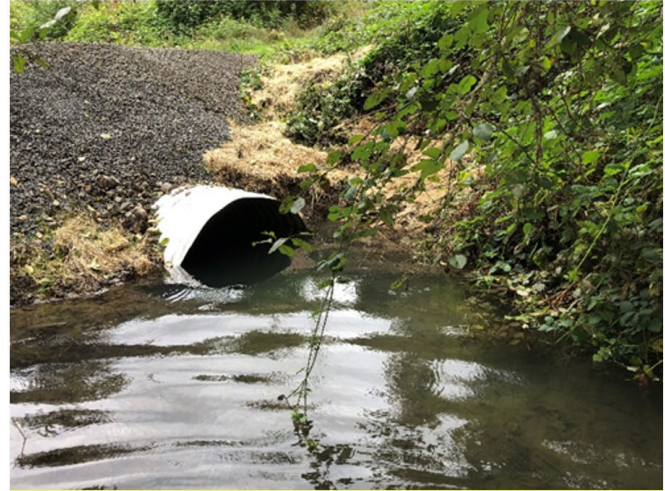
Figure 9: Spring Brook Creek Culvert Repair, Before and After

Conditions at the ODOT culvert under highway 99 were not a barrier to fish passage. However, approximately 30 feet downstream from this culvert is a private road crossing. The culvert on this road crossing was a 3-foot diameter culvert, which was undersized and placed at a stream elevation that was not conducive to fish passage. Conditions at this lower culvert presented a passage barrier to cutthroat trout downstream from the ODOT culvert.

Description: Two images, the first shows the outlet end of the private culvert pre-replacement with water running through it. The second image shows the outlet of the culvert post-replacement with water running through it.

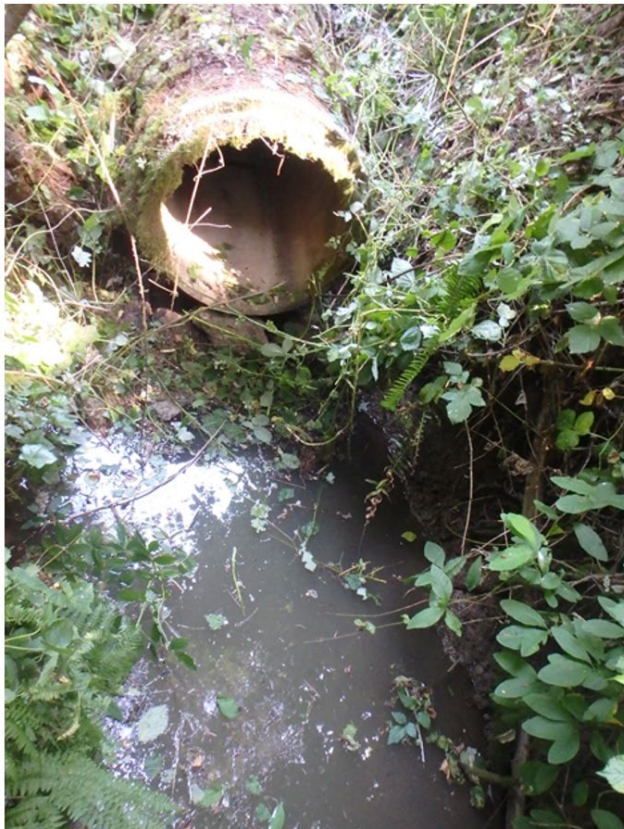
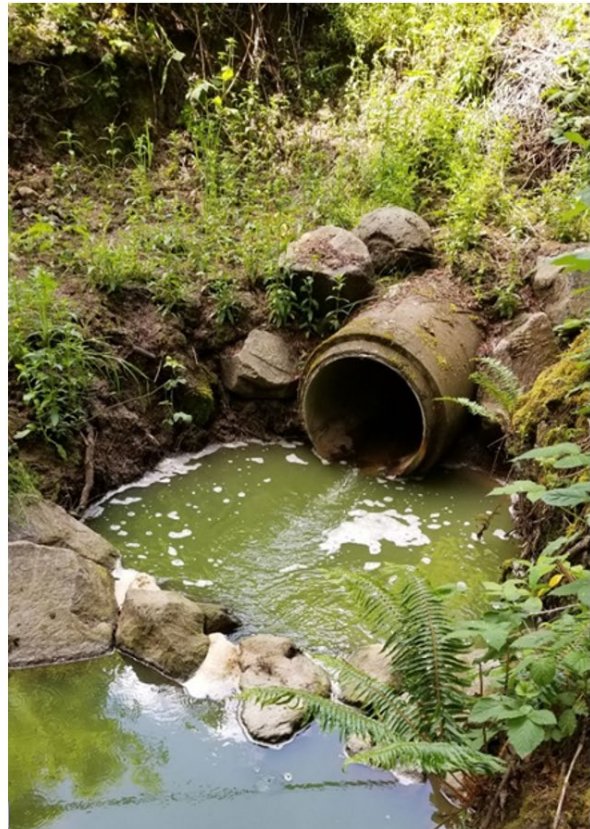
Figure 10: Unnamed Tributary to Hess Creek Culvert Repair, Before and After

Description: Two images, the first shows the outlet end of the culvert pre-repair illustrating the perched condition. The second image shows the outlet of the culvert post-repair with one downstream boulder weir. The boulder weir has backed up water and reduced the perched condition.

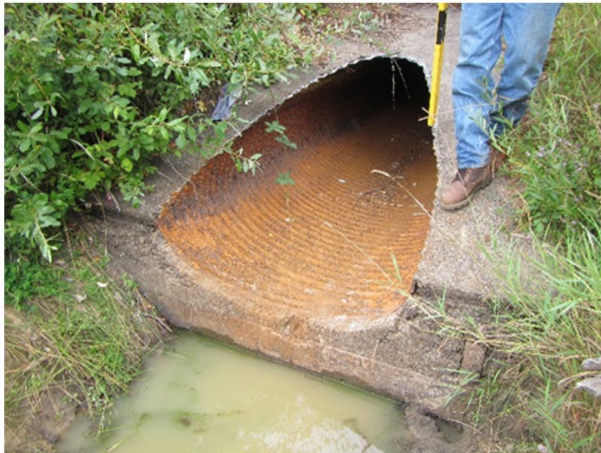
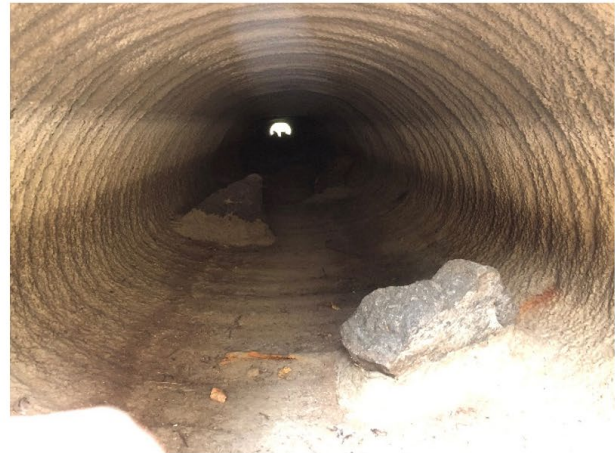
Figure 11: Long Tom River Floodplain Lake Culvert Repair, Before and After

Description: Two images, the first looks at the end of an arch culvert pre-construction, where the culvert invert is showing signs of rust and deterioration. The second image is post-repair, and looks in the end of the arch culvert. The interior of the culvert shows new concrete around the perimeter, and fish rocks placed on the inlet.

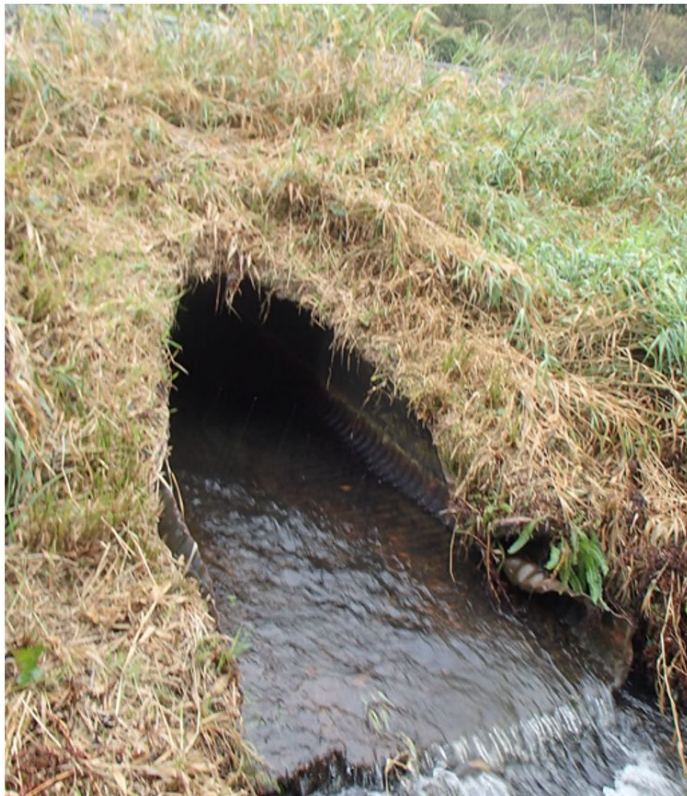
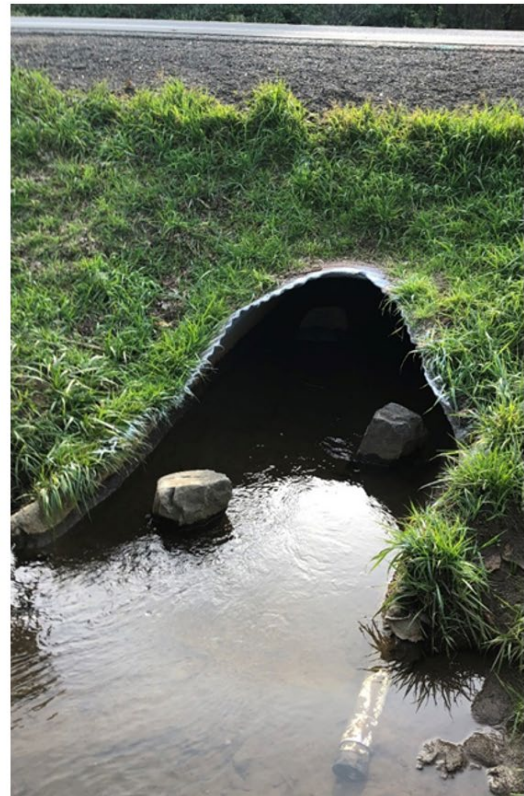
Figure 12: Unnamed Tributary to Doty Creek Culvert Repair, Before and After

Description: Two images, the first is the inside of the culvert pre-repair. The second is inside the culvert post-repair. Here we can clearly see fish rocks installed.

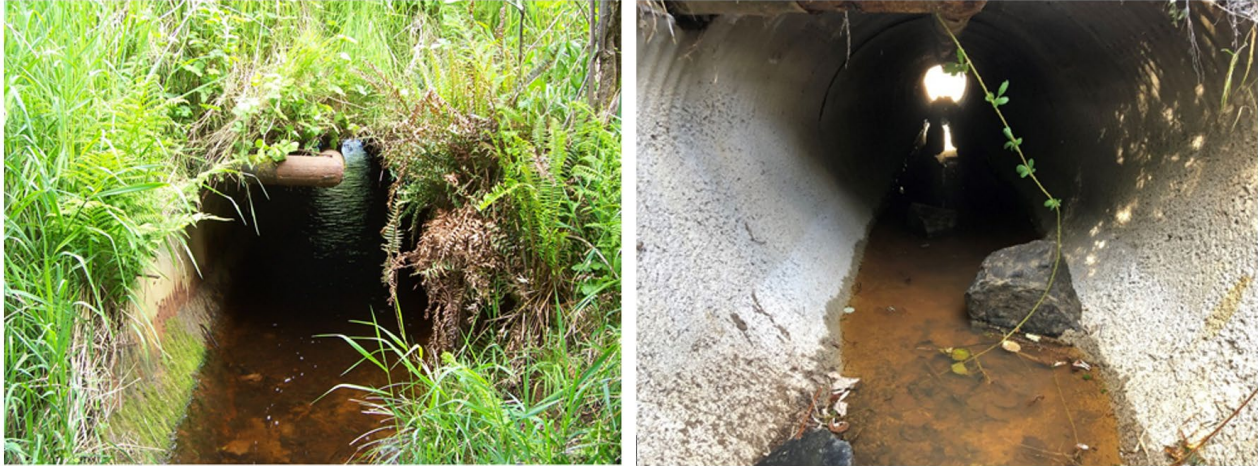
Figure 13: Unnamed Tributary to Alder Creek Culvert Repair, Before and After

Description: Two images, the first is looking inside the culvert pre-repair. The second is looking inside the culvert post-repair. We can see the paved invert of the culvert and installed fish rocks post-project.

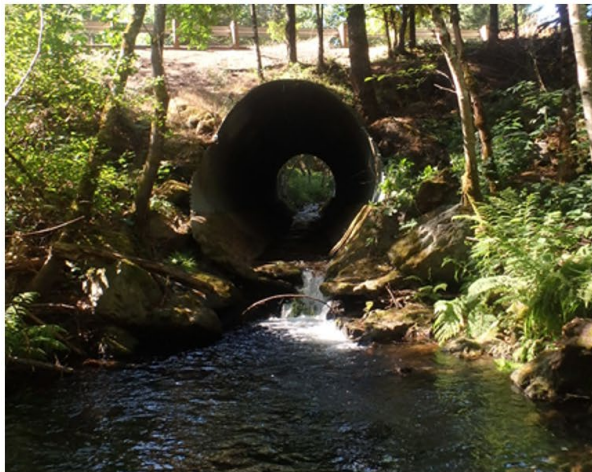
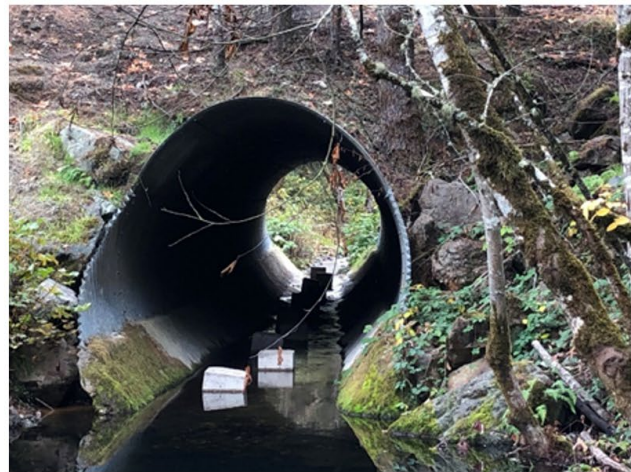
Figure 14: Canyon Creek Culvert Repair, Before and After

Description: Two photos, the first shows the outlet end of the culvert with water running through it, this clearly illustrates the perched condition of the culvert. The second photo shows standing water at the post-repaired outlet of the culvert, and fish blocks placed through the culvert.

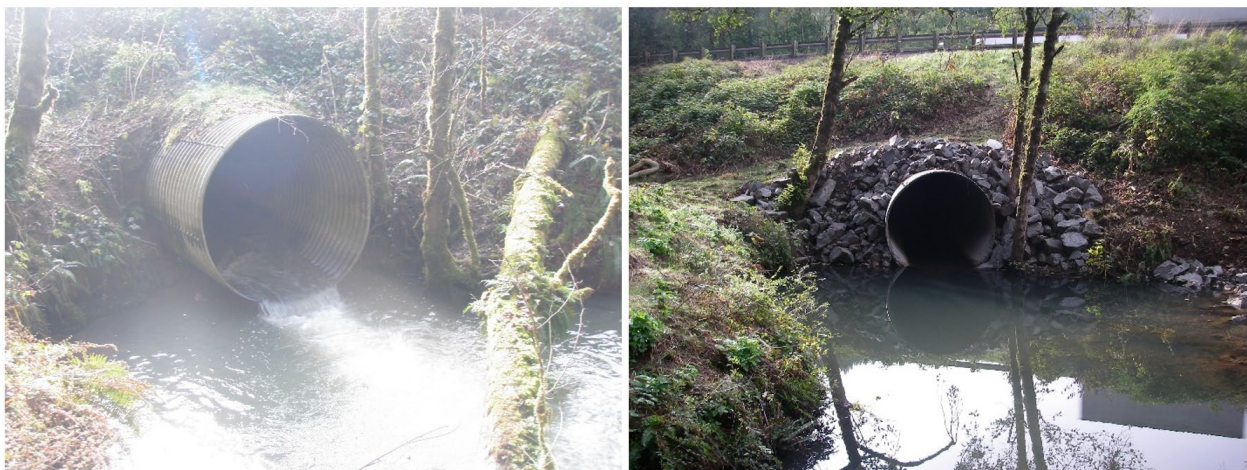
Figure 15: Pass Creek Culvert Repair, Before and After

Description: Two images, the first shows the outlet of the culvert and a perch creating a jump height pre-repair. The second image shows water running through the culvert backwatered with no jump height post-repair.

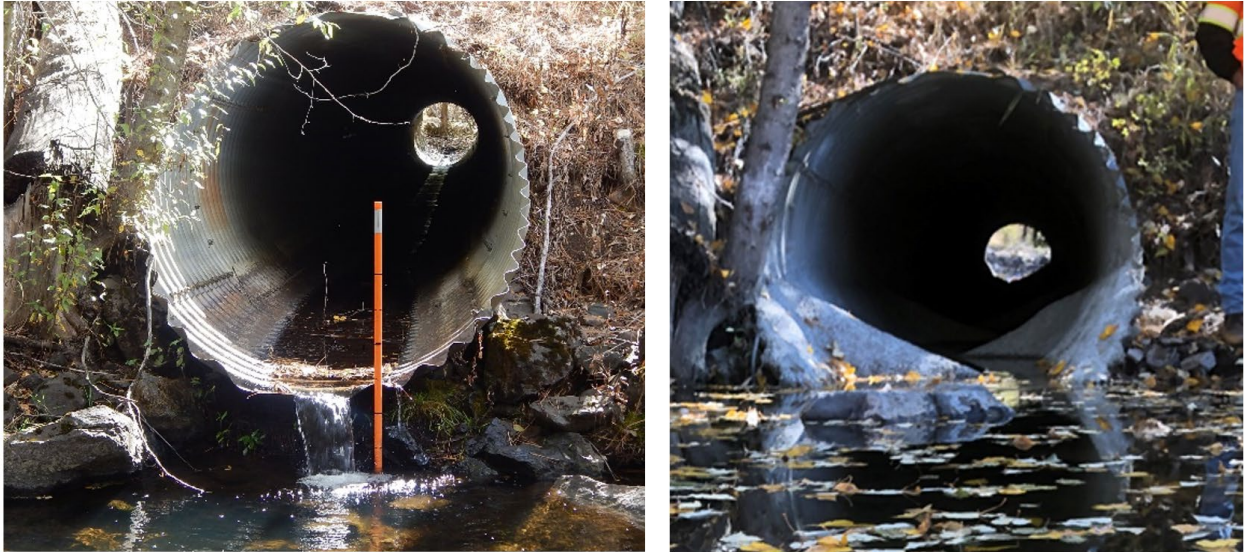
Figure 16: Marley Creek Culvert Repair, Before and After

Description: Two images, the first shows water running through the perched culvert pre-repair. The second image shows water backwatered to the culvert outlet with alternating baffles post-repair.

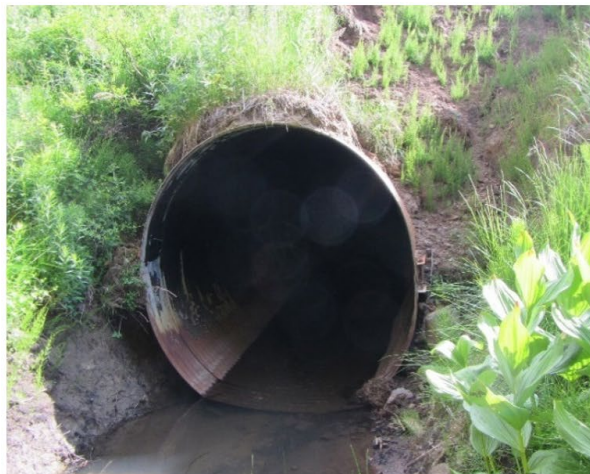
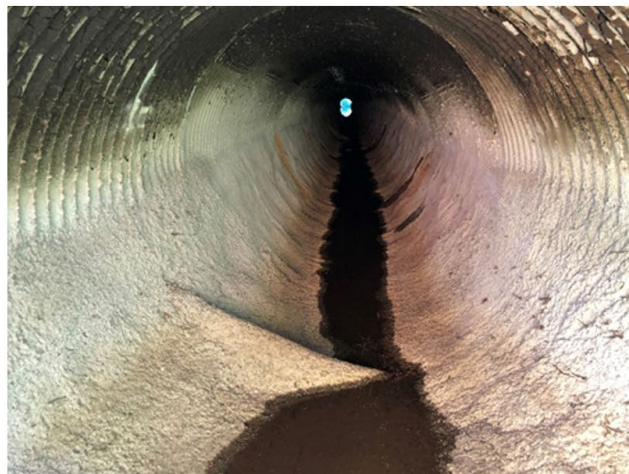
Figure 17: Two Mile Creek Culvert Repair, Before and After

Description: Two images, the first shows water running inside of the culvert pre-repair. The second image shows the paved invert of the culvert with corner baffles post-repair.
