SEISMIC PROTECTION DEVICES STUDY – MARQUAM BRIDGE

Final Report

Experimental Features 93-03

W. MARQUAM INTERCHANGE – MARQUAM BRIDGE SECTION

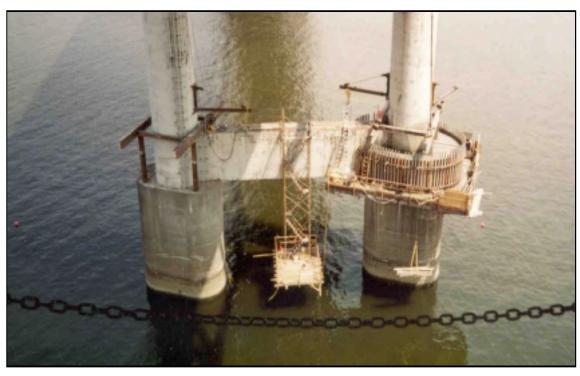
Figure 3.1: Collars Being Constructed Around Pier Columns

Installation of the VEP 1400/280-ST bearing/restraint devices at Piers #2 (left and right) and #5 (left and right) required that the existing base of the pier columns be modified to accommodate placement of the jacking columns. At the pier base, concrete support collars were constructed to carry the jacking pipe supports (Figure 3.1).

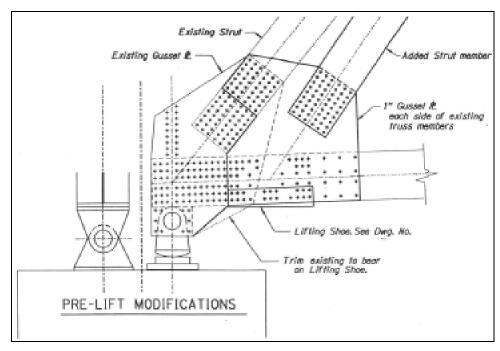
Figure 3.2: Additional Strut and Lifting Shoe Assembly at Piers #2 and #5

A lifting shoe for jacking the structure was constructed and bolted to the bottom of the bridge truss chord. An additional strut was attached to strengthen the structure to accommodate the jacking at the bearing connection (Figure 3.2).

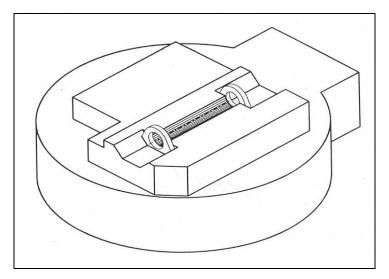
Figure 3.5: New Concrete Bearing Pedestal and Encapsulated Approach Bearing Device

A hydraulic crane lowered a new bearing shoe assembly from the top deck of the bridge. It was placed and bolted to the bottom of the truss chord. Fifteen 31.6 mm (1.25 in) threaded anchor rods, with two hex nuts and a 25.4 mm (1.0 in) x 150 mm (6 in) square plate at the top end of each rod, were drilled and bonded into the existing concrete. The bearing anchor plate was placed so that it was level and supported by the square plates on the anchor rods. The anchor plate was positioned with the transverse axis in line with the centerline of the bearing and the longitudinal axis aligned with the centerline of the bottom truss chord. The adjacent approach bearing device was not removed, but encapsulated in concrete as the concrete pedestal for the new bearing was constructed (Figure 3.5).

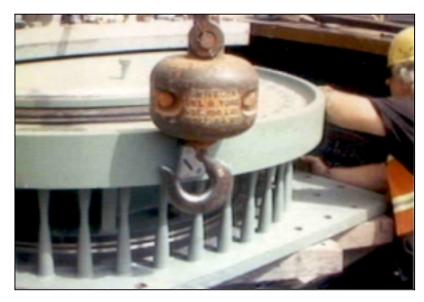
Figure 3.6: Bearing is Positioned between Masonry Plate and Top Sole Plate

The crane positioned on the top deck of the bridge lifted the new bearings from the bridge deck down the side of the bridge. The bearings were maneuvered onto the pier (Figure 3.6) and connected to the masonry plate and the sole plate of the bearing shoe assembly. Once the jacks were lowered, the bearing was operational, and carrying the live and dead loads of the structure.

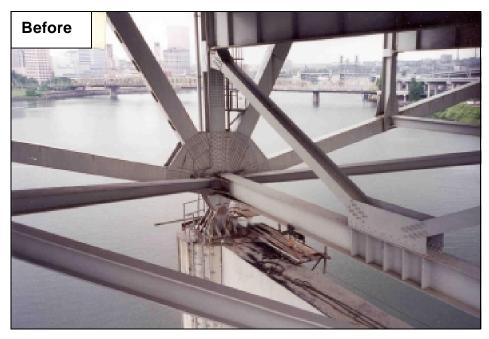
Figure 3.10A: Original Bearings on Pier #3

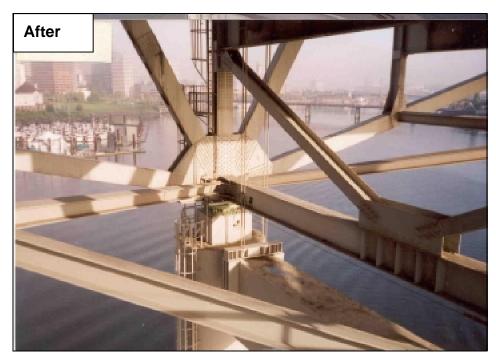
Figure 3.10B: New Bearings on Pier #4

Figure 3.10 (A & B) shows a "before" picture on Pier #3 with the original bearing and a picture on pier #4 after the VEP 5200 bearing/restraint device installation.

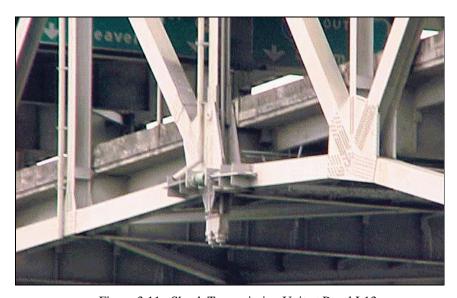
Safety hangers, installed on both sides of the main span of the bridge at panel points 13 and 21, are visible in Figure 3.11. These two panel points are the locations of the expansion joints for the suspended portion of the bridge.

Figure 3.11: Shock Transmission Unit at Panel L13

Shock transmission units were installed on each side of the lower deck bridge truss at panel points 13 and 21 (Figures 3.11 and 3.12). The shock transmission devices are designed to diffuse the rapidly applied loads of a seismic event. With their action, both longitudinal and

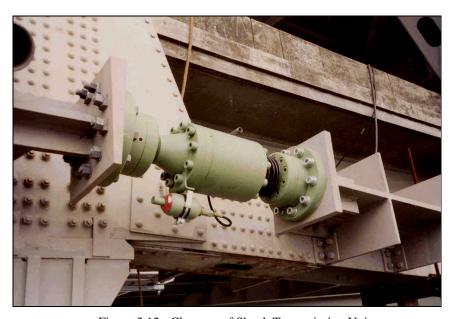
Figure 3.12: Close-up of Shock Transmission Unit
