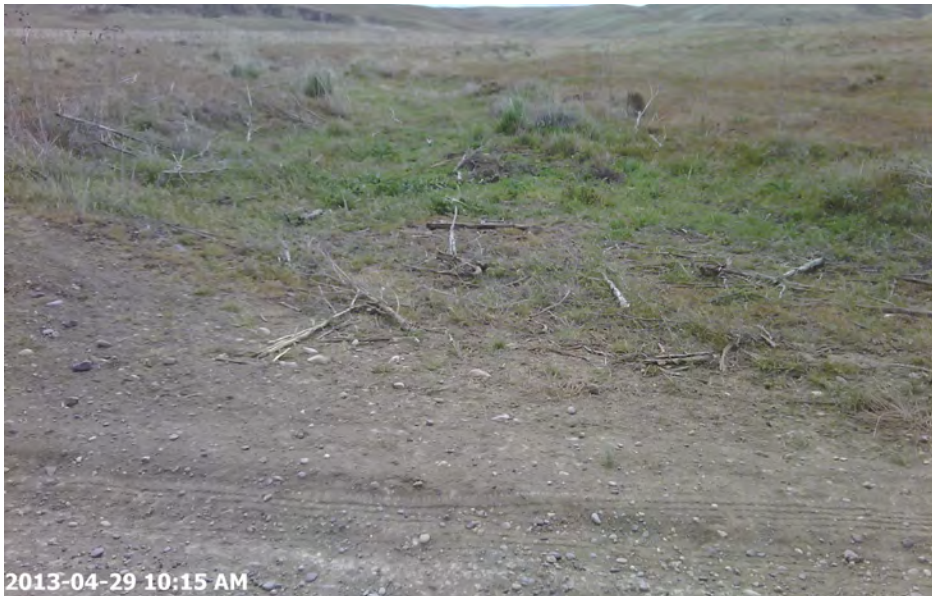
Photo P324. Feature MA\_TM\_432. Vegetated swale in the center of the image, access road in the foreground. Looking East, in Malheur County. 4/29/2013 10:11. Latitude 44.111768. Longitude -117.208615.

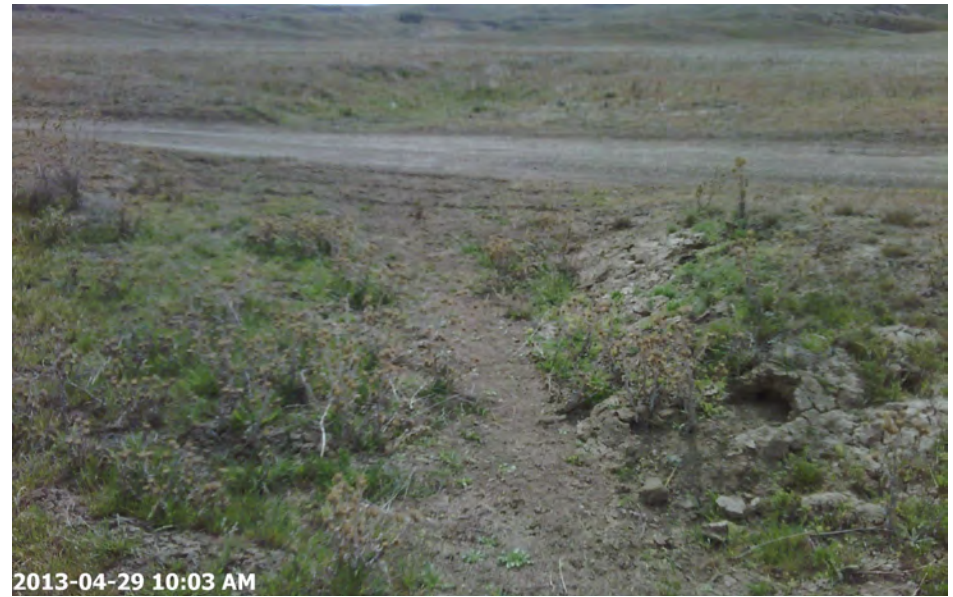
Photo P325. Feature MA\_TM\_431. Swale now used as a trail can be seen on either side of the access road. Looking SE, in Malheur County. 4/29/2013 9:59. Latitude 44.109813. Longitude -117.216273.

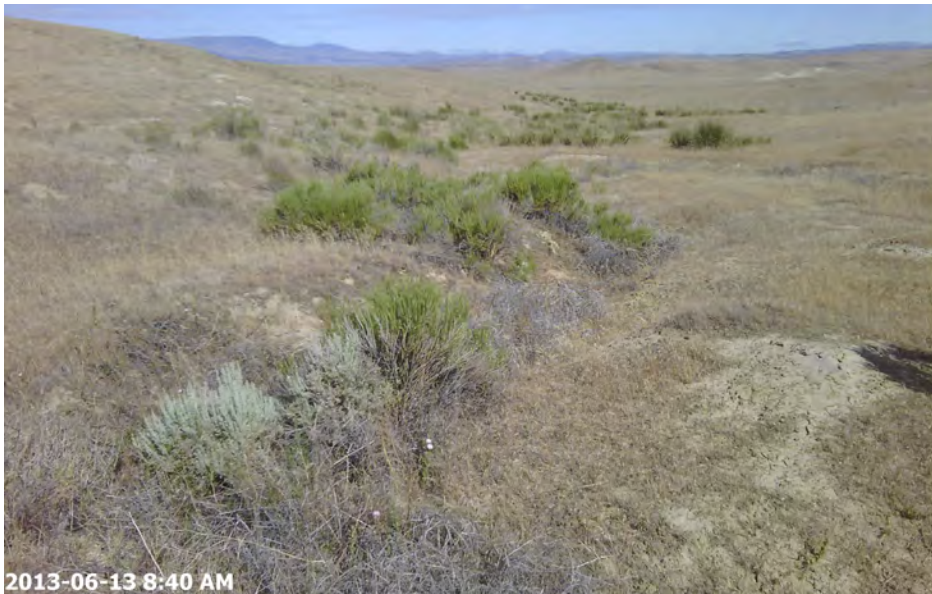
Photo P326. Feature MA\_TM\_466. Upland swale with no signs of water influence. Russian thistle in bottom of swale. Looking West, in Malheur County. 6/13/2013 8:39. Latitude 44.100628. Longitude -117.205499.

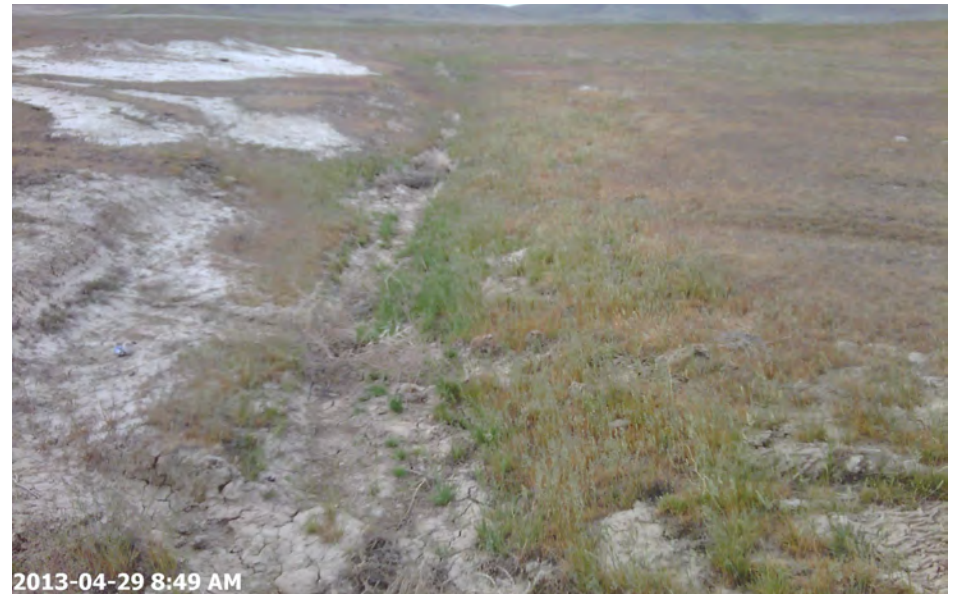
Photo P327. Feature MA\_TM\_427. Ephemeral channel in the center on the image with sediment deposits in channel. Looking SE, in Malheur County. 4/29/2013 8:46. Latitude 44.109076. Longitude -117.233024.

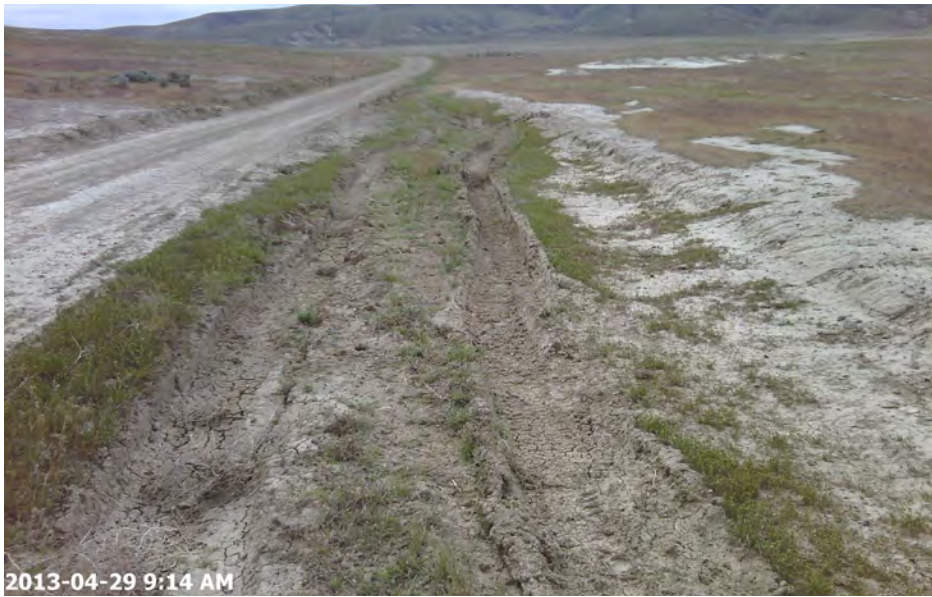
Photo P328. Feature MA\_TM\_428. Access road to the left and temporarily ponded area with old tire tracks in the center. Looking East, in Malheur County. 4/29/2013 9:16. Latitude 44.109363. Longitude -117.233629.

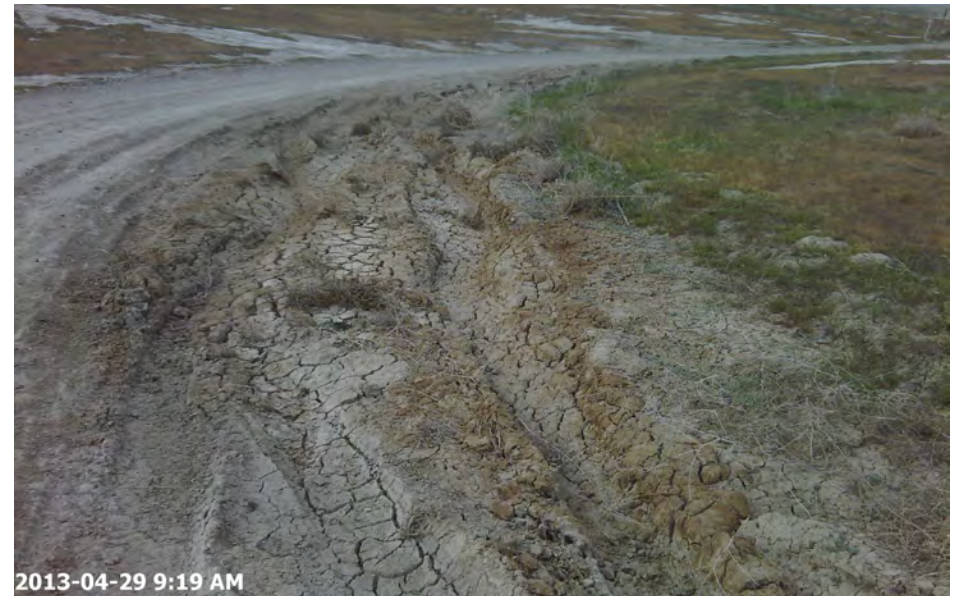
Photo P329. Feature MA\_TM\_429. Temporarily ponded area adjacent to road. No hydric soil or wetland vegetation indicators. Looking South, in Malheur County. 4/29/2013 9:20. Latitude 44.109438. Longitude -117.23451.

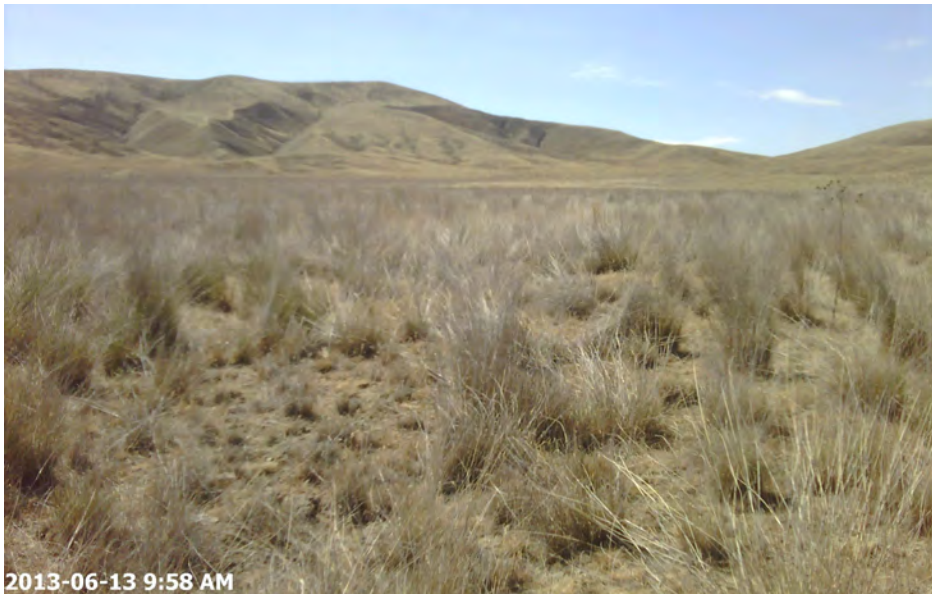
Photo P330. Feature MA\_TM\_472. Upland valley bottom with no signs of water influence in NWI mapped R4. Looking SE, in Malheur County. 6/13/2013 9:56. Latitude 44.090533. Longitude -117.230246.

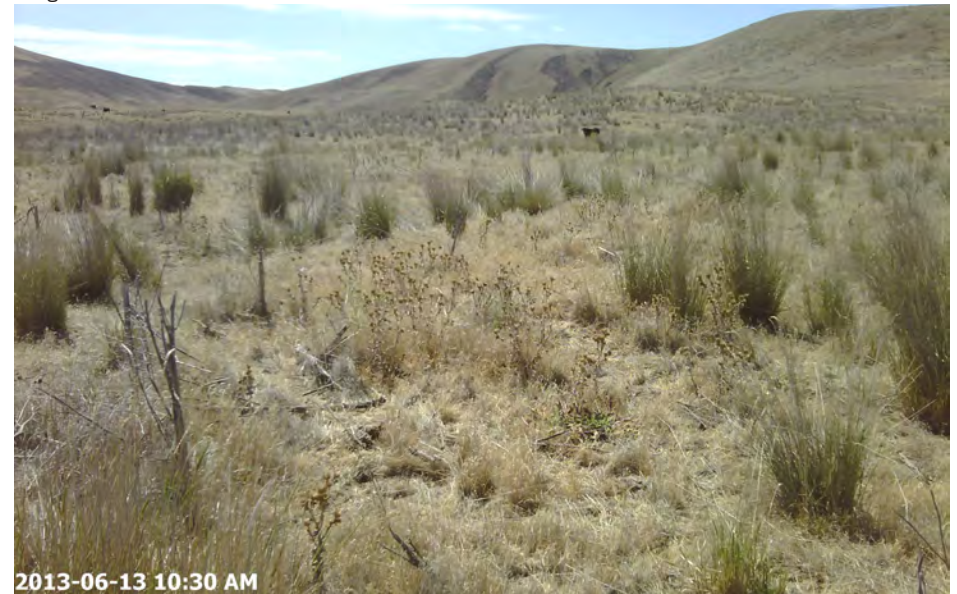
Photo P331. Feature MA\_TM\_475. Dry valley bottom with no channel indicators, livestock in the background. Looking South, in Malheur County. 6/13/2013 10:30. Latitude 44.08619. Longitude -117.244639.

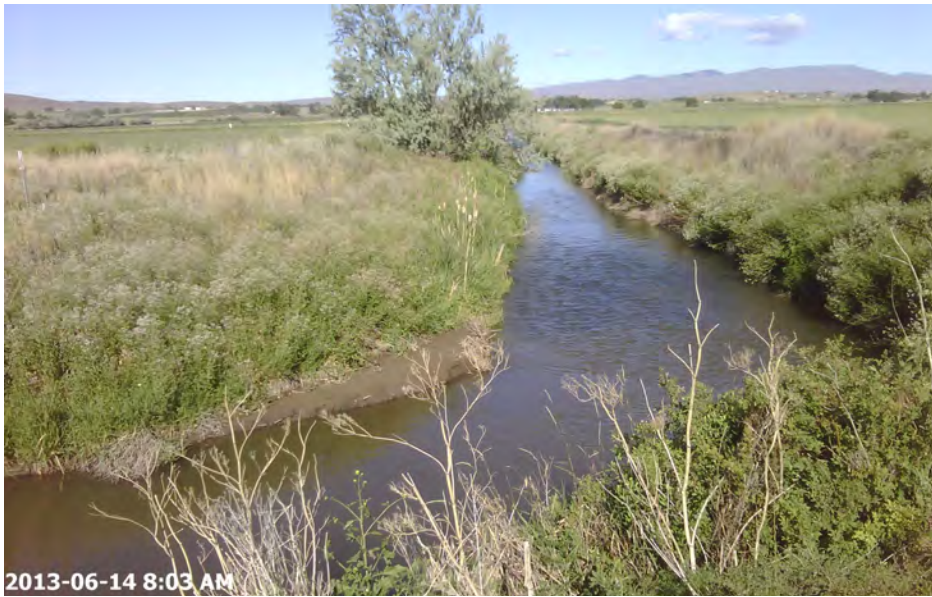
Photo P332. Feature MA\_TM\_481. Canal with dense *Lepidium* along bank. Looking West, in Malheur County. 6/14/2013 7:59. Latitude 44.076246. Longitude -117.285267.

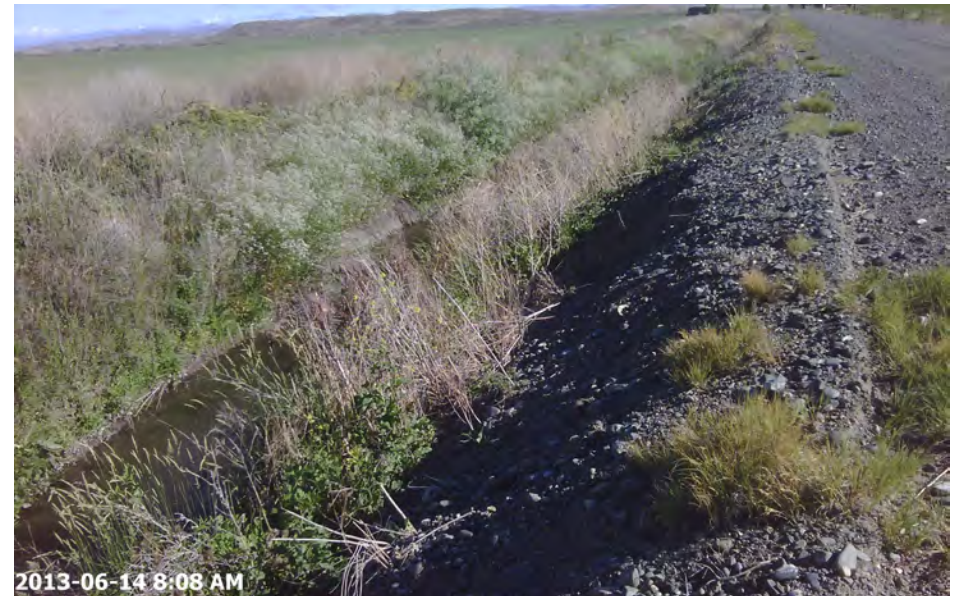
Photo P333. Feature MA\_TM\_482. Irrigation canal running adjacent to a gravel access road. Looking North, in Malheur County. 6/14/2013 8:07. Latitude 44.076409. Longitude -117.285293.

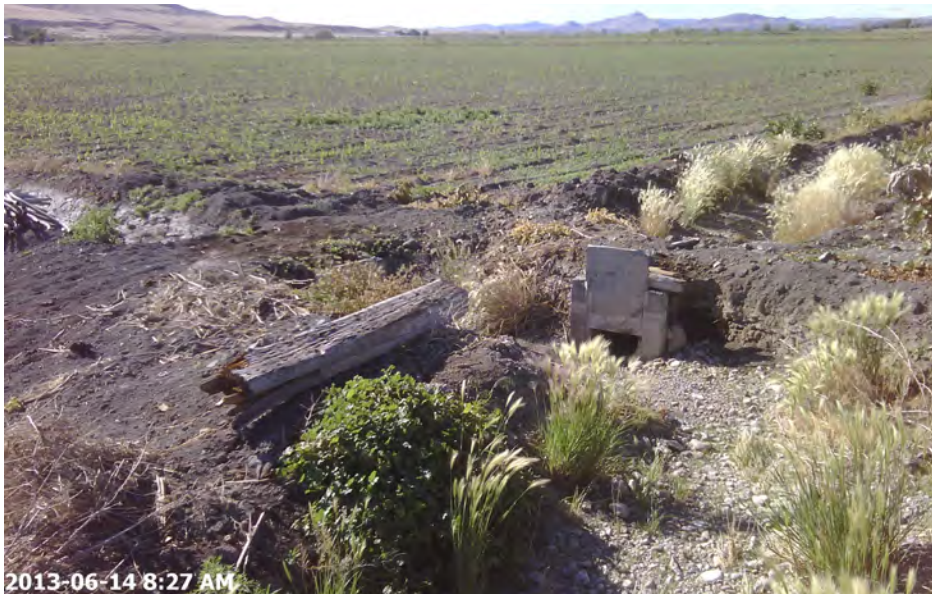
Photo P334. Feature MA\_TM\_483. Irrigation ditch with a cement control structure in the center of the image. Looking East, in Malheur County. 6/14/2013 8:24. Latitude 44.076207. Longitude -117.28519.

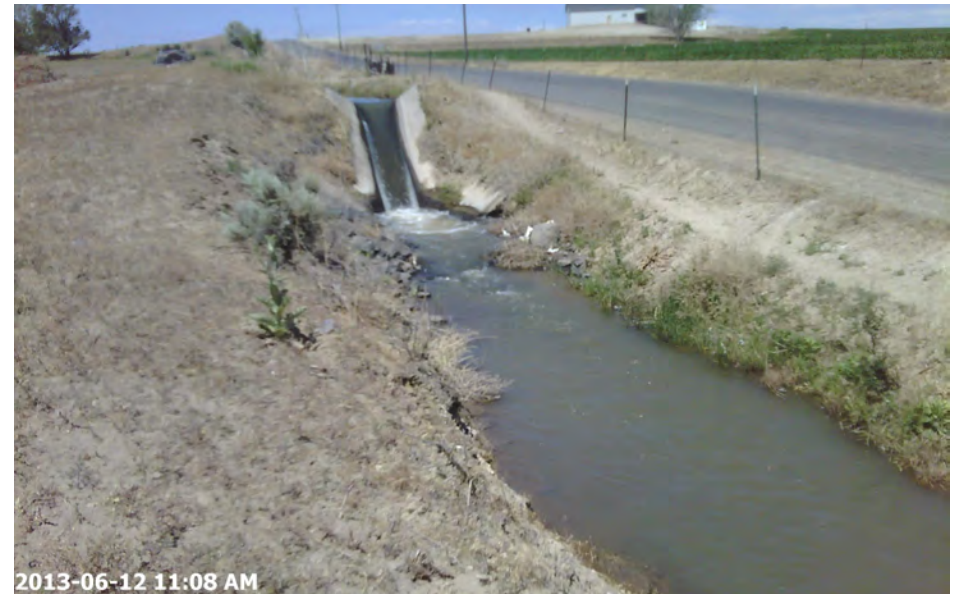
Photo P335. Feature MA\_TM\_465. Cement spillway in the center of the image with the paved road to the right. Looking West, in Malheur County. 6/12/2013 11:04. Latitude 44.068933. Longitude -117.309946.

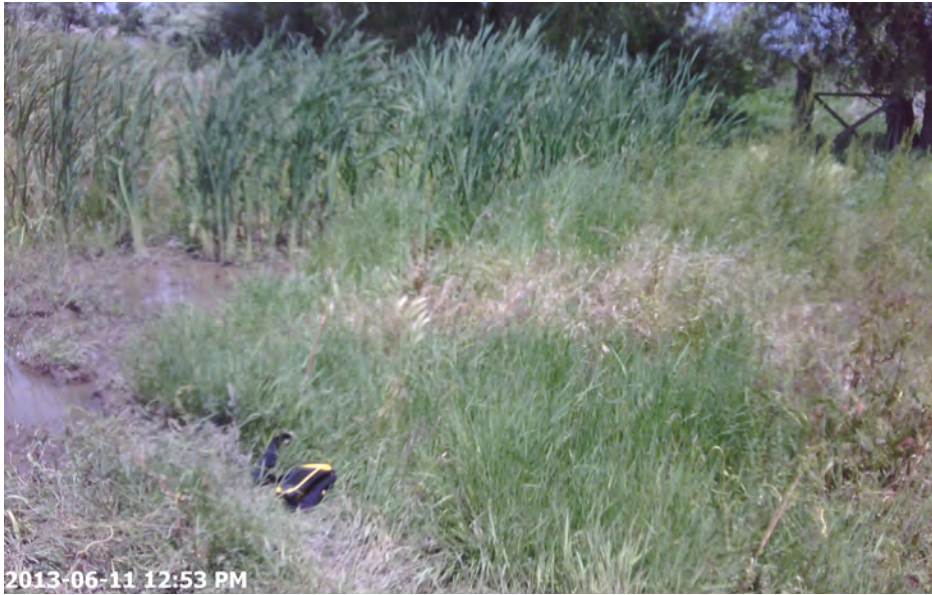
Photo P336. Feature MA\_TM\_460. Wetland to the left of the yellow GPS unit and upland to the right. Looking NE, in Malheur County. 6/11/2013 12:50. Latitude 44.065308. Longitude -117.315484.

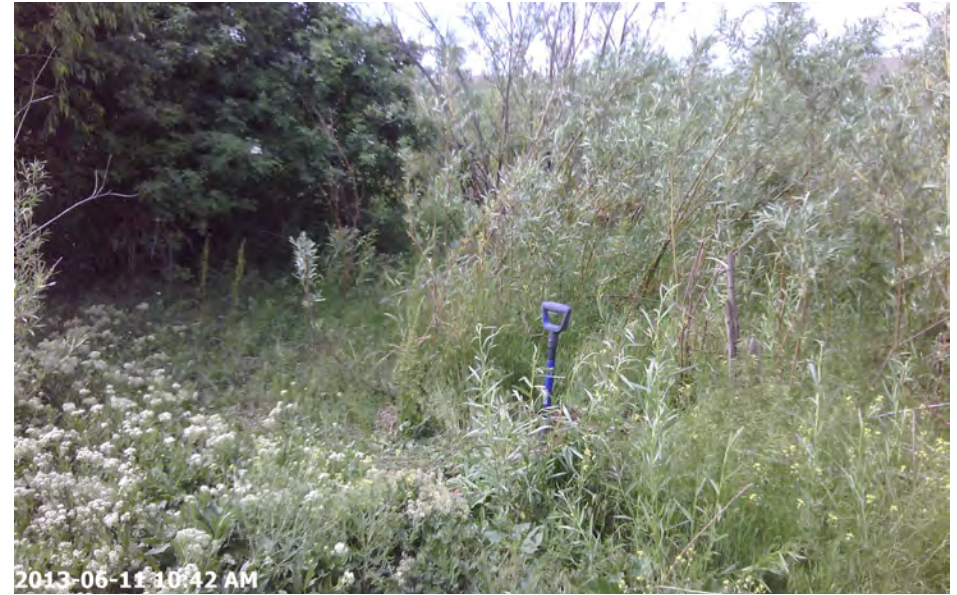
Photo P337. Feature MA\_TM\_459. Shovel marks upland plot in area with whitetop and rose, no wetland indicators. Looking SW, in Malheur County. 6/11/2013 10:41. Latitude 44.062566. Longitude -117.316686.

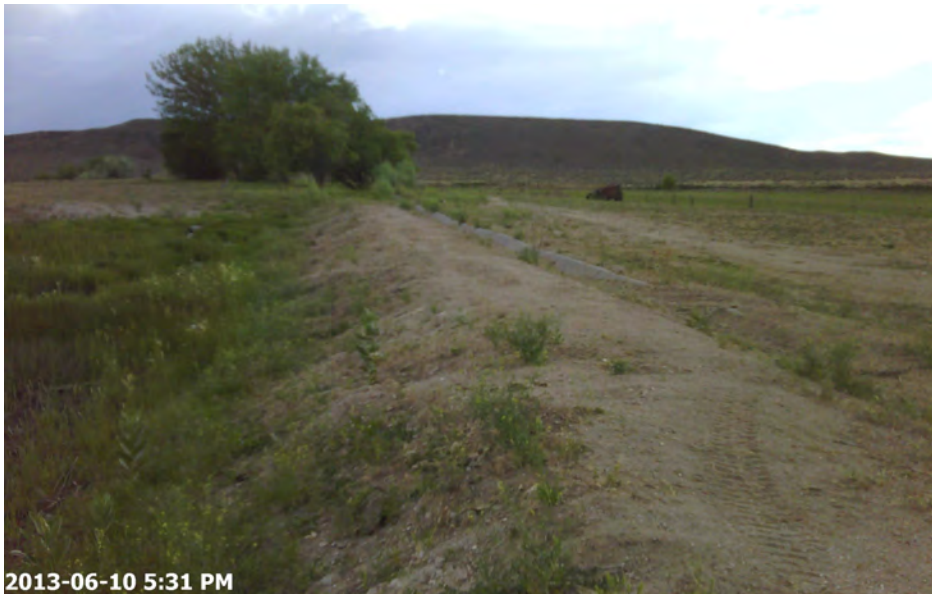
Photo P338. Feature MA\_TM\_453. Survey area to the right of the constructed berm, upland meadow with no wetland indicators. Looking SW, in Malheur County. 6/10/2013 17:30. Latitude 44.062212. Longitude -117.324042.

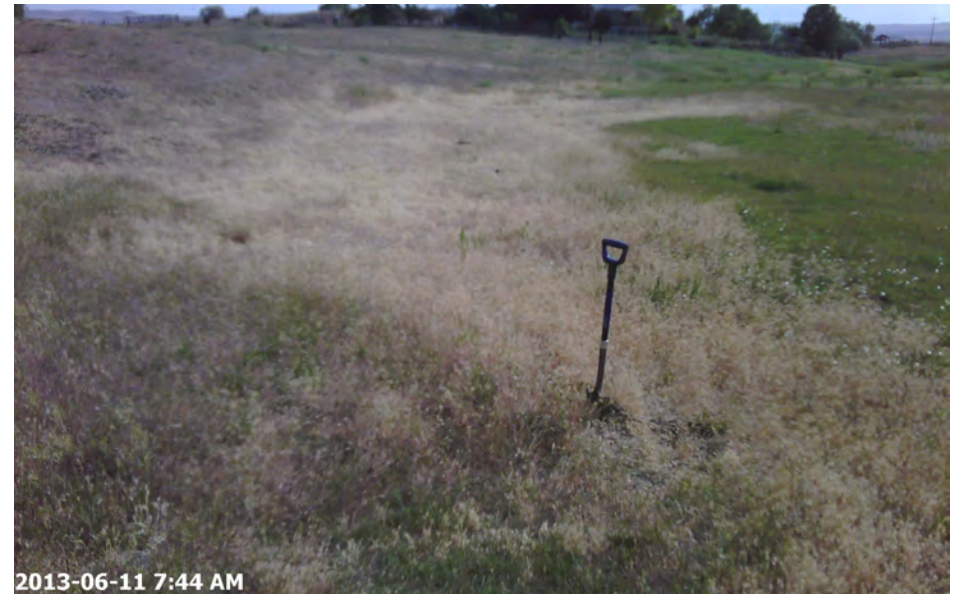
Photo P339. Feature MA\_TM\_456. Shovel in center of the image marks the upland verification plot, houses in the background. Looking NE, in Malheur County. 6/11/2013 7:43. Latitude 44.067678. Longitude -117.325256.

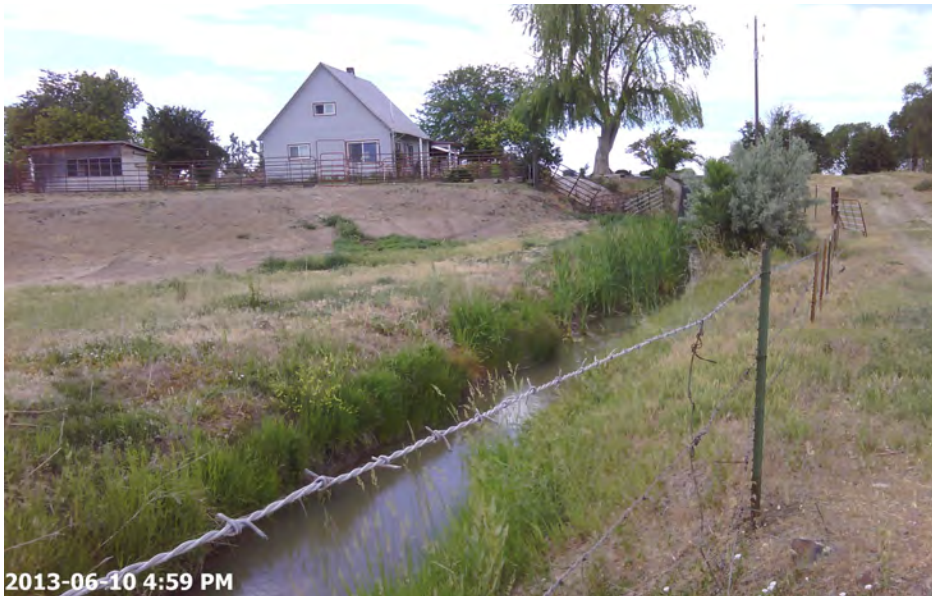
Photo P340. Feature MA\_TM\_452. Canal with narrow wetland fringe. Looking NW, in Malheur County. 6/10/2013 16:50. Latitude 44.067454. Longitude -117.325326.

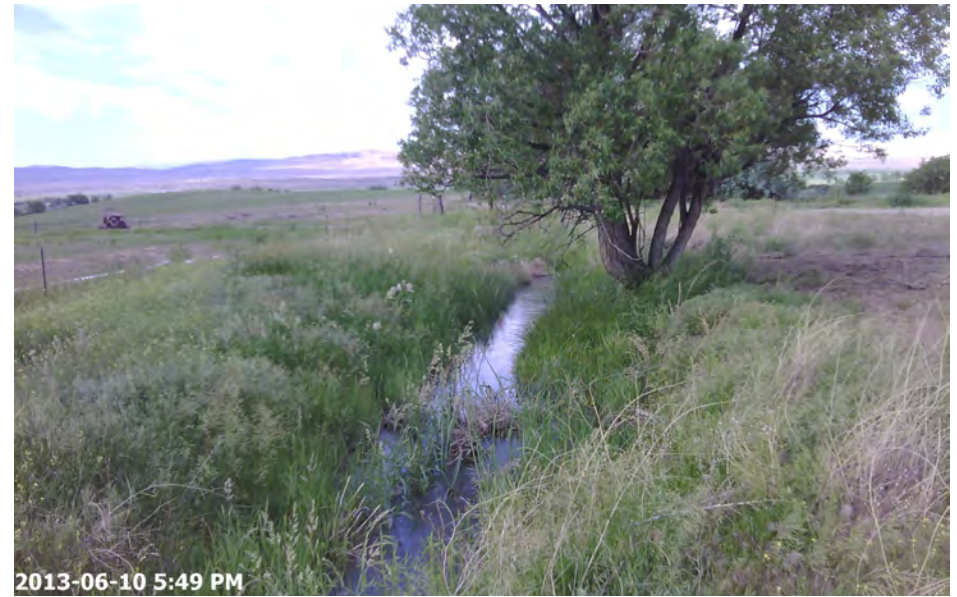
Photo P341. Feature MA\_TM\_454. Irrigation canal with fringe wetland within bankful width located in the center of the image. Looking East, in Malheur County. 6/10/2013 17:41. Latitude 44.060782. Longitude -117.325825.

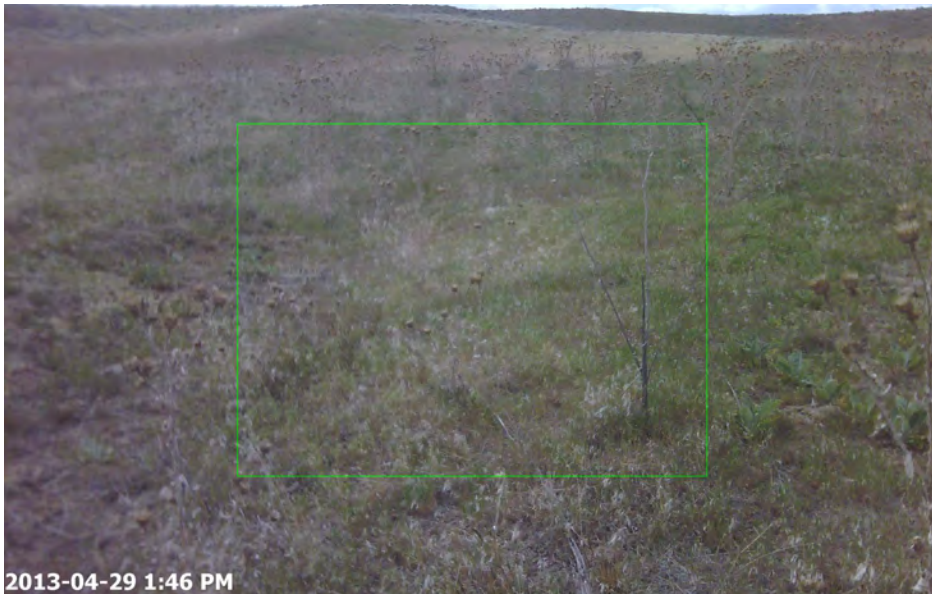
Photo P342. Feature MA\_TM\_036. Well vegetated upland swale with no signs of a channel. Looking West, in Malheur County. 4/29/2013 13:46. Latitude 44.058867. Longitude -117.354668.

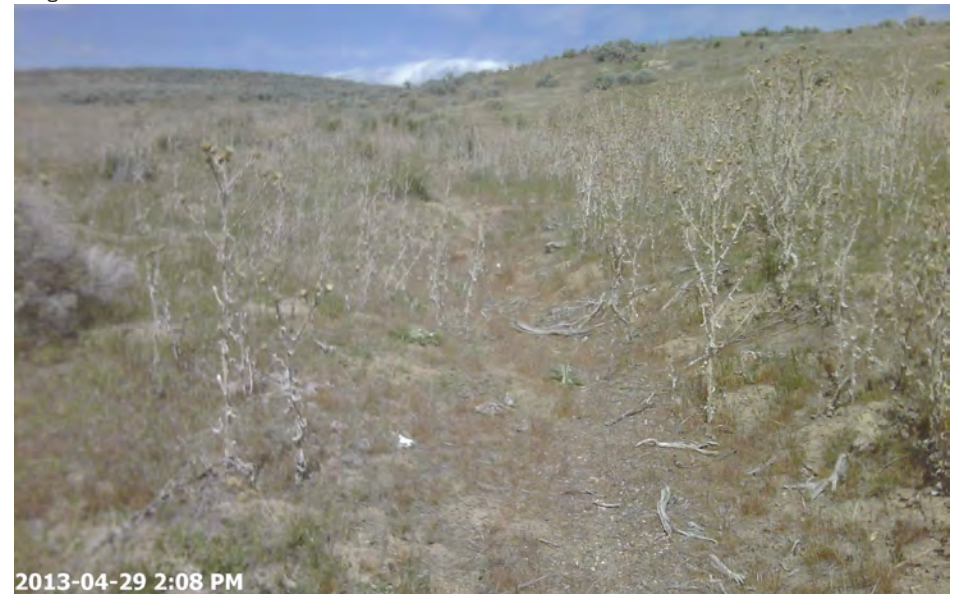
Photo P343. Feature MA\_TM\_037. Upland swale with no signs of an active channel. Looking North, in Malheur County. 4/29/2013 14:06. Latitude 44.058775. Longitude -117.36484.

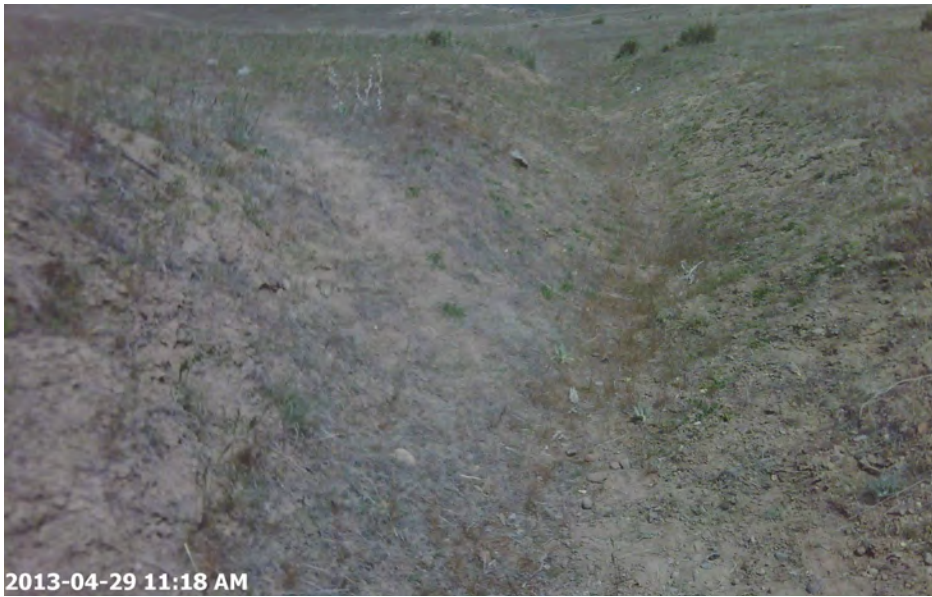
Photo P344. Feature MA\_TM\_033. Upland swale with sparse upland vegetation. Looking North, in Malheur County. 4/29/2013 11:19. Latitude 44.057348. Longitude -117.390193.

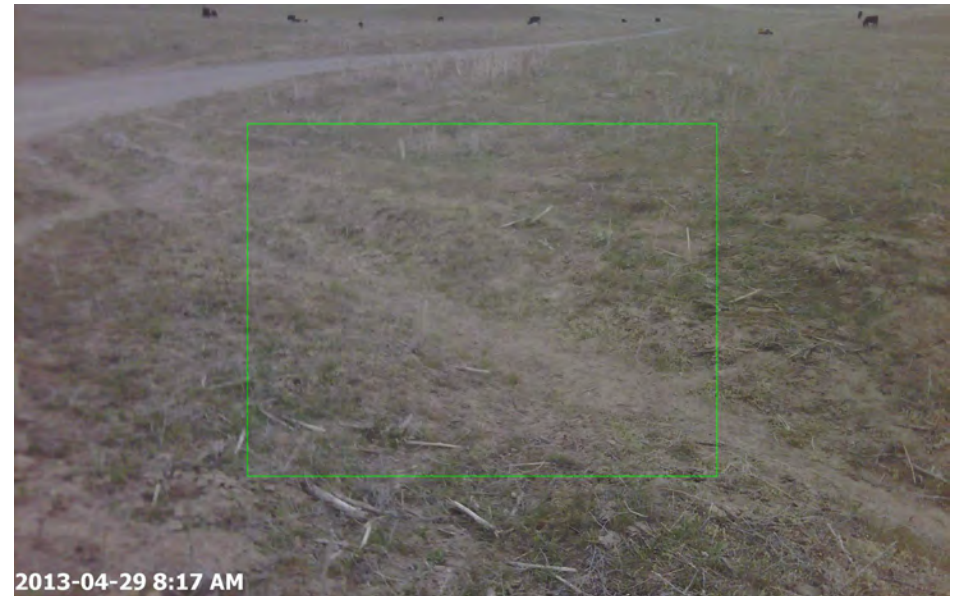
Photo P345. Feature MA\_TM\_022. Livestock disturbed upland grassland, no wetland indicators. Looking North, in Malheur County. 4/29/2013 8:15. Latitude 44.051465. Longitude -117.389768.

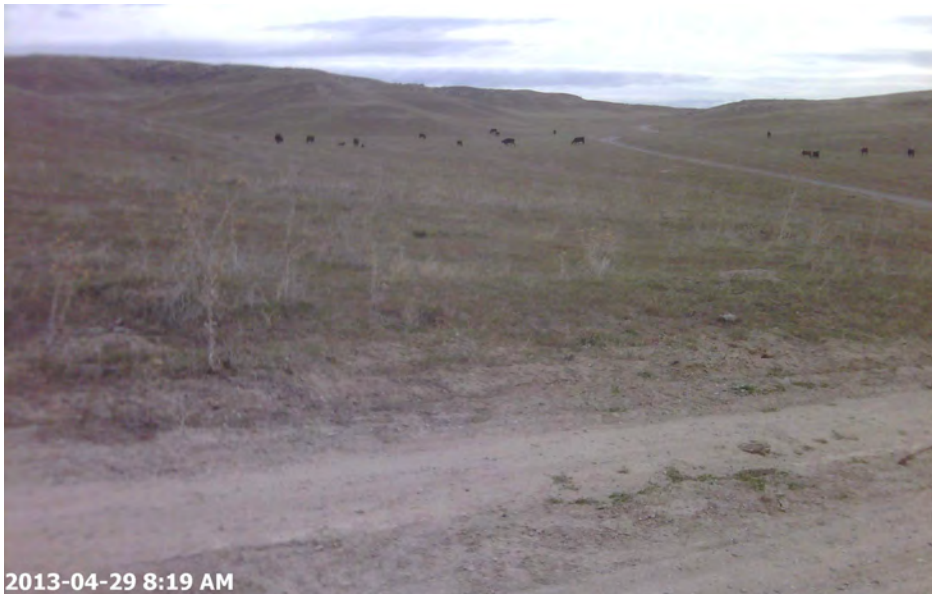
Photo P346. Feature MA\_TM\_023. No signs of an active channel at NHD mapped line, livestock in the background. Looking NE, in Malheur County. 4/29/2013 8:18. Latitude 44.051554. Longitude -117.390371.

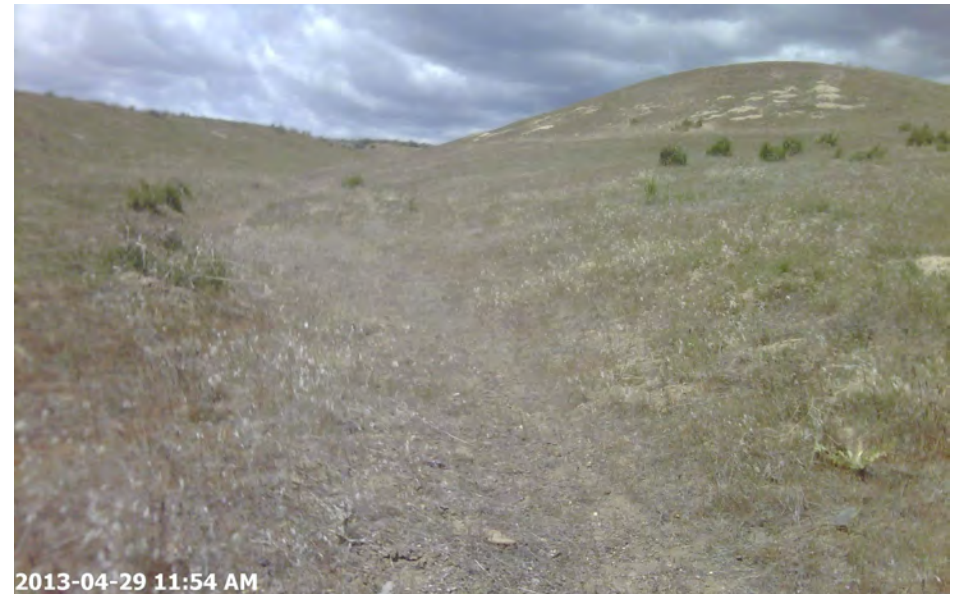
Photo P347. Feature MA\_TM\_034. Swale located in the bottom of a steep depression, no signs of past flow or bed and bank development. Looking North, in Malheur County. 4/29/2013 11:49. Latitude 44.056965. Longitude -117.393635.

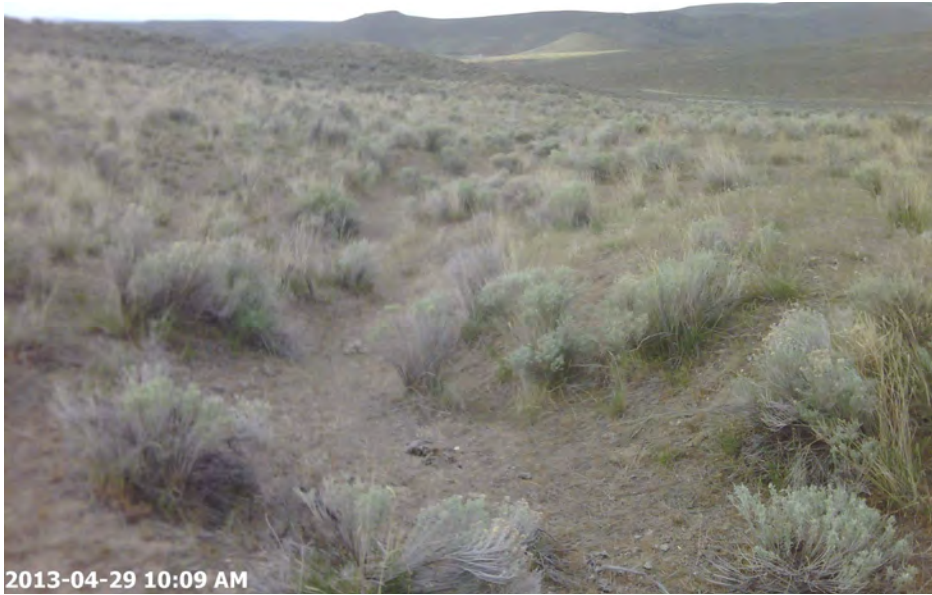
Photo P348. Feature MA\_TM\_030. Dry gully in sagebrush shrubland with no signs of an active channel. Looking South, in Malheur County. 4/29/2013 10:09. Latitude 44.05135. Longitude -117.414001.

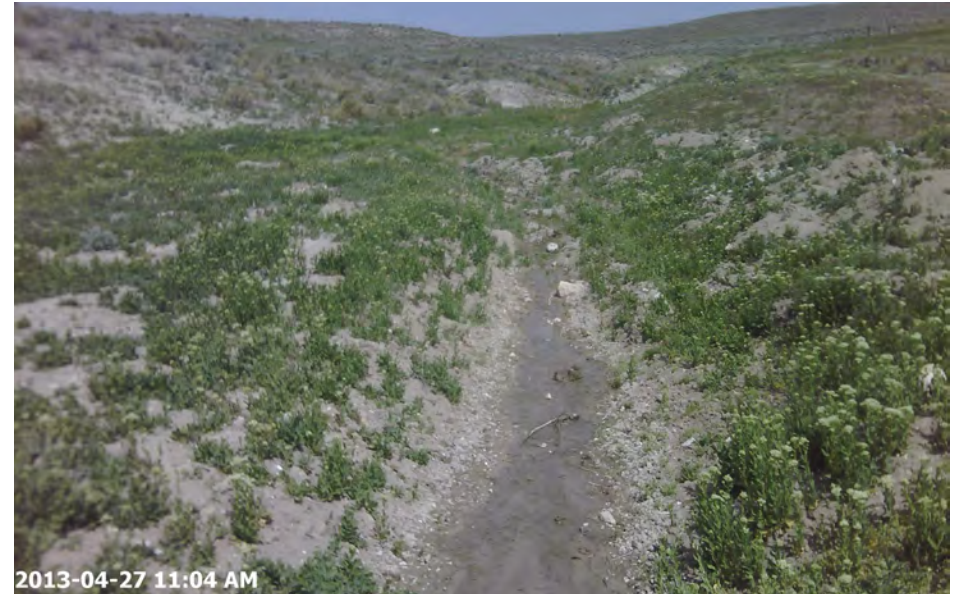
Photo P349. Feature MA\_TM\_005. Small channel in the center of the image surrounded by whitetop. Looking North, in Malheur County. 4/27/2013 10:42. Latitude 44.034972. Longitude -117.480431.

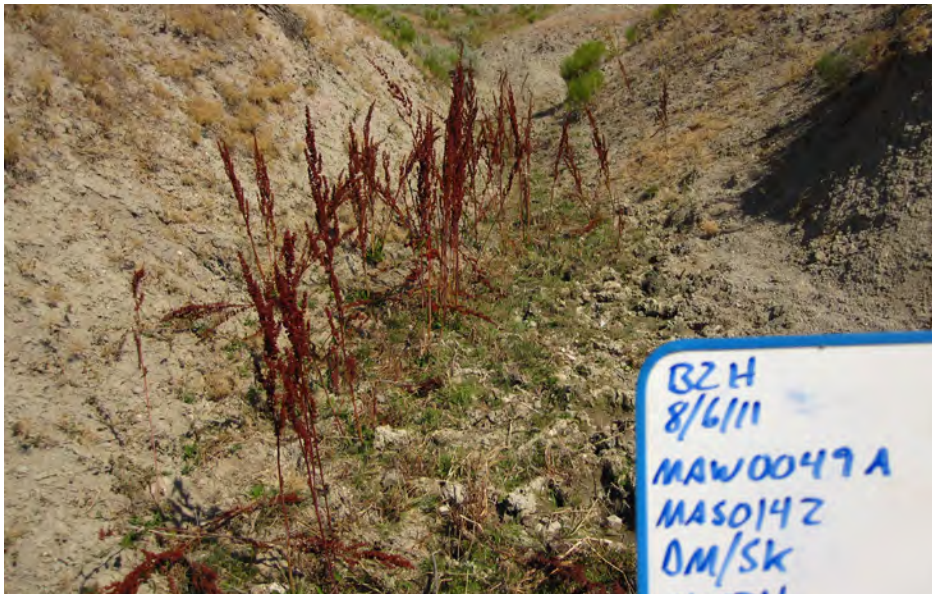
Photo P350. Feature MA\_W\_0049. Narrow swale with wetland located in the bottom. Signs of livestock use visible. Looking North, in Malheur County. 8/6/2011. Latitude 44.036011. Longitude -117.480609.

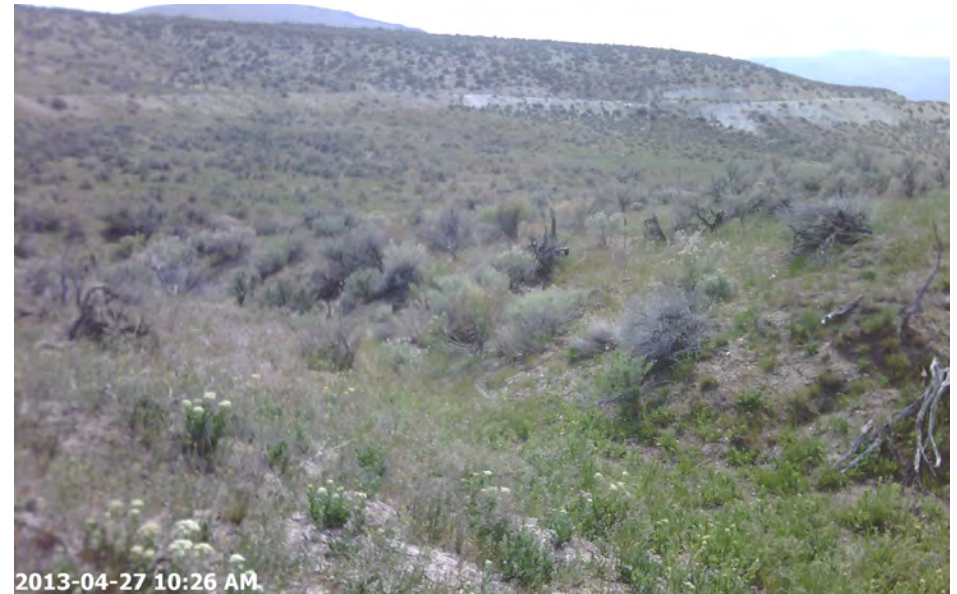
Photo P351. Feature MA\_TM\_004. Vegetated upland swale with no signs of an active channel. Looking East, in Malheur County. 4/27/2013 10:21. Latitude 44.033999. Longitude -117.480376.

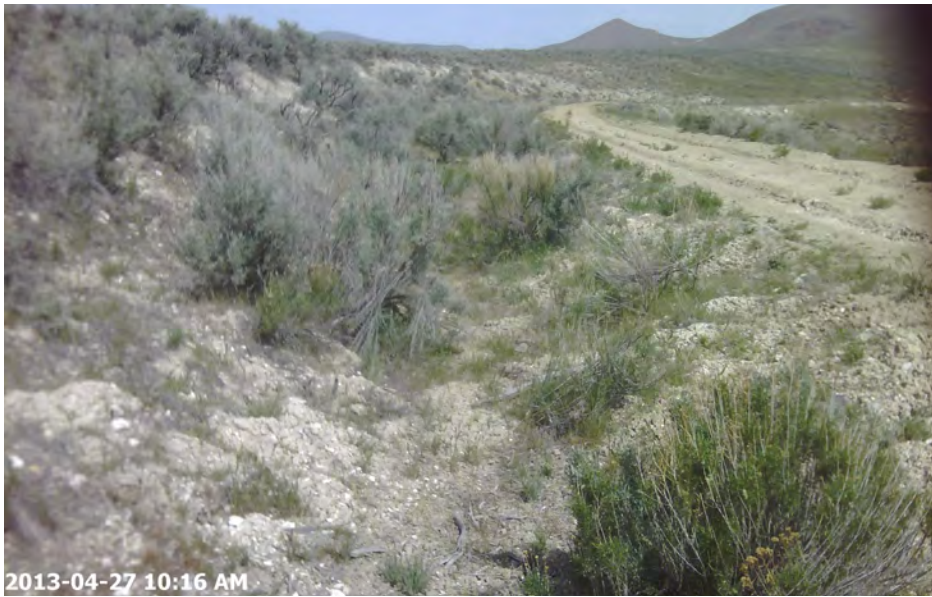
Photo P352. Feature MA\_TM\_003. Drainage gully adjacent to access road, no signs of an active channel. Looking North, in Malheur County. 4/27/2013 10:15. Latitude 44.031652. Longitude -117.480749.

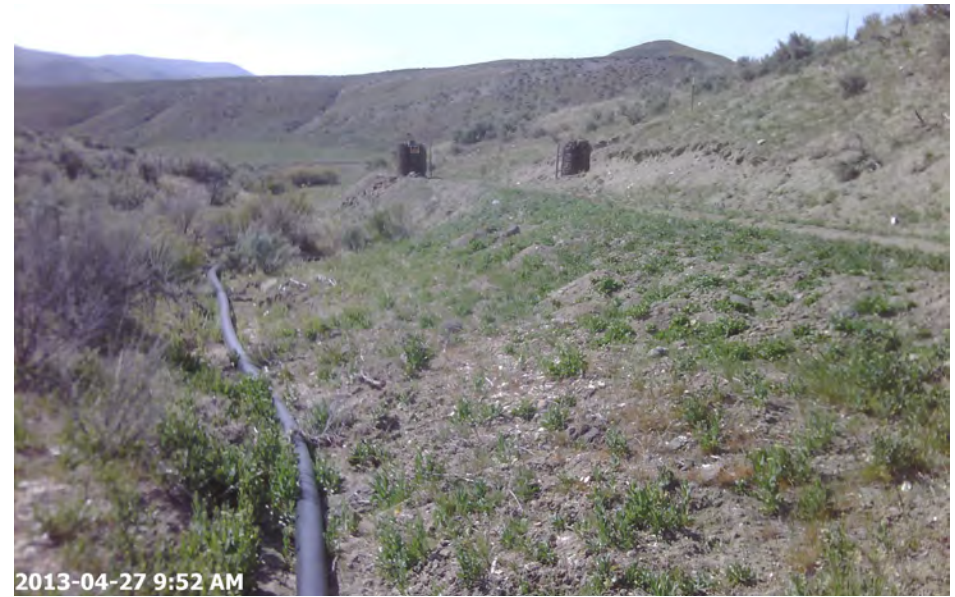
Photo P353. Feature MA\_TM\_001. Ephemeral drainage containing a large pipe located adjacent to the access road. Looking South, in Malheur County. 4/27/2013 9:38. Latitude 44.027021. Longitude -117.477596.

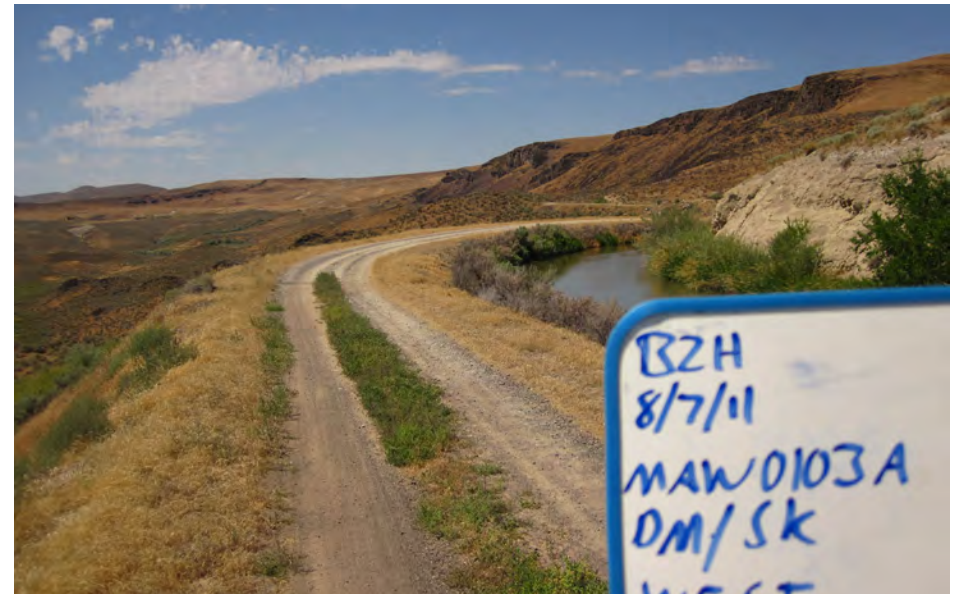
Photo P355. Feature MA\_W\_0103. Canal bank, no wetland indicators. Looking West, in Malheur County. 8/7/2011. Latitude 43.964768. Longitude -117.460751.

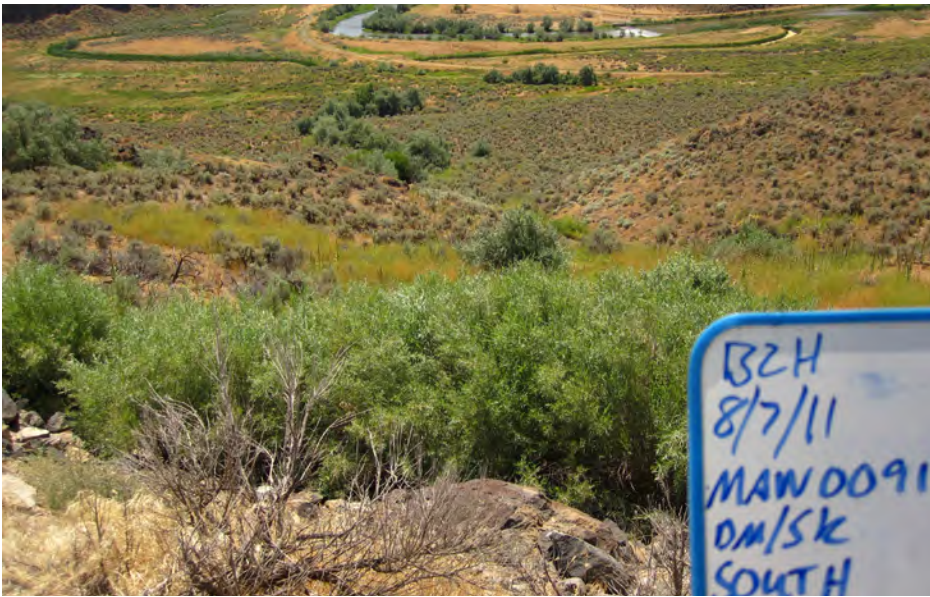
Photo P356. Feature MA\_W\_0091. Canal bank looking out at valley below road. No wetland indicators on roadbed. Looking South, in Malheur County. 8/7/2011. Latitude 43.964598. Longitude -117.463602.

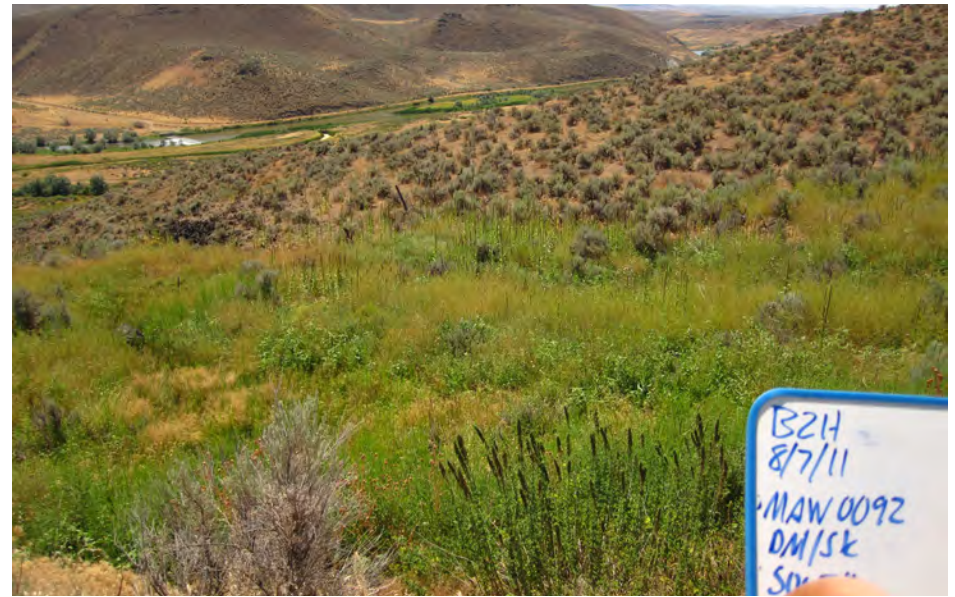
Photo P357. Feature MA\_W\_0092. Upland ravine with river in the valley below. Looking South, in Malheur County. 8/7/2011. Latitude 43.964604. Longitude -117.464553.

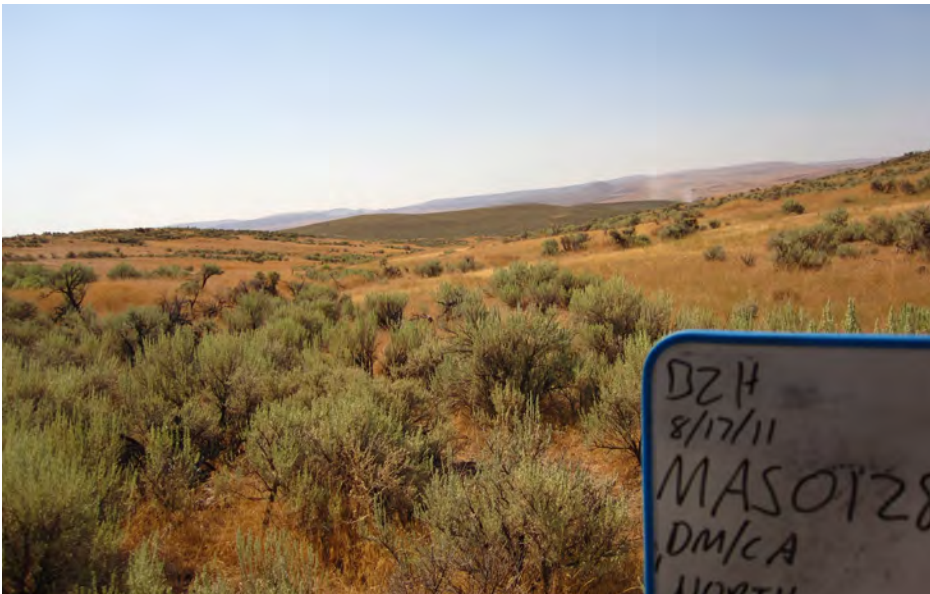
Photo P362. Feature MA\_S\_0128. Sagebrush dominated depression with no signs of a channel. Looking North, in Malheur County. 8/17/2011. Latitude 43.924714. Longitude -117.456285.

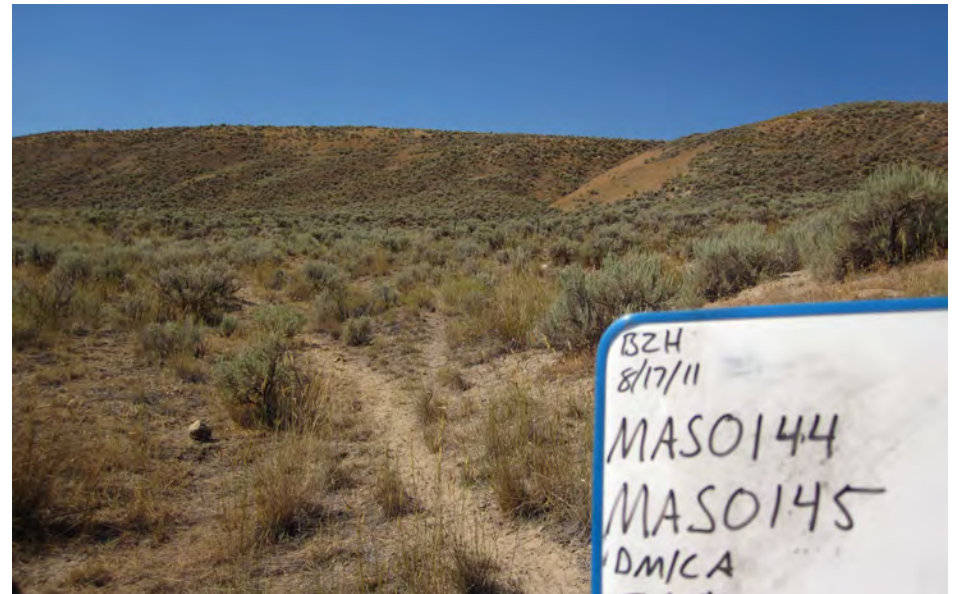
Photo P363. Feature MA\_S\_0144. Livestock trail at the base of a slope, no signs of a channel. Looking East, in Malheur County. 8/17/2011. Latitude 43.911667. Longitude -117.446756.

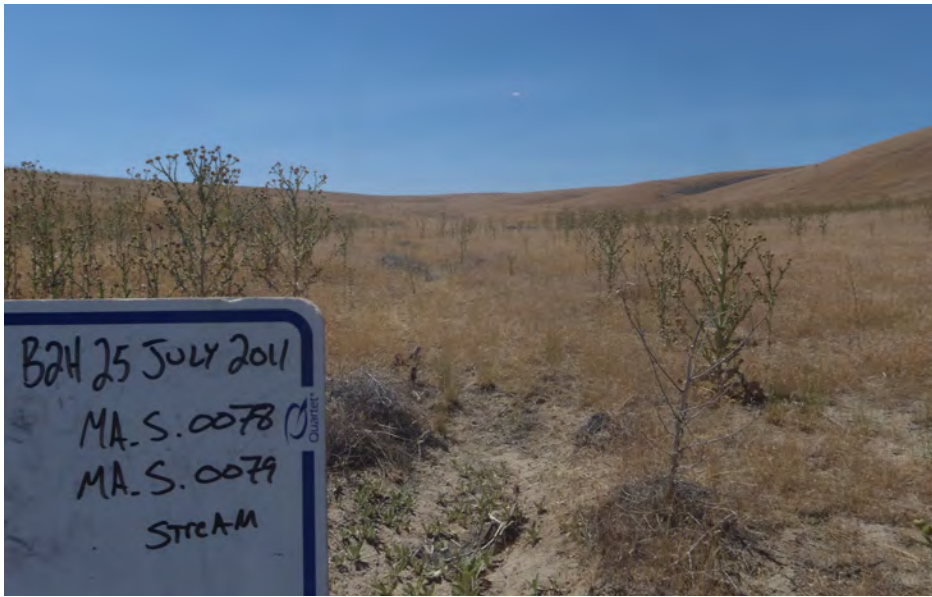
Photo P364. Feature MA\_S\_0078. Vegetated depression in a broad valley, thistle visible throughout, no signs of a channel. Looking SW, in Malheur County. 7/25/2011. Latitude 43.850278. Longitude -117.276738.

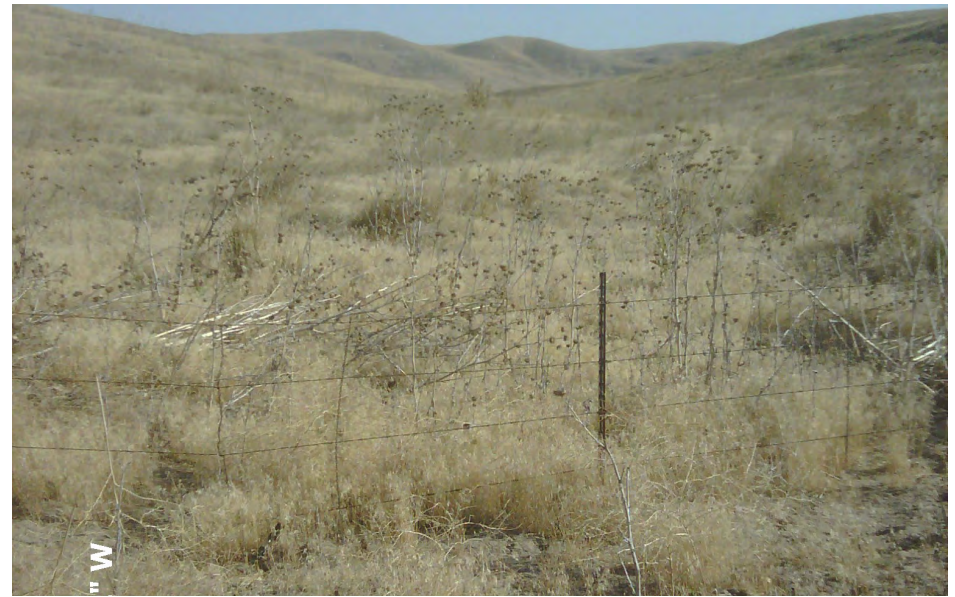
Photo P365. Feature MApro\_397. Dry valley with fence line visible in center of image. Looking South, in Malheur County. 7/31/2012 8:37. Latitude 43.835499. Longitude -117.263293.
