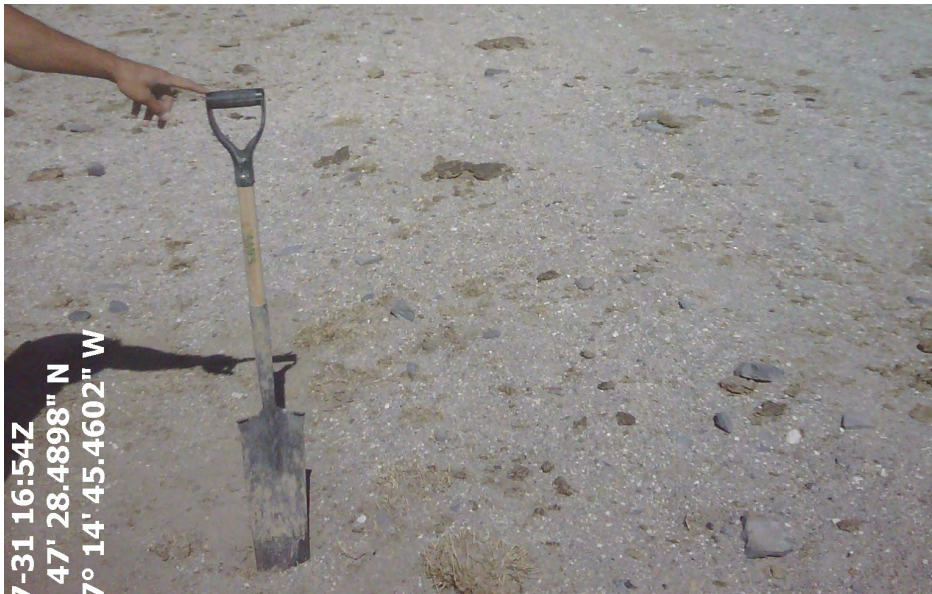
Photo P366. Feature Malpro\_631. Biologist holding shovel to the left of the image with road to the right. Looking West, in Malheur County. 7/31/2012 9:52. Latitude 43.791246. Longitude -117.245943.

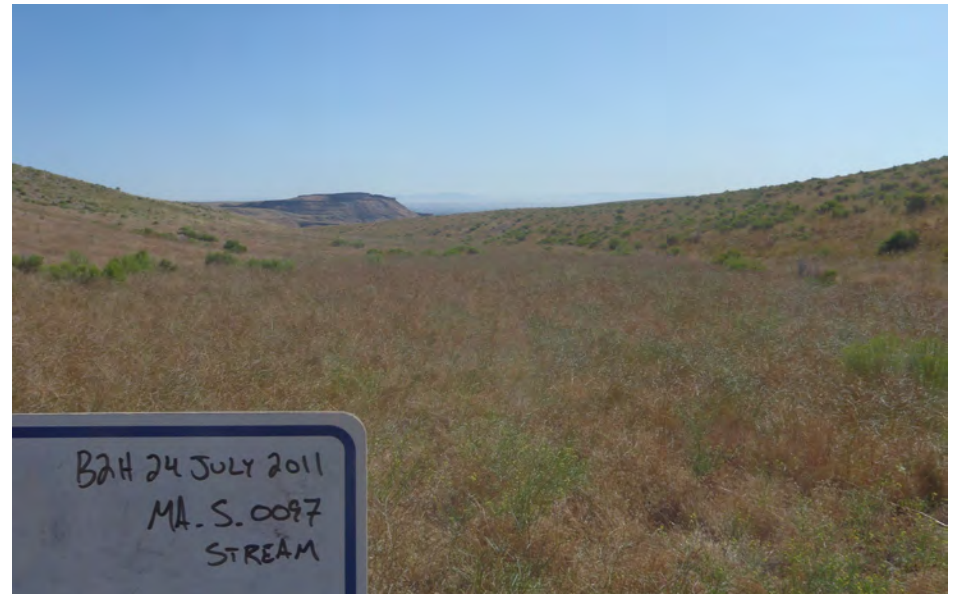
Photo P368. Feature MA\_S\_0097. Upland valley with no signs of an active channel. Looking North, in Malheur County. 7/25/2011. Latitude 43.692461. Longitude -117.133495.

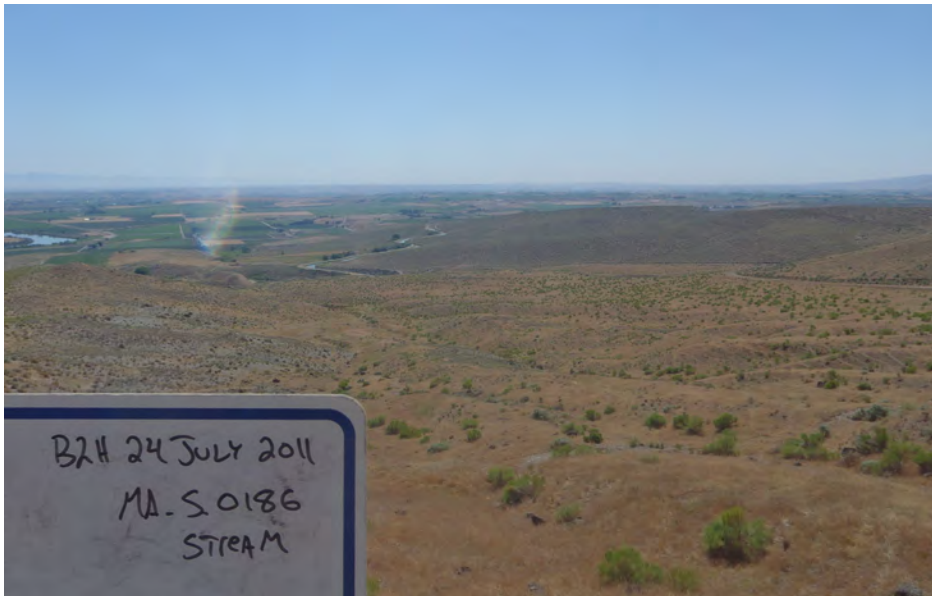
Photo P369. Feature MA\_S\_0186. Upland swale in the center of the image, view of the valley. Looking North, in Malheur County. 7/24/2011. Latitude 43.669045. Longitude -117.12302.

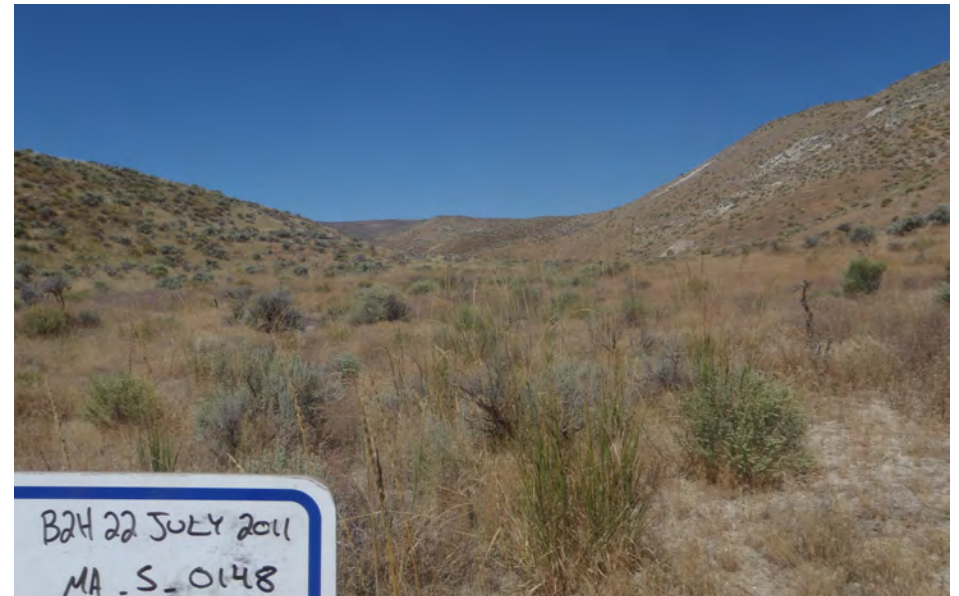
Photo P370. Feature MA\_S\_0148. Broad valley with no signs of an active channel. Looking West, in Malheur County. 7/22/2011. Latitude 43.631602. Longitude -117.101459.

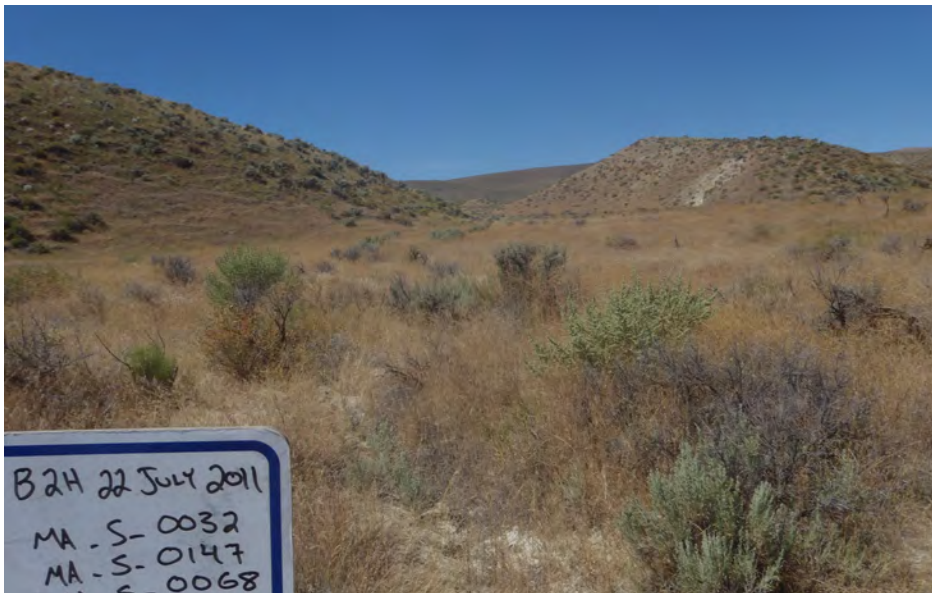
Photo P371. Feature MA\_S\_0032. Upland valley with no signs of an active channel. Looking West, in Malheur County. 7/22/2011. Latitude 43.631114. Longitude -117.098012.

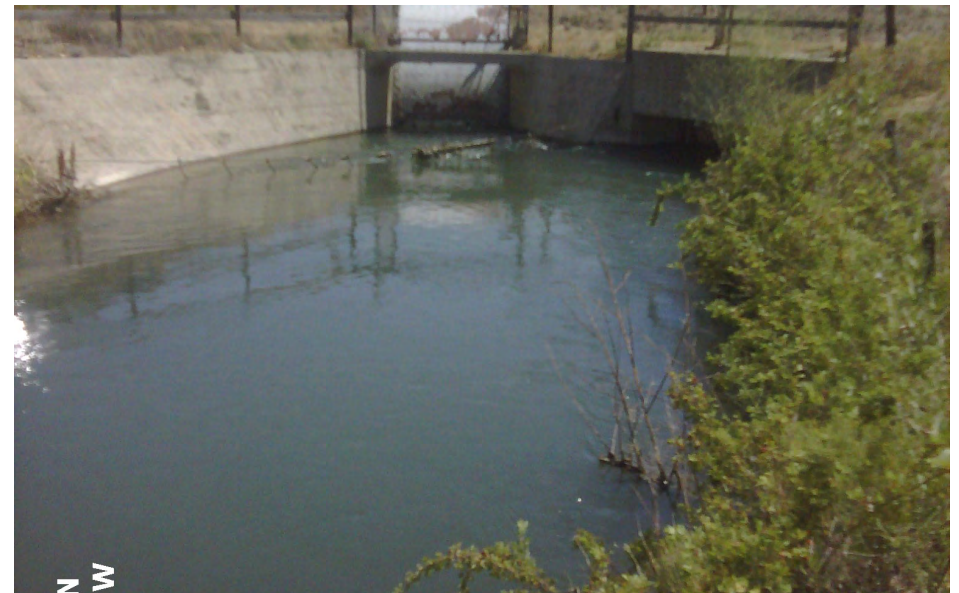
Photo P373. Feature MAPro\_435. Irrigation canal with flow control structure in the center of the image. Looking East, in Malheur County. 7/28/2012 12:20. Latitude 43.586434. Longitude -117.076679.

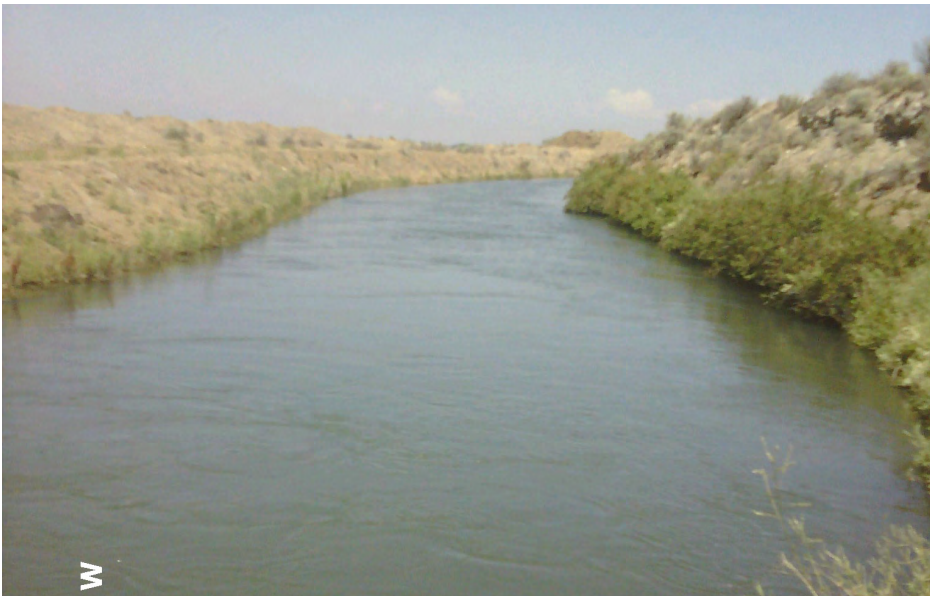
Photo P374. Feature MApro\_437. Bankfull irrigation canal in the center of the image. Looking NE, in Malheur County. 7/28/2012 14:38. Latitude 43.586088. Longitude -117.073656.

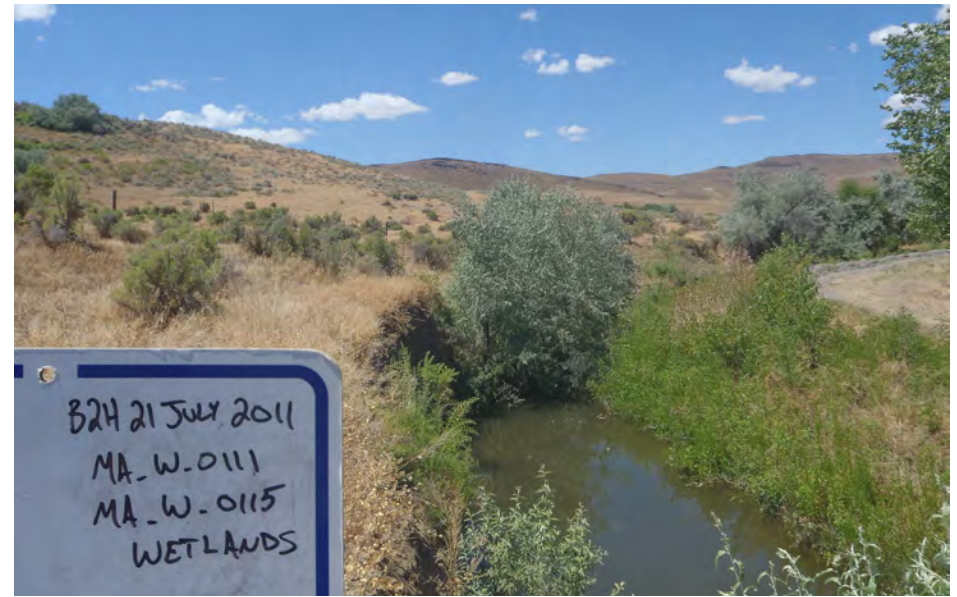
Photo P375. Feature MA\_W\_0111. Stream to the right of the image with a steep cut bank, no wetland indicators. Looking SW, in Malheur County. 7/21/2011. Latitude 43.58832. Longitude -117.068044.

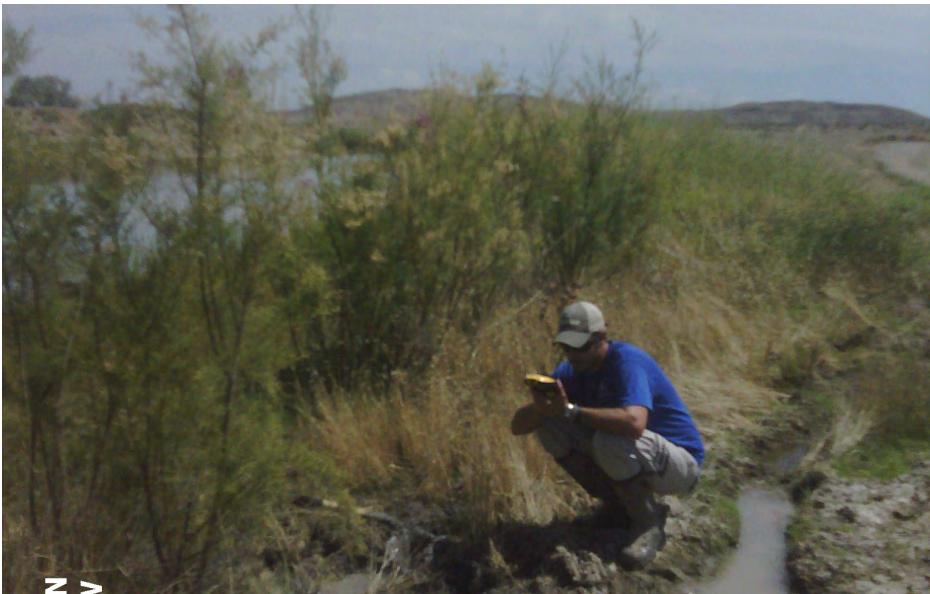
Photo P376. Feature MApro\_446. Irrigation canal with fringe wetland, biologist in the background. Looking East, in Malheur County. 7/27/2012 11:49. Latitude 43.562297. Longitude -117.050256.

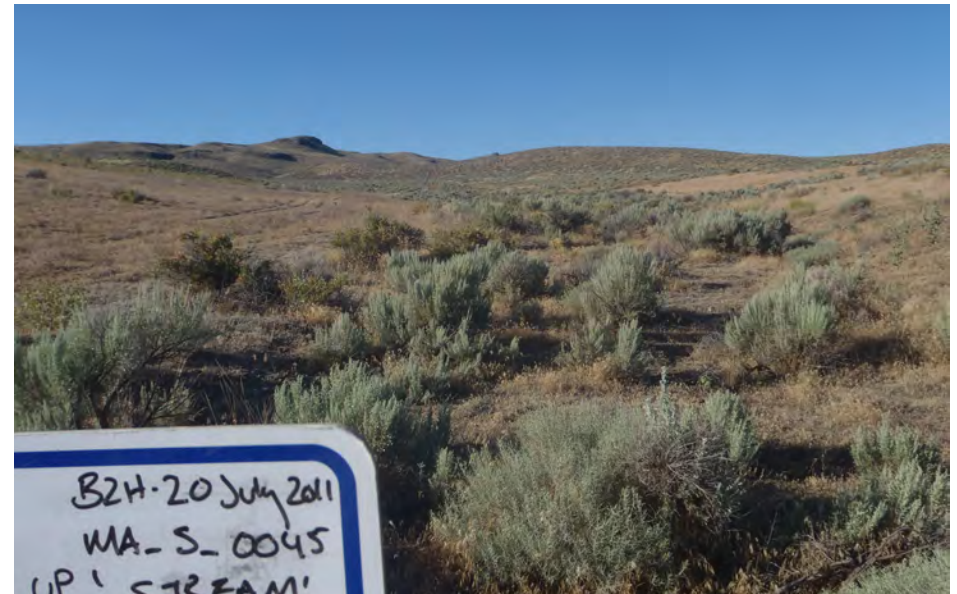
Photo P378. Feature MA\_S\_0045. Sagebrush dominated swale in the center of the image, no signs of an active channel. Looking North, in Malheur County. 7/20/2011. Latitude 43.559166. Longitude -117.034679.
