Douglas County - Bullock Road

Douglas County - Scottsburg West Road

Tillamook County – Trask River Road

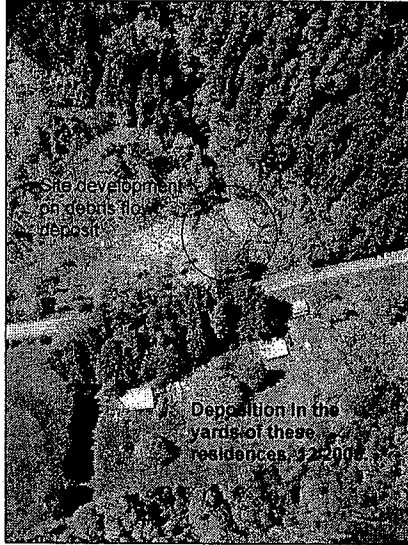
Left - Slide out of unmanaged BLM old growth impacted site during 05/06 winter. Several homes on debris fan impacted with mud against them and in yards. Note the recent development.

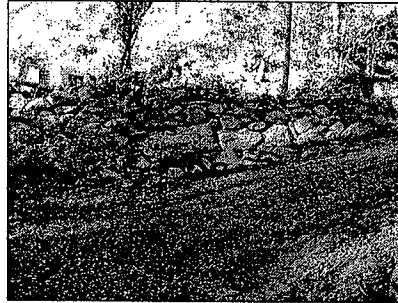
Below - Home site being prepared on debris fan within area impacted by recent slide. Large boulders from the recent slide have been cleared off the home site and used in a retaining wall for the driveway.

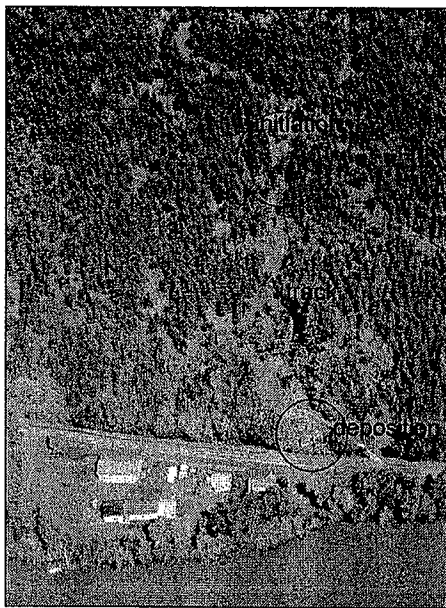
Left - Slide impacted site during 05/06 winter.

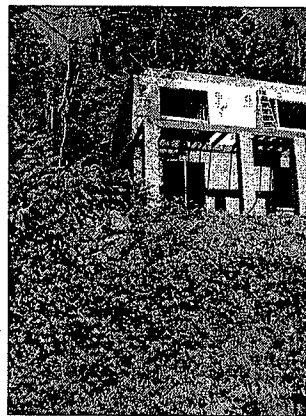
Below - Home is being constructed on debris fan within area impacted by recent slide.

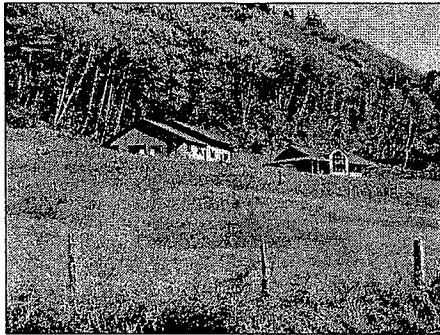
Below – Two new homes constructed over the past year cut into the toe of a steep slope.

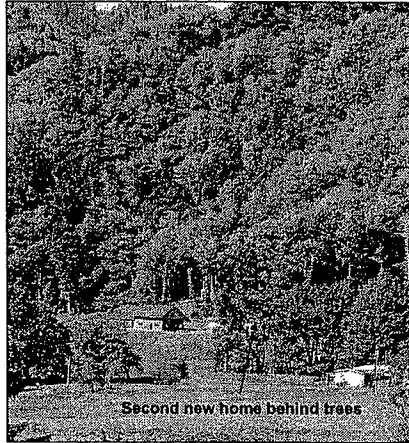
Right – Hillslope affected by the new home development. Tillamook State Forest had plans to harvest the area and have since backed off due to construction of the homes.
