Appendix A – Selected Images

Rogue River

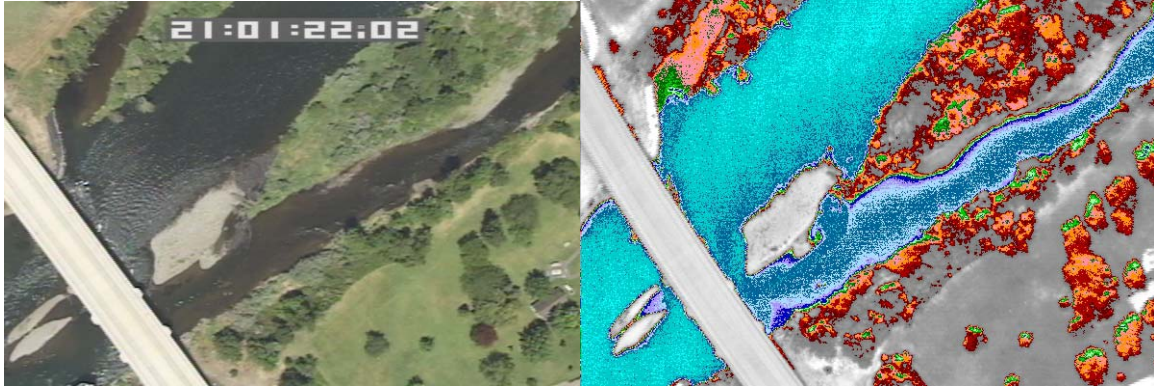
Frame: lb0183 – The Rogue River combines with two side channels at river mile 131.1. The one on the left bank is 18.7°C, and the right bank channel is 26.3°C, compared to the Rogue’s temperature of 17.3°C.

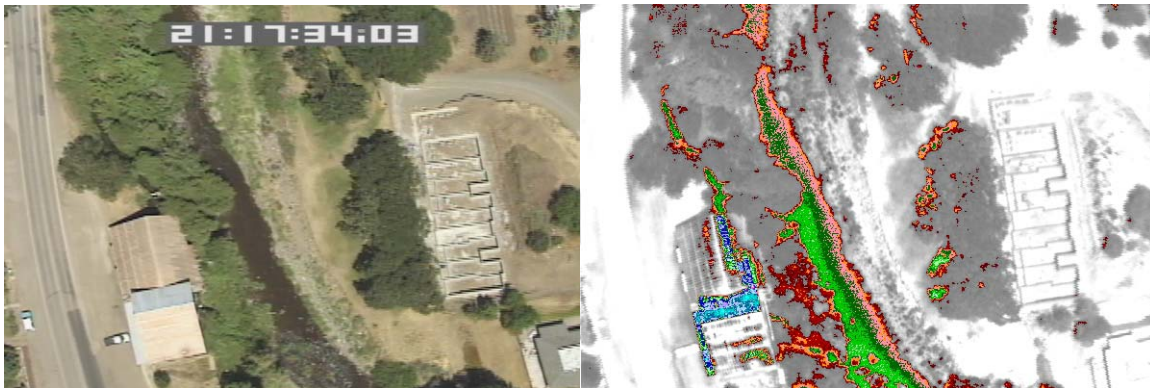
Frame: lb0582: Confluence of the Little Butte Creek (25.8°C) and canal return (24.4°C) at river mile 5.1 in the town of Eagle Point. The canal has a cooling influence on the stream, although both have temperatures over 24°C.

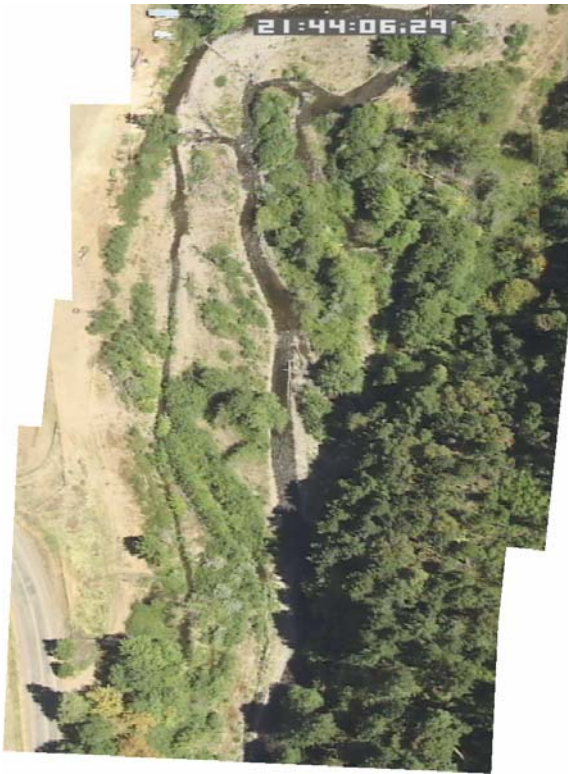
Frame: Mosaic lb1352-1356 – South Fork Little Butte Creek at river mile 6.7. Apparent cold water seeps are visible along both banks create local thermal variability with this reach.

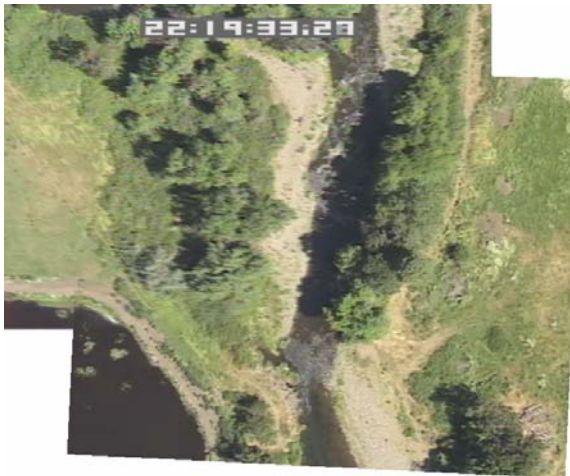
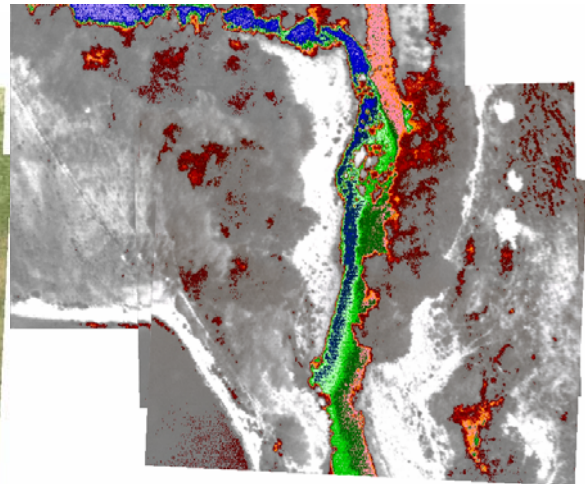
Mosaic: nflb0032-0034 – This image mosaic show the confluence of the SF Little Butte Creek (26.8°C) and the NF Little Butte Creek (22.2°C). Flow direction is from the top to bottom of the image and the NF Little Butte Creek flows in from the left side of the image.

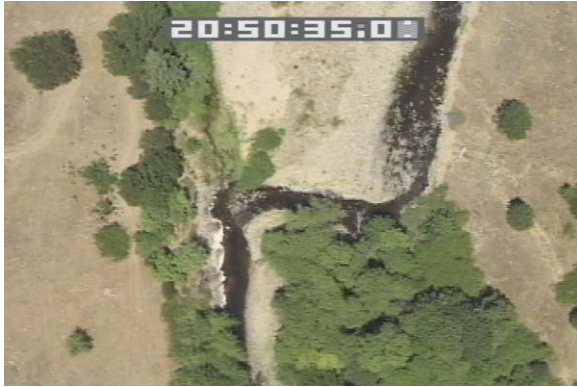
Frame: velk0254 – At river mile 4.4, a small, unnamed inflow (25.0°C) enters into the right bank of Elk Creek (26.6°C).

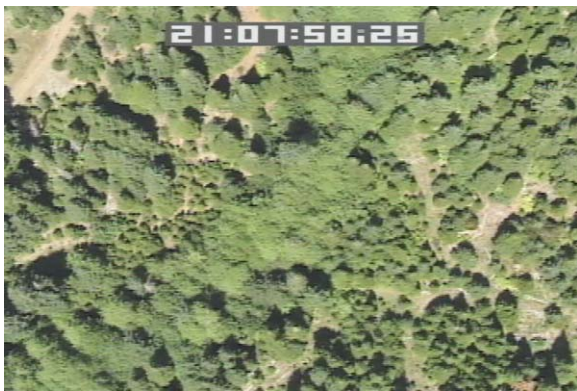
Frame: velk0776 – This image pair is representative of a section of creek from rm 14.8 to rm15.8 where canopy masks the stream surface and precludes an accurate sample.
