Appendix A - Selected Images

Fish Creek

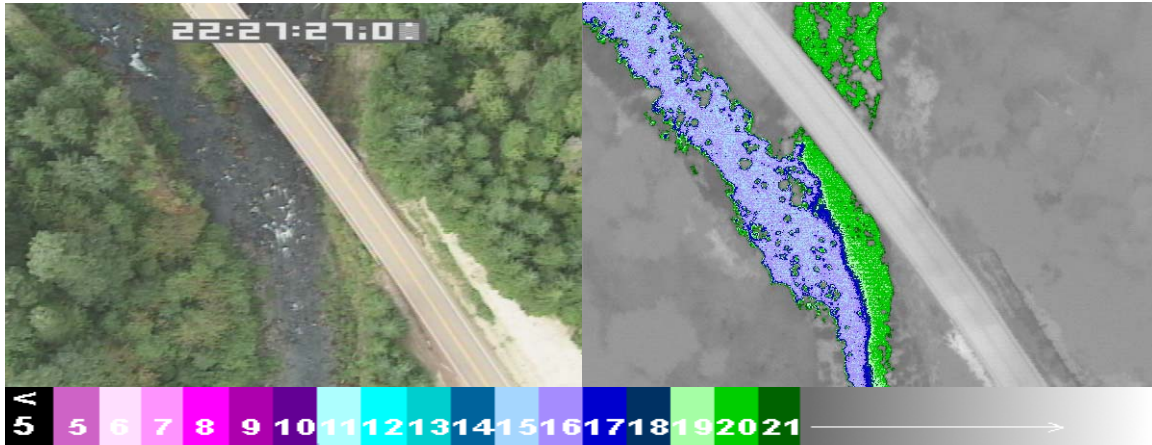
Frame: Fc0019 – Confluence of Fish Creek (20°C) and the North Umpqua River (15.9°C). Flow direction is from the top to bottom of the image.

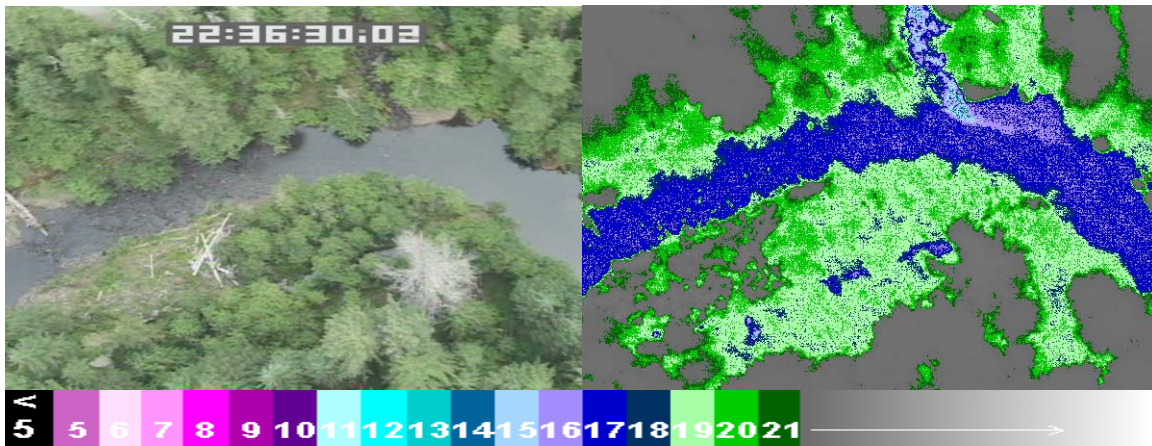
Frame: Fc0290 – Fish Creek (17.4°C) and Eva Creek (15.8°C) at river mile 4.6. Flow direction is from right to left in the image.

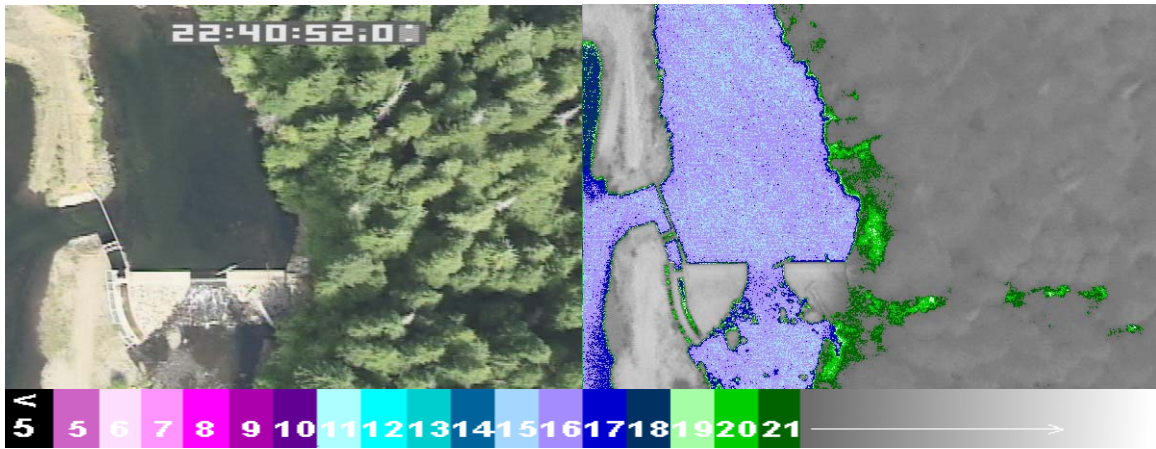
Frame: Fc0421 – Fish Creek (15.9°C) at the Fish Creek Diversion Dam (river mile 6.8). Flow direction is from the top to bottom of the image.

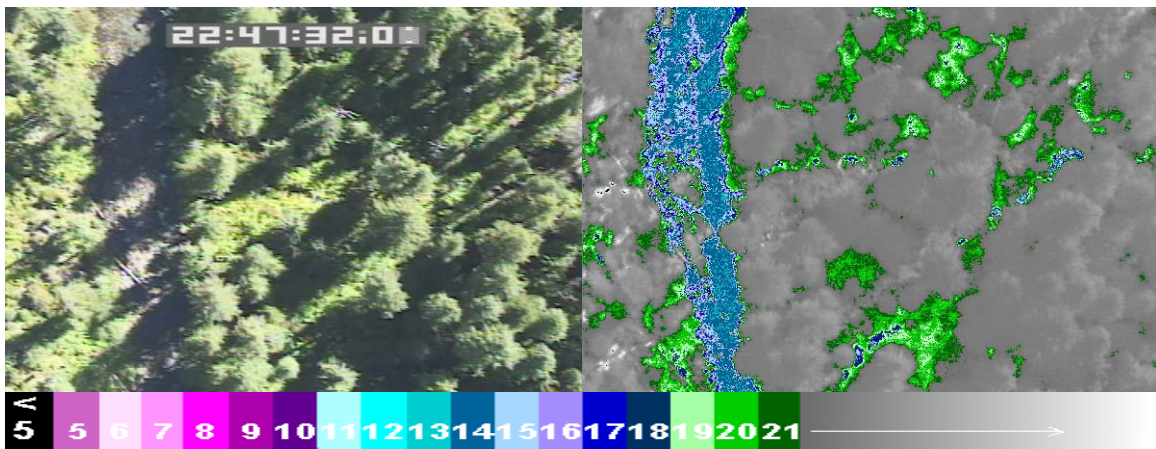
Frame: Fc0621 – The confluence of Fish Creek (14.6°C) and Grave Creek (15.0°C). The forest canopy and small width of the Grave Creek make identification in the visible band image difficult. The Grave Creek inflow is easily to detect in the TIR image; however, it is not possible to get an accurate temperature sample from a stream of this size.

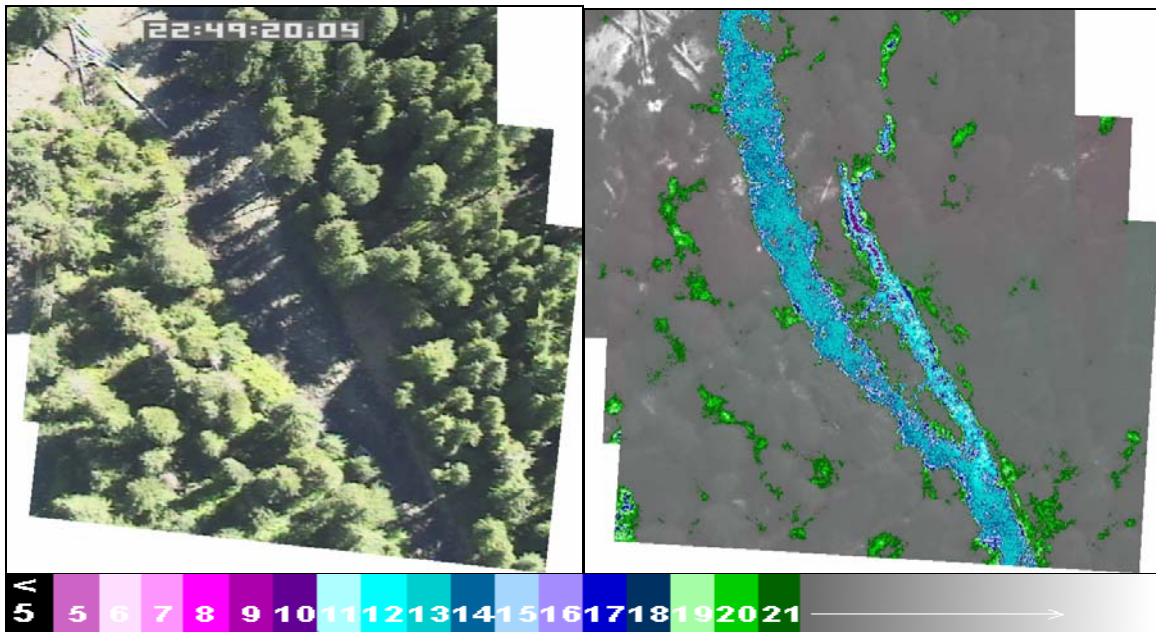
Frames: Fc0673-0675 – Image mosaics showing Fish Creek (13.7°C) and a cool inflow (11.2°C) at river mile 12.2. Flow direction is from the top to bottom of the image.

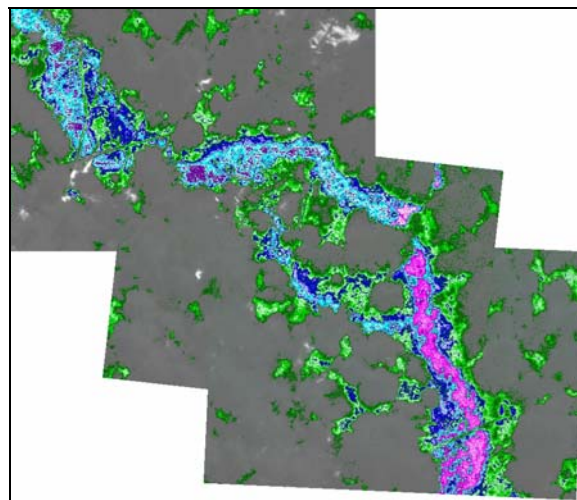
Frames: Fc0851-0853 – TIR image mosaic showing Fish Creek (8.2°C) and a spring (7.3°C) at river mile 15.5. Flow direction is from the top to bottom of the image.

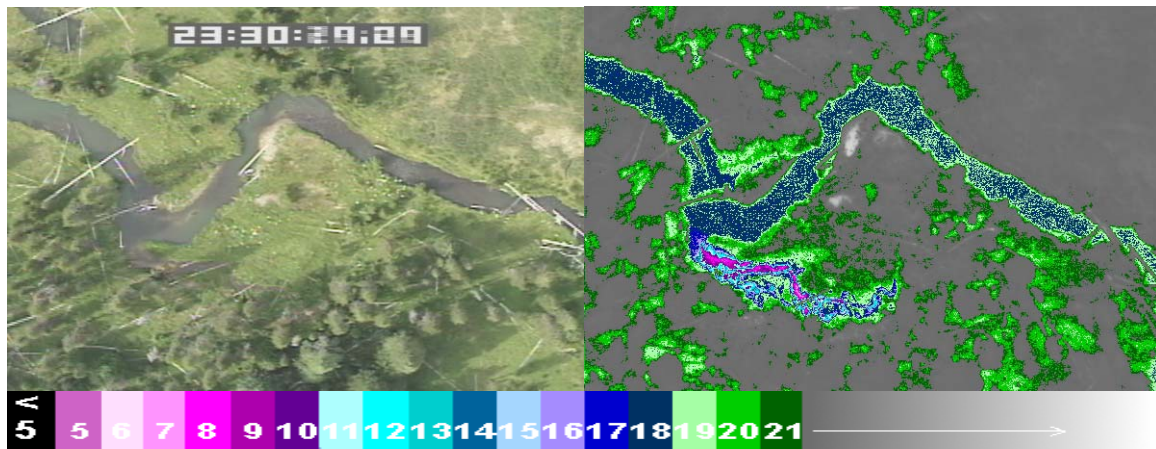
Frame: Lak0642 –Image pair showing an apparent Spring inflow (9.0°C) to Lake Creek (19.0°C) at river mile 0.9. Flow direction is from right to left in the image.

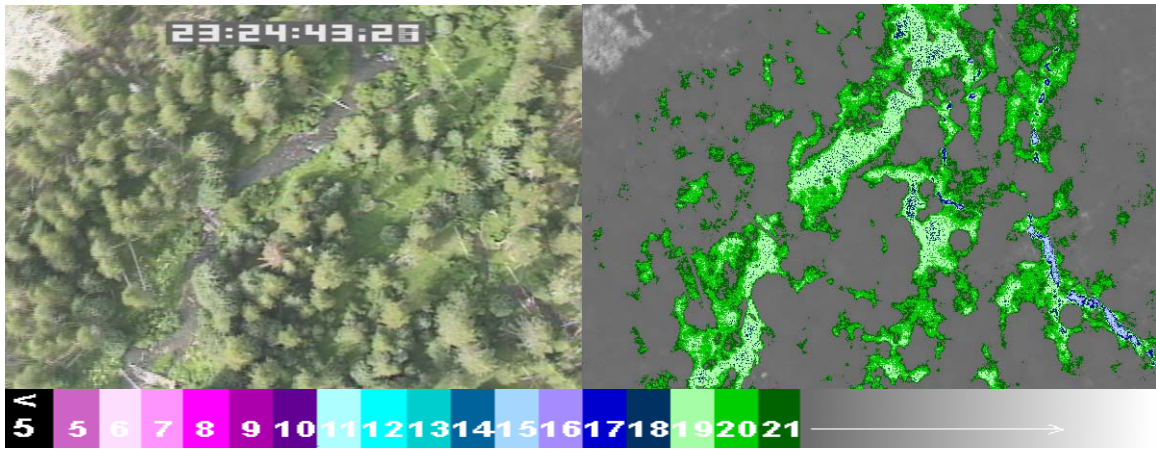
Frame: Lak0474 – Confluence of Lake Creek (19.3°C) and Thielsen Creek (15.7°C) at river mile 4.1. Flow direction is from the bottom to top of the image. Thielsen Creek flows from right to left in the image fans out prior to entering Lake Creek.

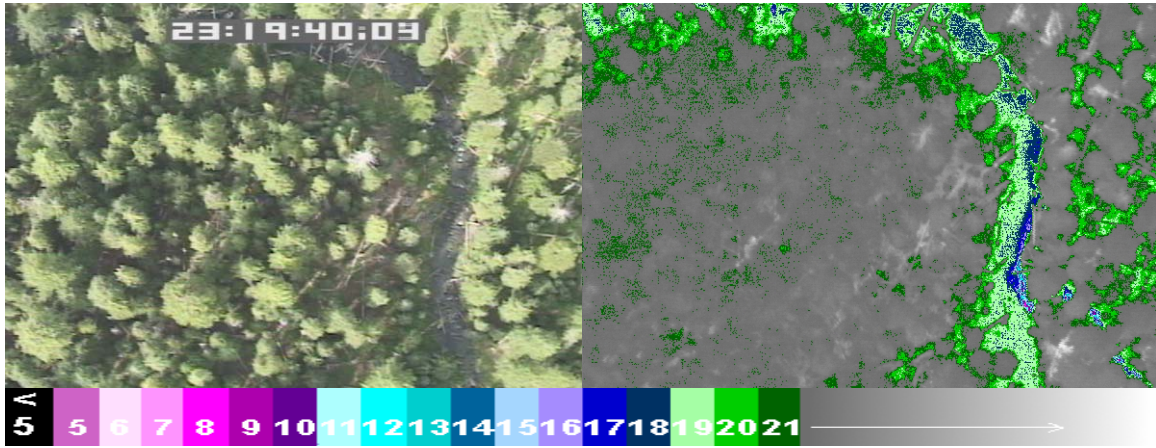
Frame: Lak0322 – Image pair showing the confluence of Lake Creek (19.3°C) and Sheep Creek (10.8°C) at river mile 6.6. Flow direction is from the bottom to top of the image.

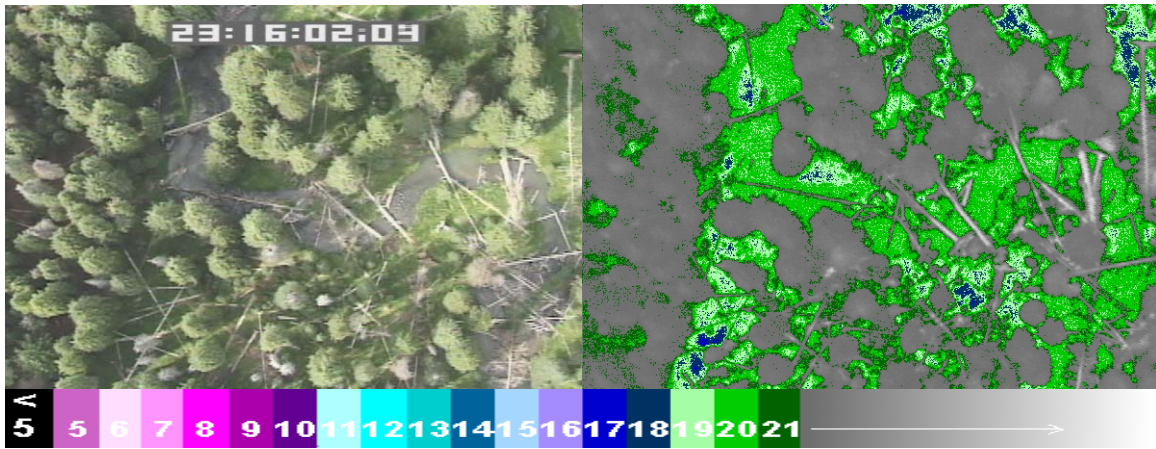
Frame: Lak0213 – Lake Creek (20.2°C) at river mile 8.3. The image is a typical TIR image for Lake Creek. Flow direction is from the top to bottom of the image.

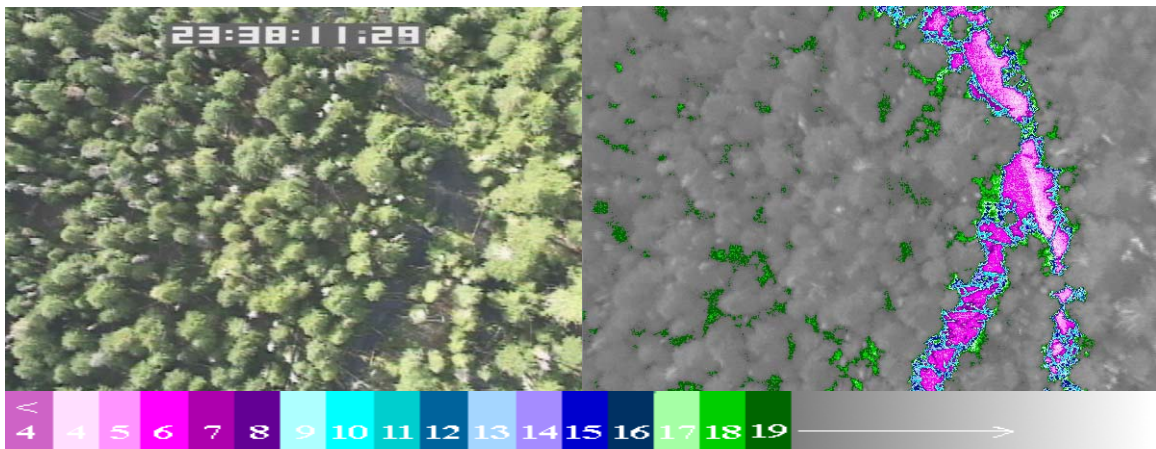
Frame: clrb0136 – Image pair showing the confluence of the Clearwater River (6.2°C) and Lava Creek (4.7°C) at river mile 10.1. The flow direction is from the bottom to top of the image.

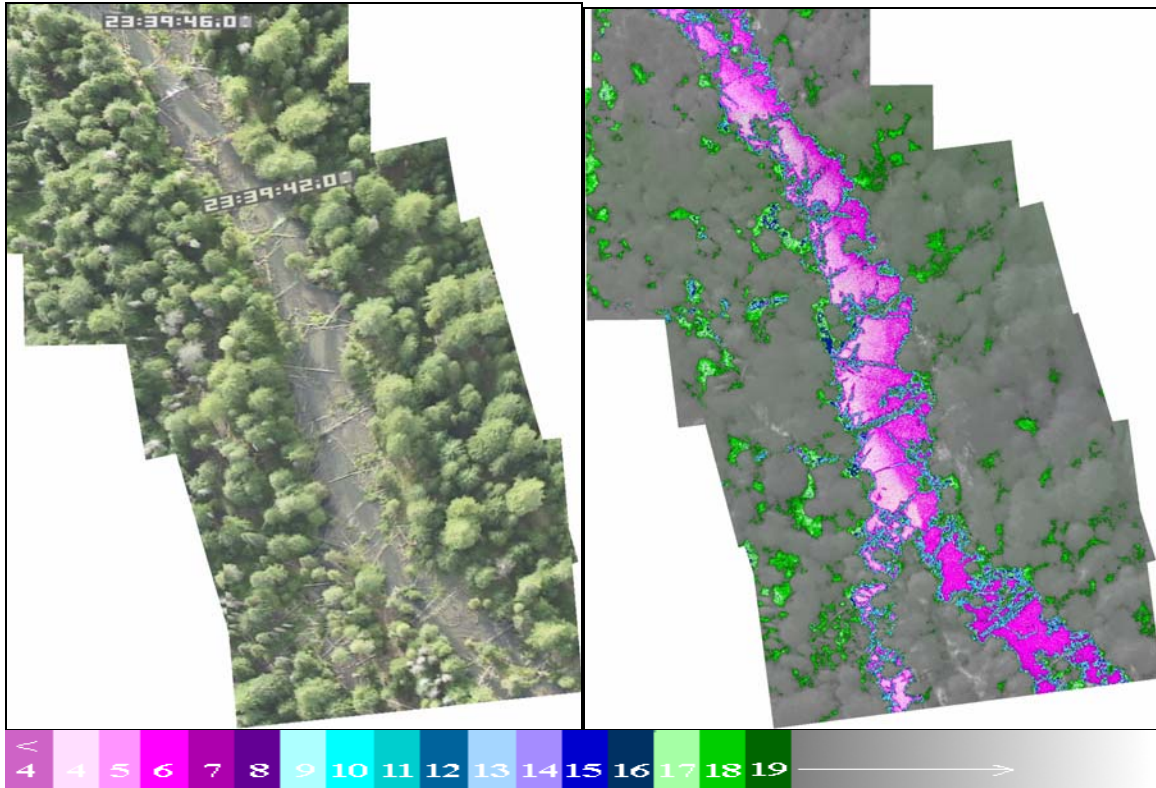
Frames: clrb0178–0183 – Image mosaic showing the confluence of the Clearwater River and an unnamed tributary at river mile . Flow direction is from the bottom to top of the image.

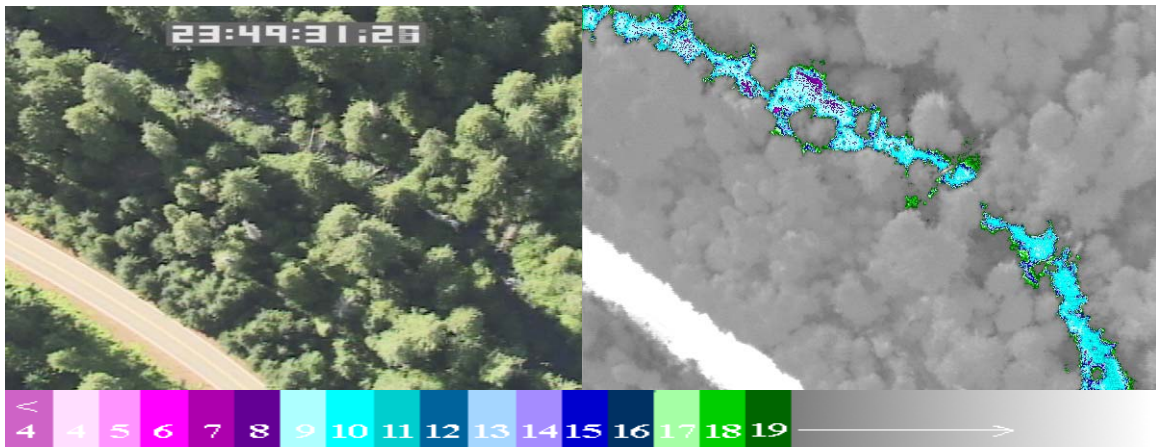
Frame: clrb0476 - Clearwater River (9.4°C) at river mile 2.3. A drop in water temperature through this reach that is not associated with a tributary. Flow direction is from the bottom to top of the image.

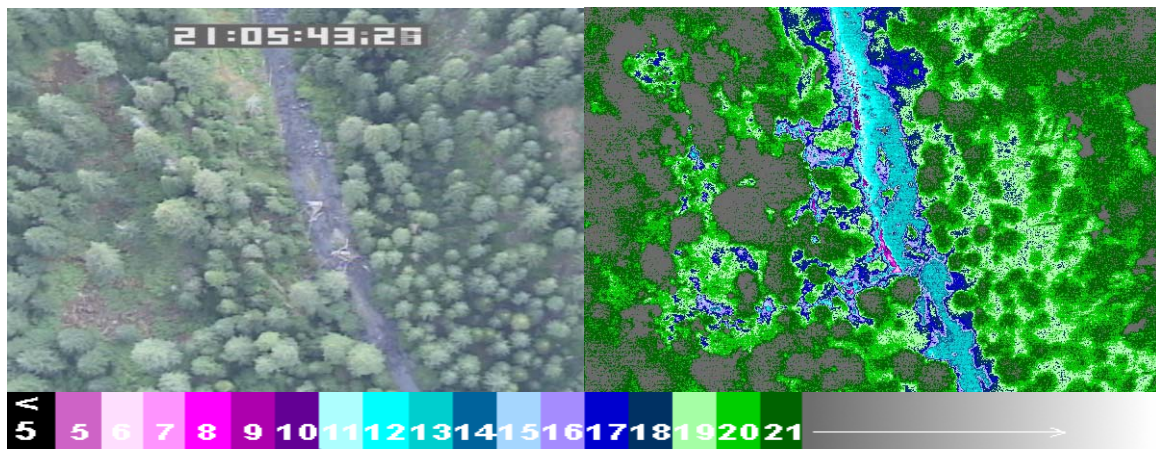
Frame: njum0416 – Image pair showing an apparent spring inflow at river mile 80.3 on the N. Umpqua River. Flow direction is from the bottom to top of the river.

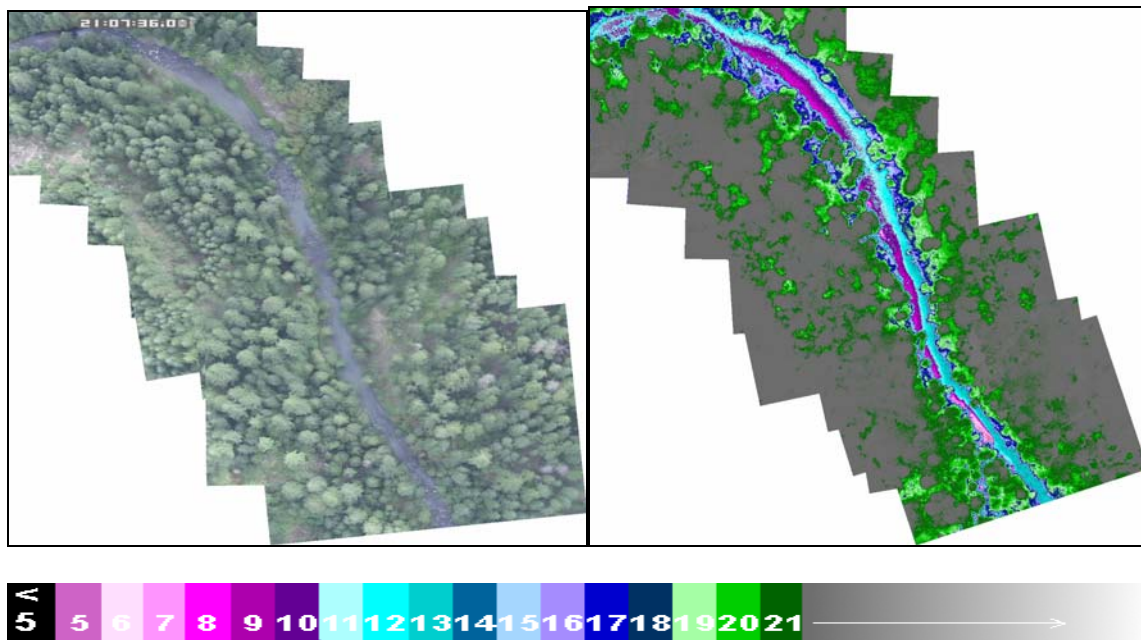
Frames: njum0464-0472 – Image mosaic showing the confluence of the N. Umpqua River (13.3°C) and Loafer Creek (6.6°C) at river mile 79.3. Loafer Creek as a cooling influence on the N. Umpqua River. Flow direction is from the bottom to top of the image.

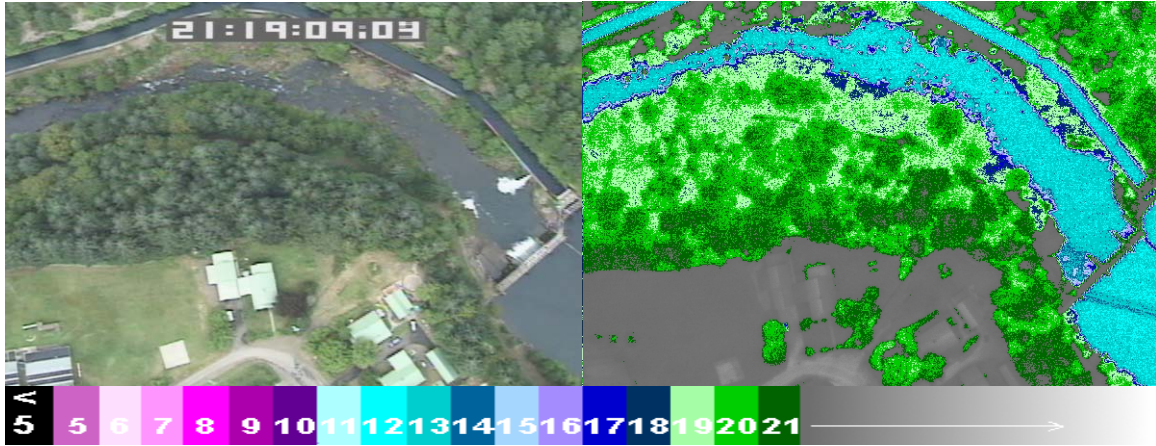
Frame: njum0790 - Slide Creek Dam on the N. Umpqua River at river mile 72.3. The outlets into the N. Umpqua River on either side downstream of the dam did not show a discernable temperature difference on the FLIR image. Flow direction is from the bottom to top of the image.

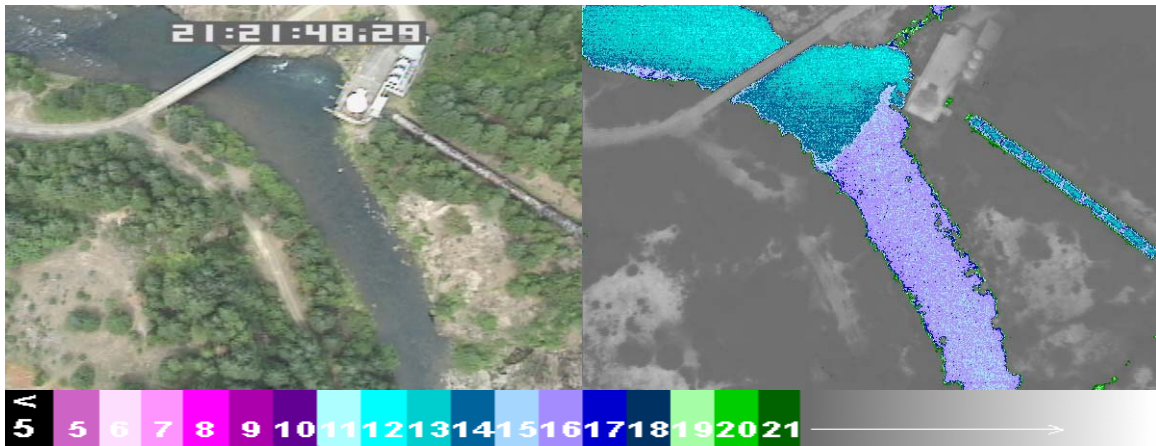
Frame: njum0870 – Image pair of the N. Umpqua River showing the East end of the Soda Spring Reservoir. Flow direction is from the bottom to the top of the image.

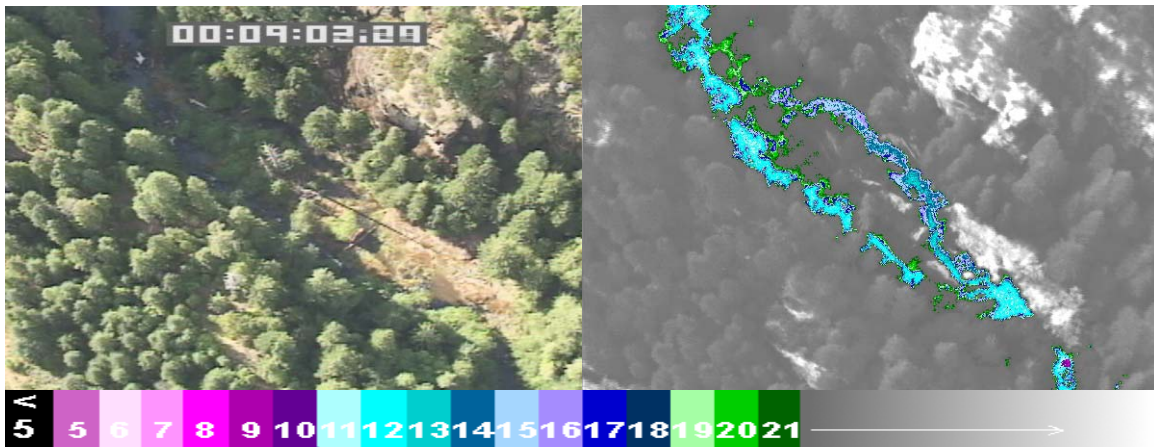
Frame: nfb0042 - N. Umpqua River at river mile 73.5 showing a warmer side channel along the right bank. Flow direction is from the bottom to top of the image.

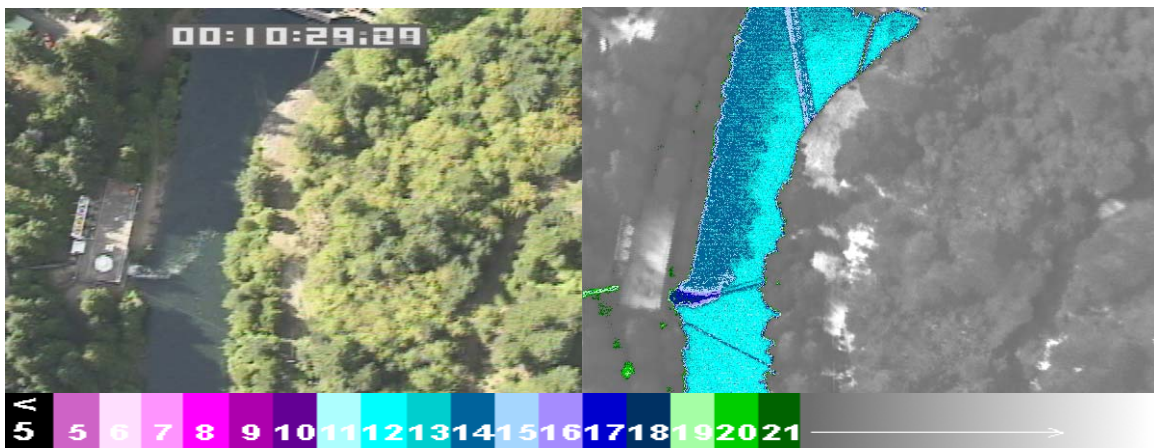
Frame: nfb0085 - N. Umpqua River (12.7°C) and the Fish Creek Power Plant outlet (18.7°C) at river mile 72.4. Flow direction is from the bottom to top of the image.

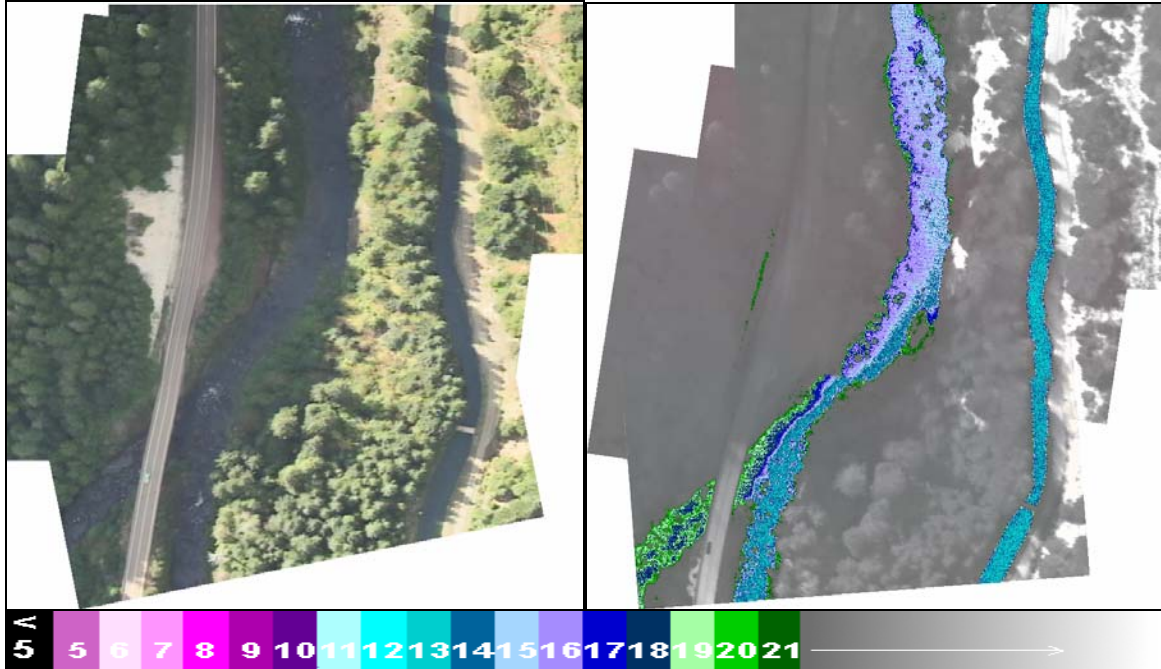
Frames: nfb0145-0148 - The confluence of the N. Umpqua River (16.1°C) and Fish Creek (18.8°C). The flow direction is from the bottom to the top of the image.

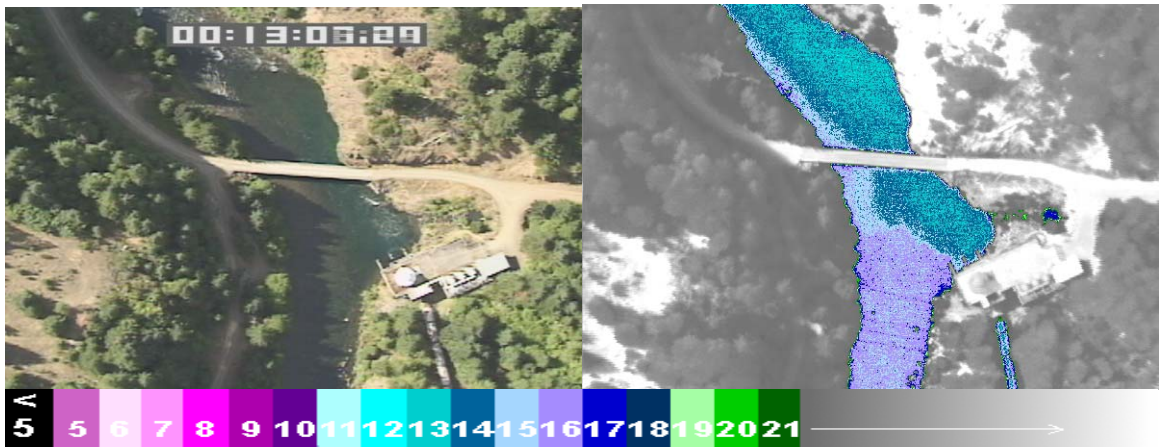
Frame: nfb0164 - N. Umpqua River at the Slide Creek Power Plant at river mile 70.32. The outflow of the power plant lowers the water temperature of the N. Umpqua River. The flow direction is from the bottom to the top of the image.

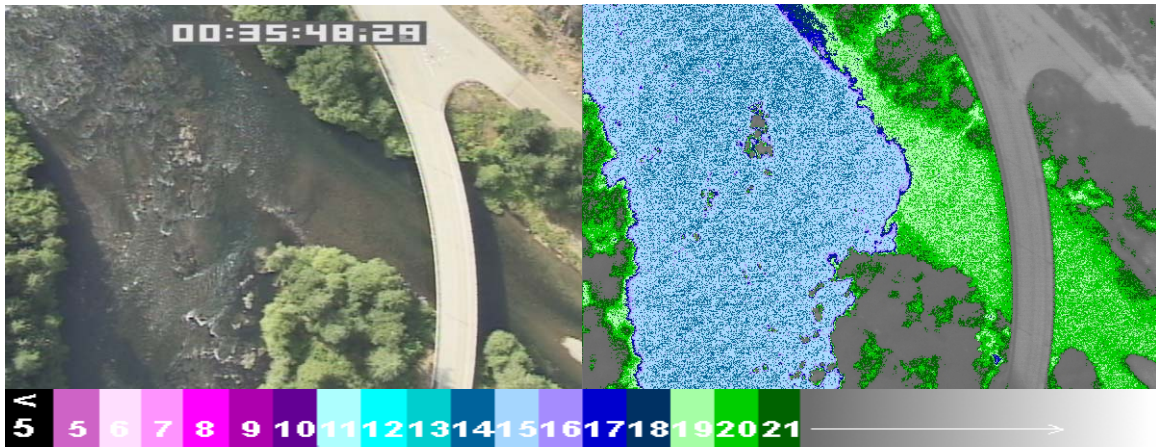
Frame: nfb0845 - The confluence of the N. Umpqua River (15.4°C) and Steamboat Creek (19.6°C at river mile 52.4. Flow direction is from the bottom to top of the image. Steamboat Creek flows in from the right side of the image under the bridge.

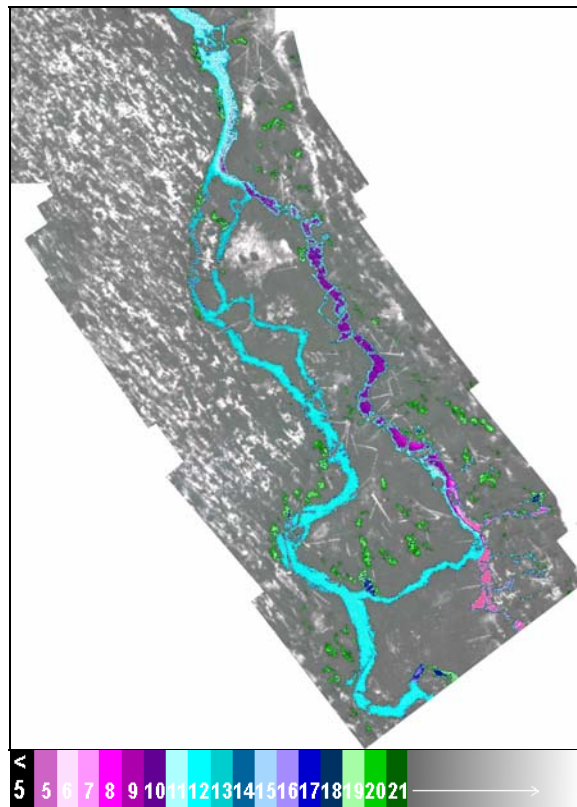
Frames: nfu0123–0135 – TIR Image mosaic showing the Spring Complex upstream of Lemolo Lake. Flow direction is from the bottom to top of the image.

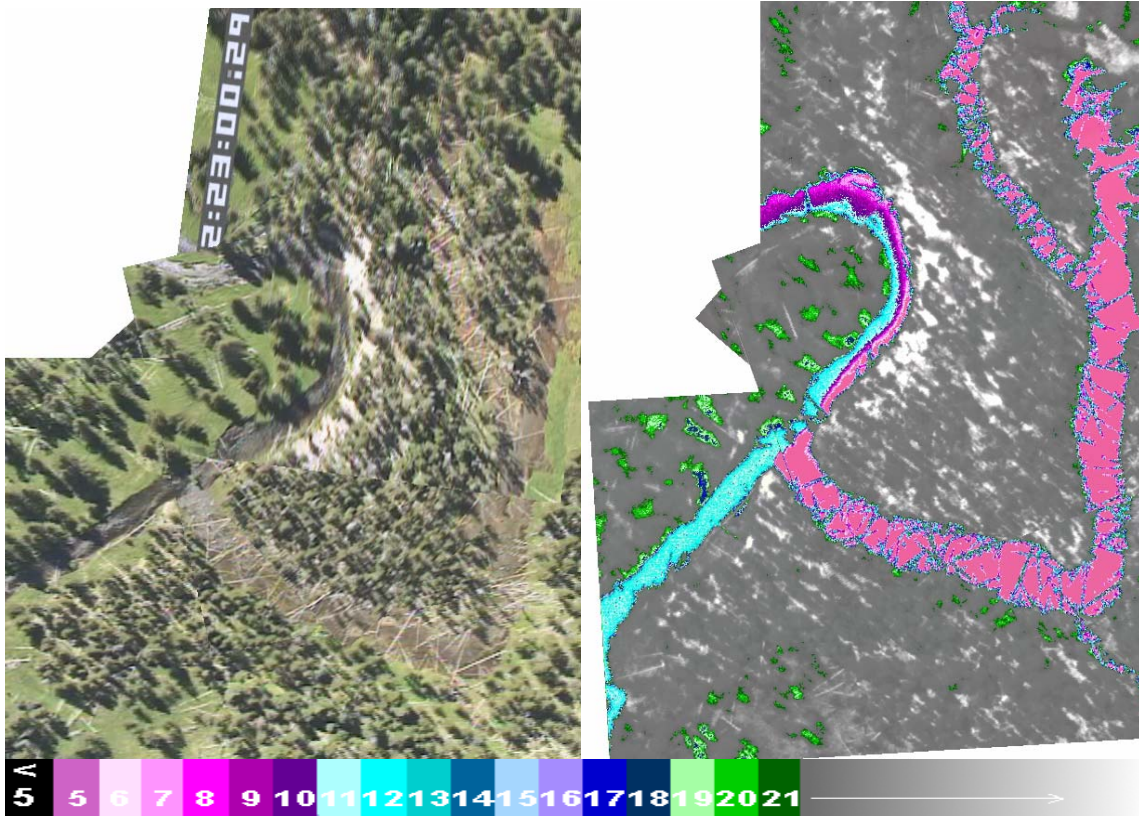
Frames: nfu0173–0176 – Visible band and TIR image mosaics showing Crystal Springs upstream of Lemolo Lake. Flow direction is from the bottom to top of the image.

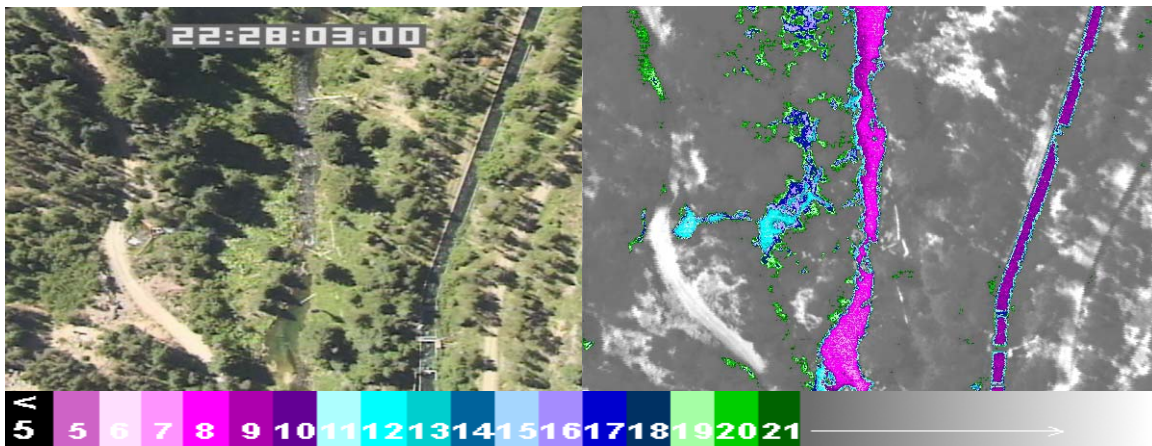
Frame: nfu0327 - Image pair showing the N. Umpqua River (8.3°C) at river mile 91.7. A cold area, which appears to be surface water, was detected near the road along the LB. However, it is uncertain if there is connectivity with the mainstream. Flow direction is from the bottom to top of the image.

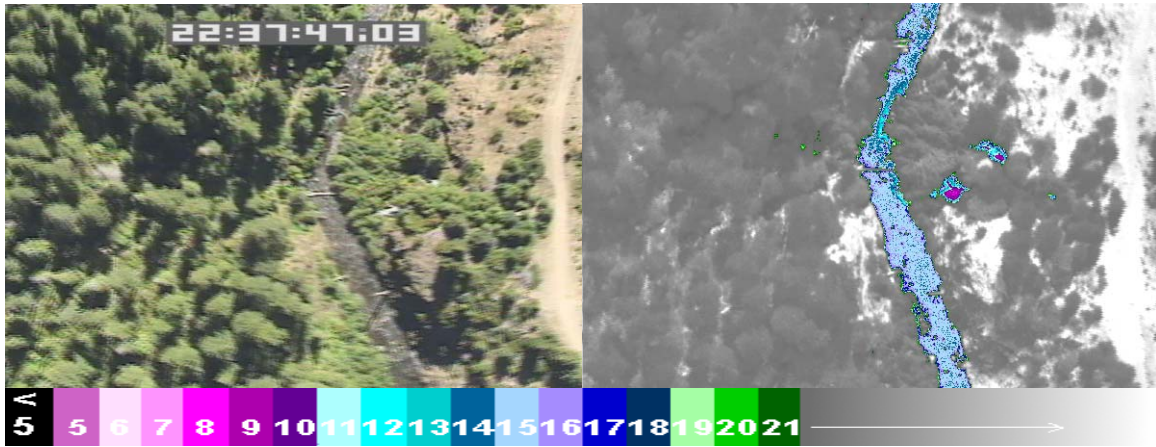
Frame: nfu0619 - Image pair showing the confluence of the N. Umpqua River (15.6°C) and Dorothy Creek (11.6°C).
