WATER WELL ASSESSMENT REPORT

WEST SIDE QUARRY LLC

6655 SW Hergert Road
Cornelius, Oregon 97113
Washington County Tax Lot 1S3200000405

February 9, 2021
EVREN NORTHWEST, INC.
Project No. 1350-20001-05

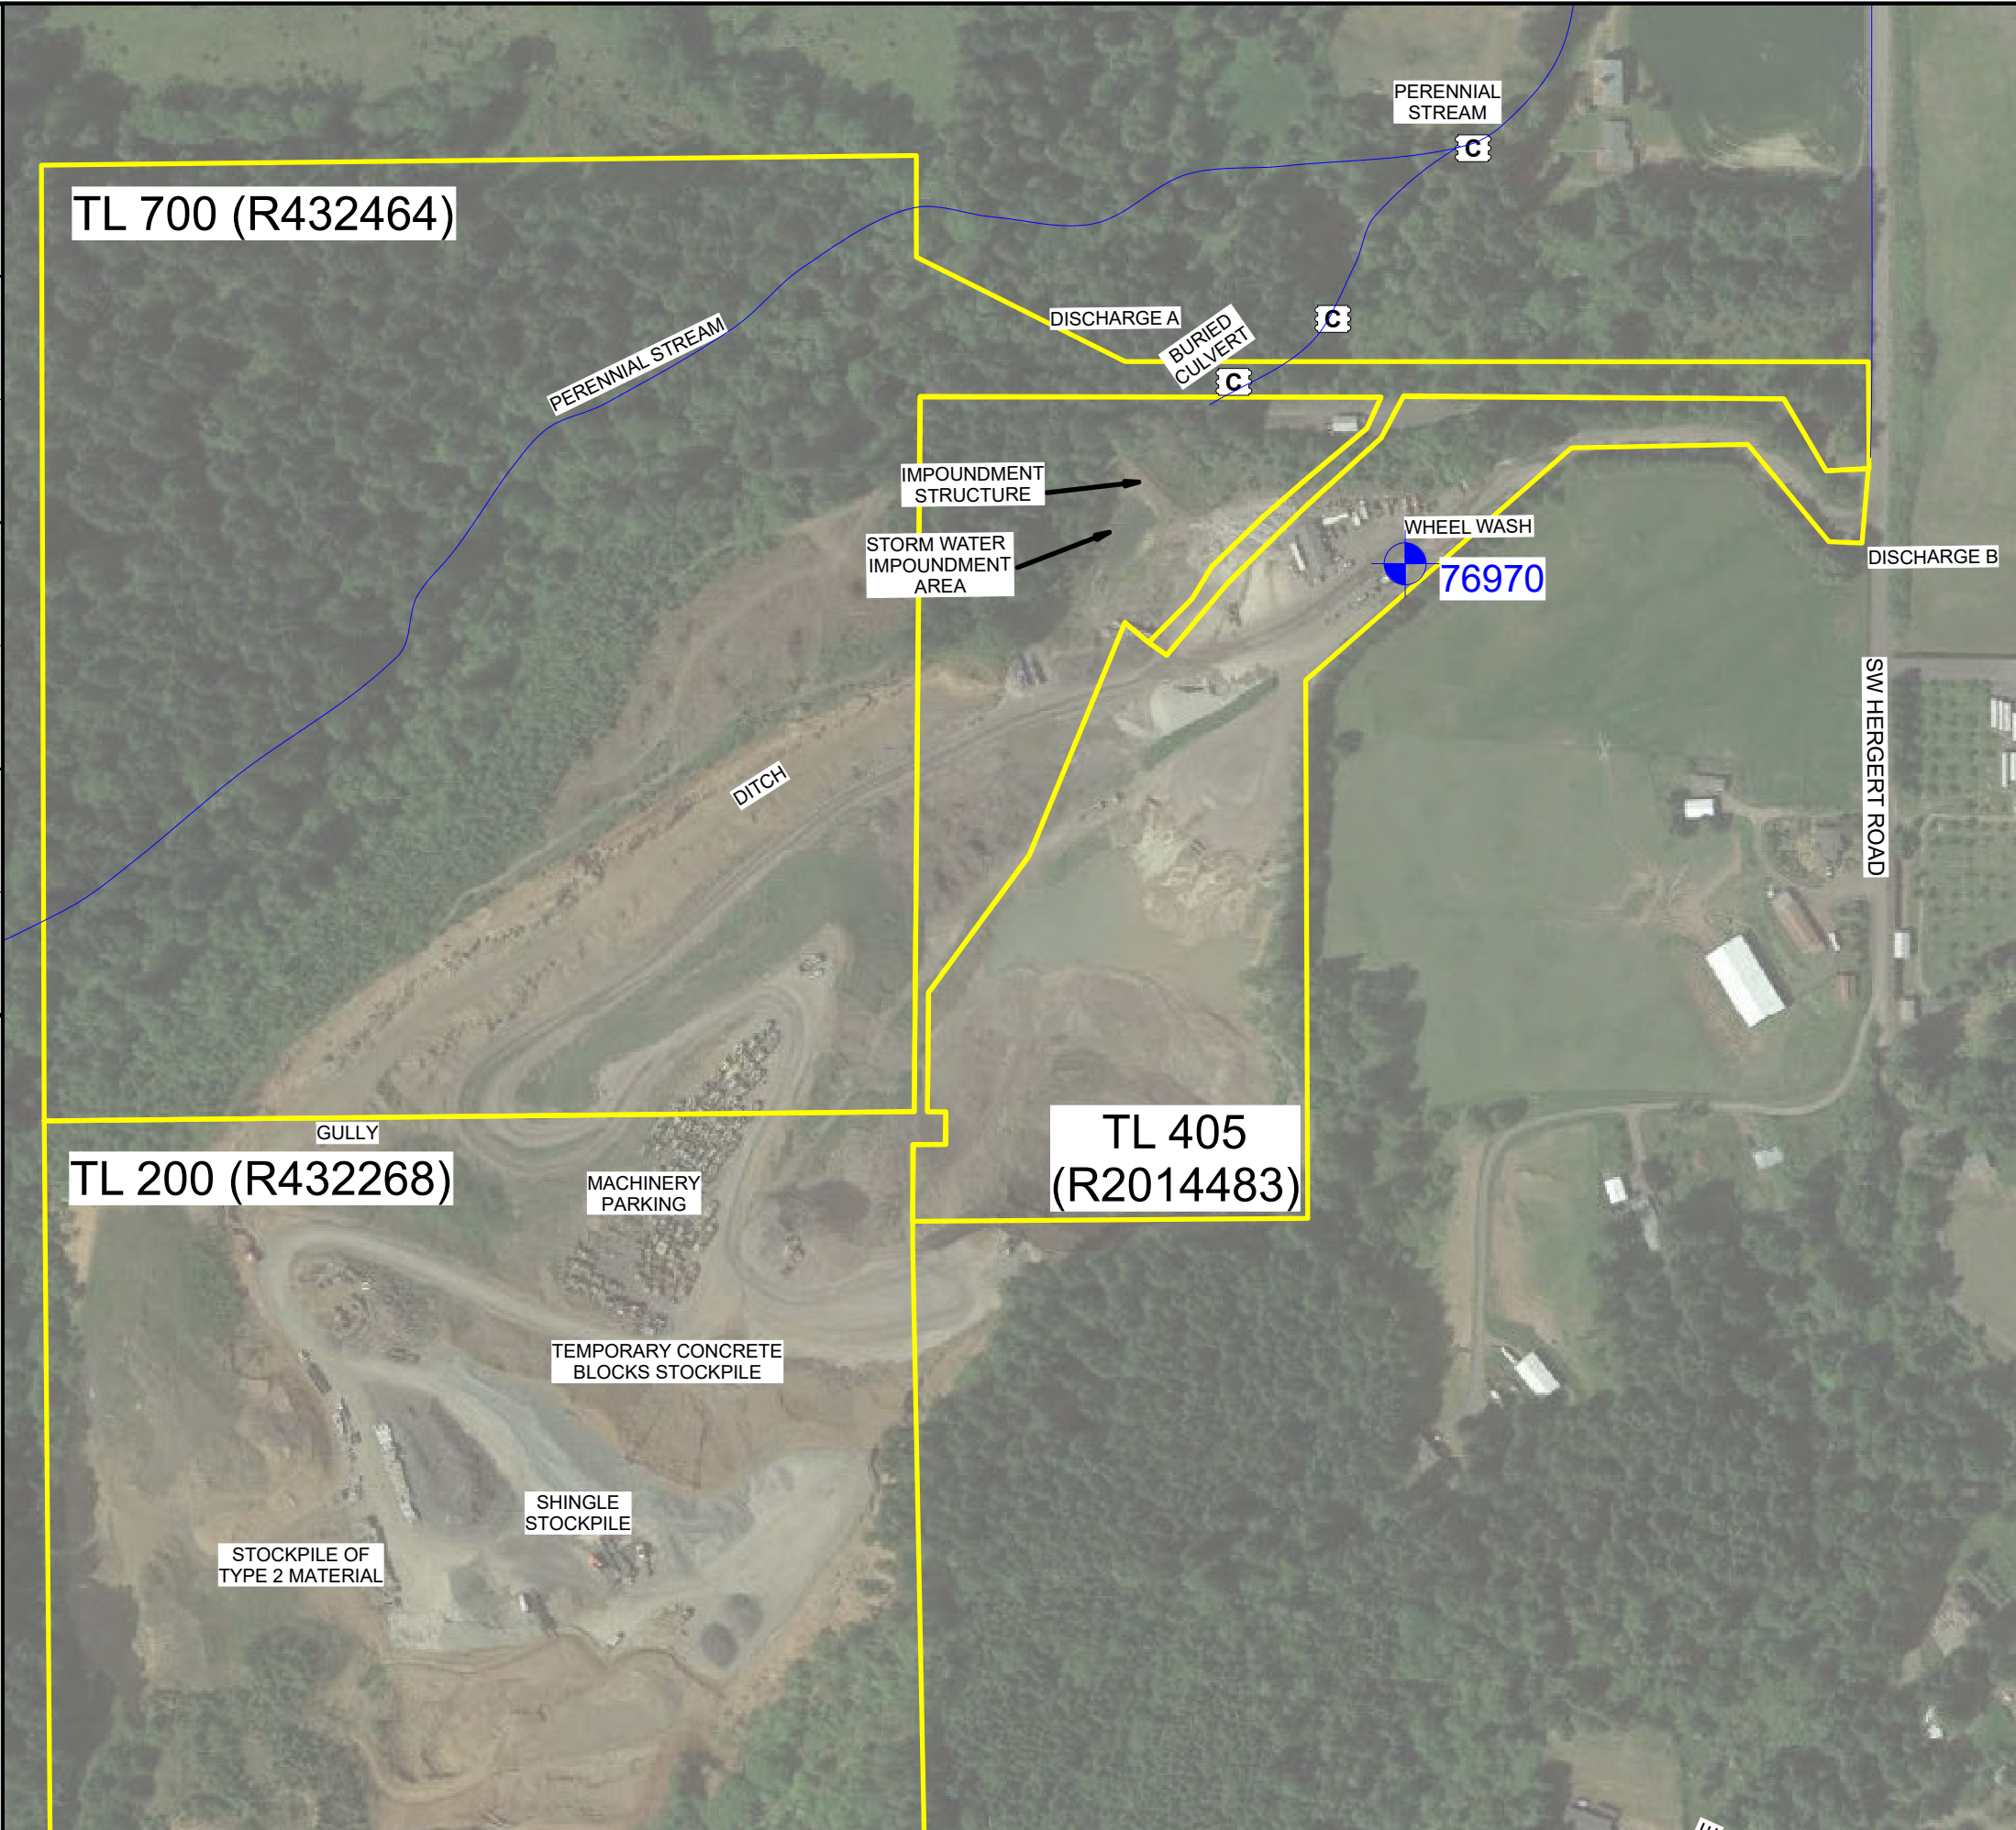
FIGURE 2
 SITE PLAN

Details of the on-site well's construction are presented in Table 2-1 and a copy of the OWRD well report for the on-site well is included in Appendix B. The well is located near the tipping station at the northeastern part of the quarry at an elevation of approximately 364 feet amsl (see Figure 2). The well is completed with a 6-inch diameter welded steel casing extending to 98 feet bgs, below which is an open borehole extending to the total depth of 268 feet bgs. A 4.5-inch diameter welded plastic pipe installed inside the outer steel casing withdraws ground water from perforations extending from 248 to 267 feet bgs. Static water in the well was reported at 73 feet bgs, and the water-bearing unit is described as basalt with occasional soft interbeds.

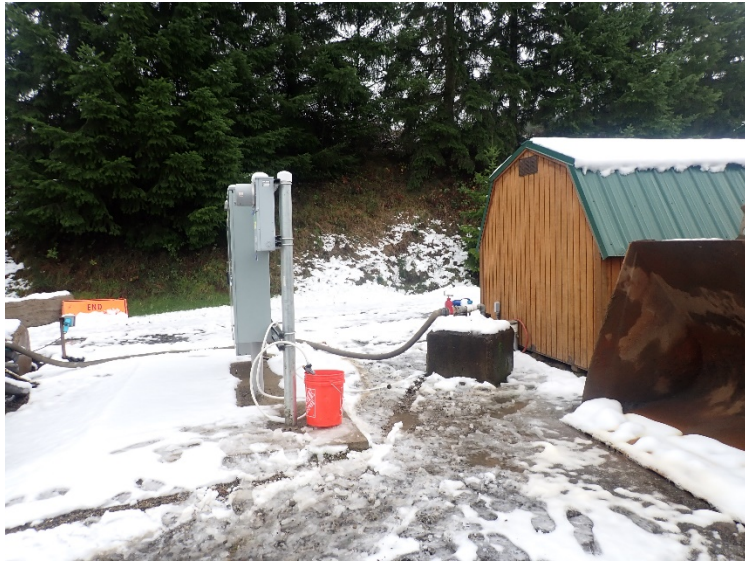
The on-site water well is located in the northeastern part of the Westside Rock quarry. The well head is shown next to the shed. The control panel and pressure tank were located inside the shed.

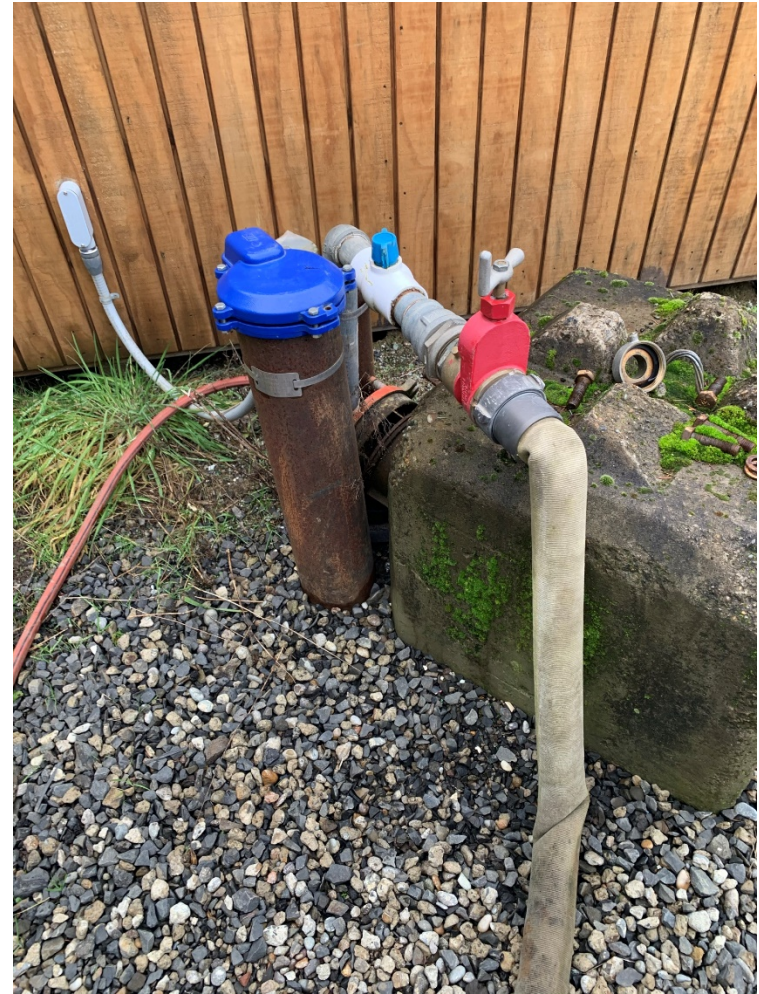
A close-up view taken the week before sampling shows the wellhead with a gate valve and a 2-inch flex hose attached to the well. The flex hose was used to purge the well prior to sampling.

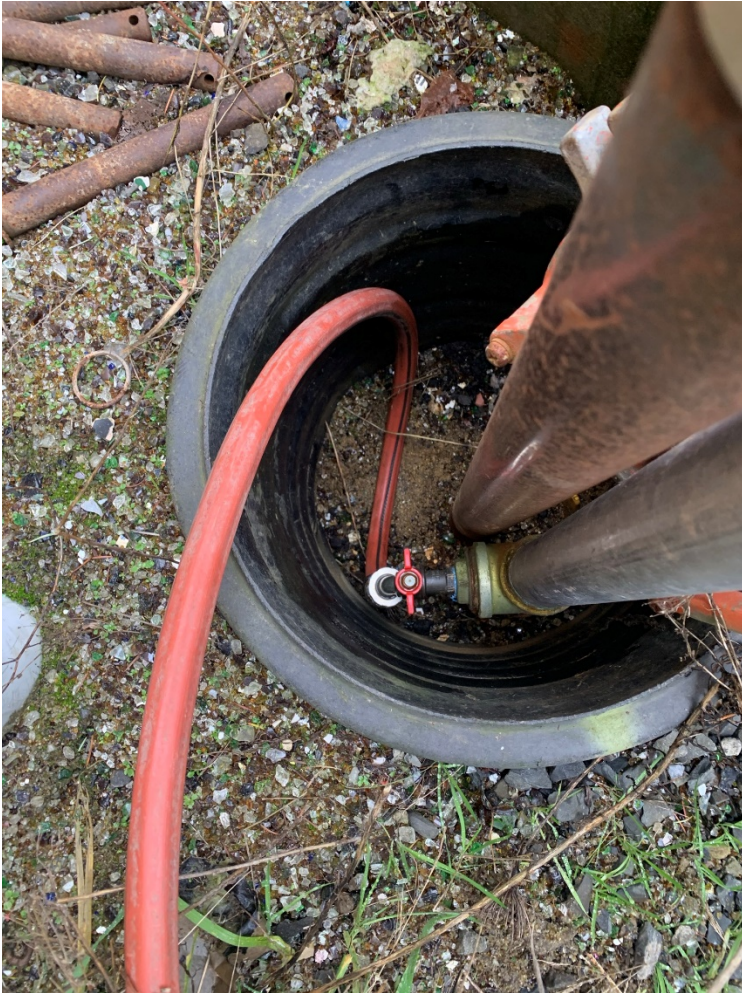
A garden spigot connected to the well head inside the well monument provided access for sampling. Note: the pictured hose was not utilized for sampling collection.

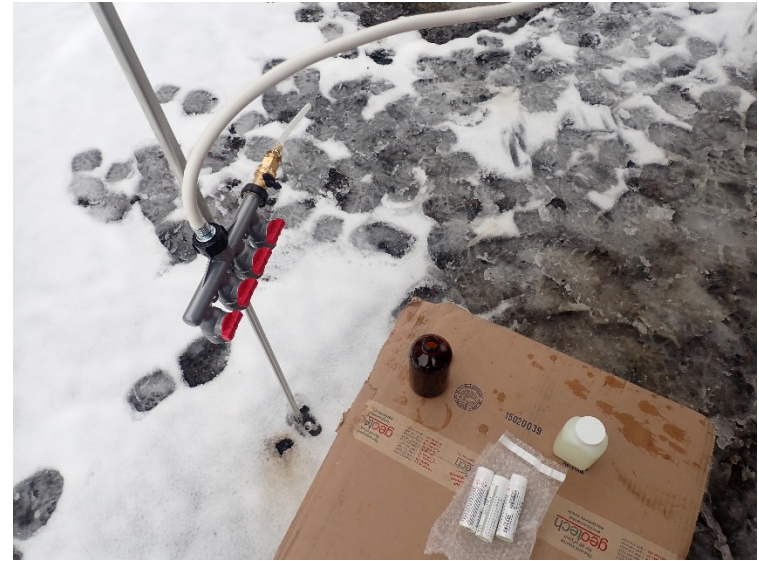
View of sampling manifold and hose connected to the spigot on the wellhead during sampling.

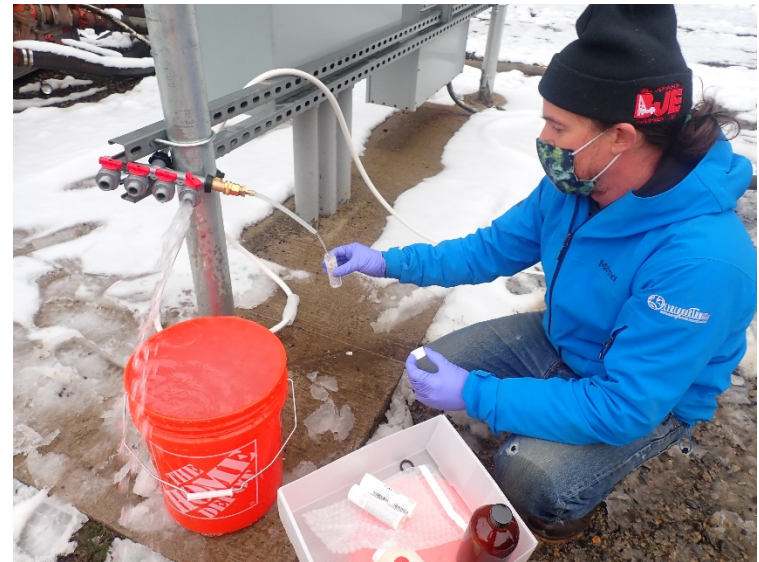
View of ground water being sampled from a barbed fitting on the sample manifold.
