SAFETY INVESTIGATION MANUAL WORKSHEET

CASE STUDY: OR-43 AND RICHARDSON CT.

Case Study #1: OR-43 and Richardson Ct.

- Unsignalized intersection
- Six-year study period
- 1/1/2011 – 12/31/2016
 - MP 1.11 to MP 1.15 on OR-43

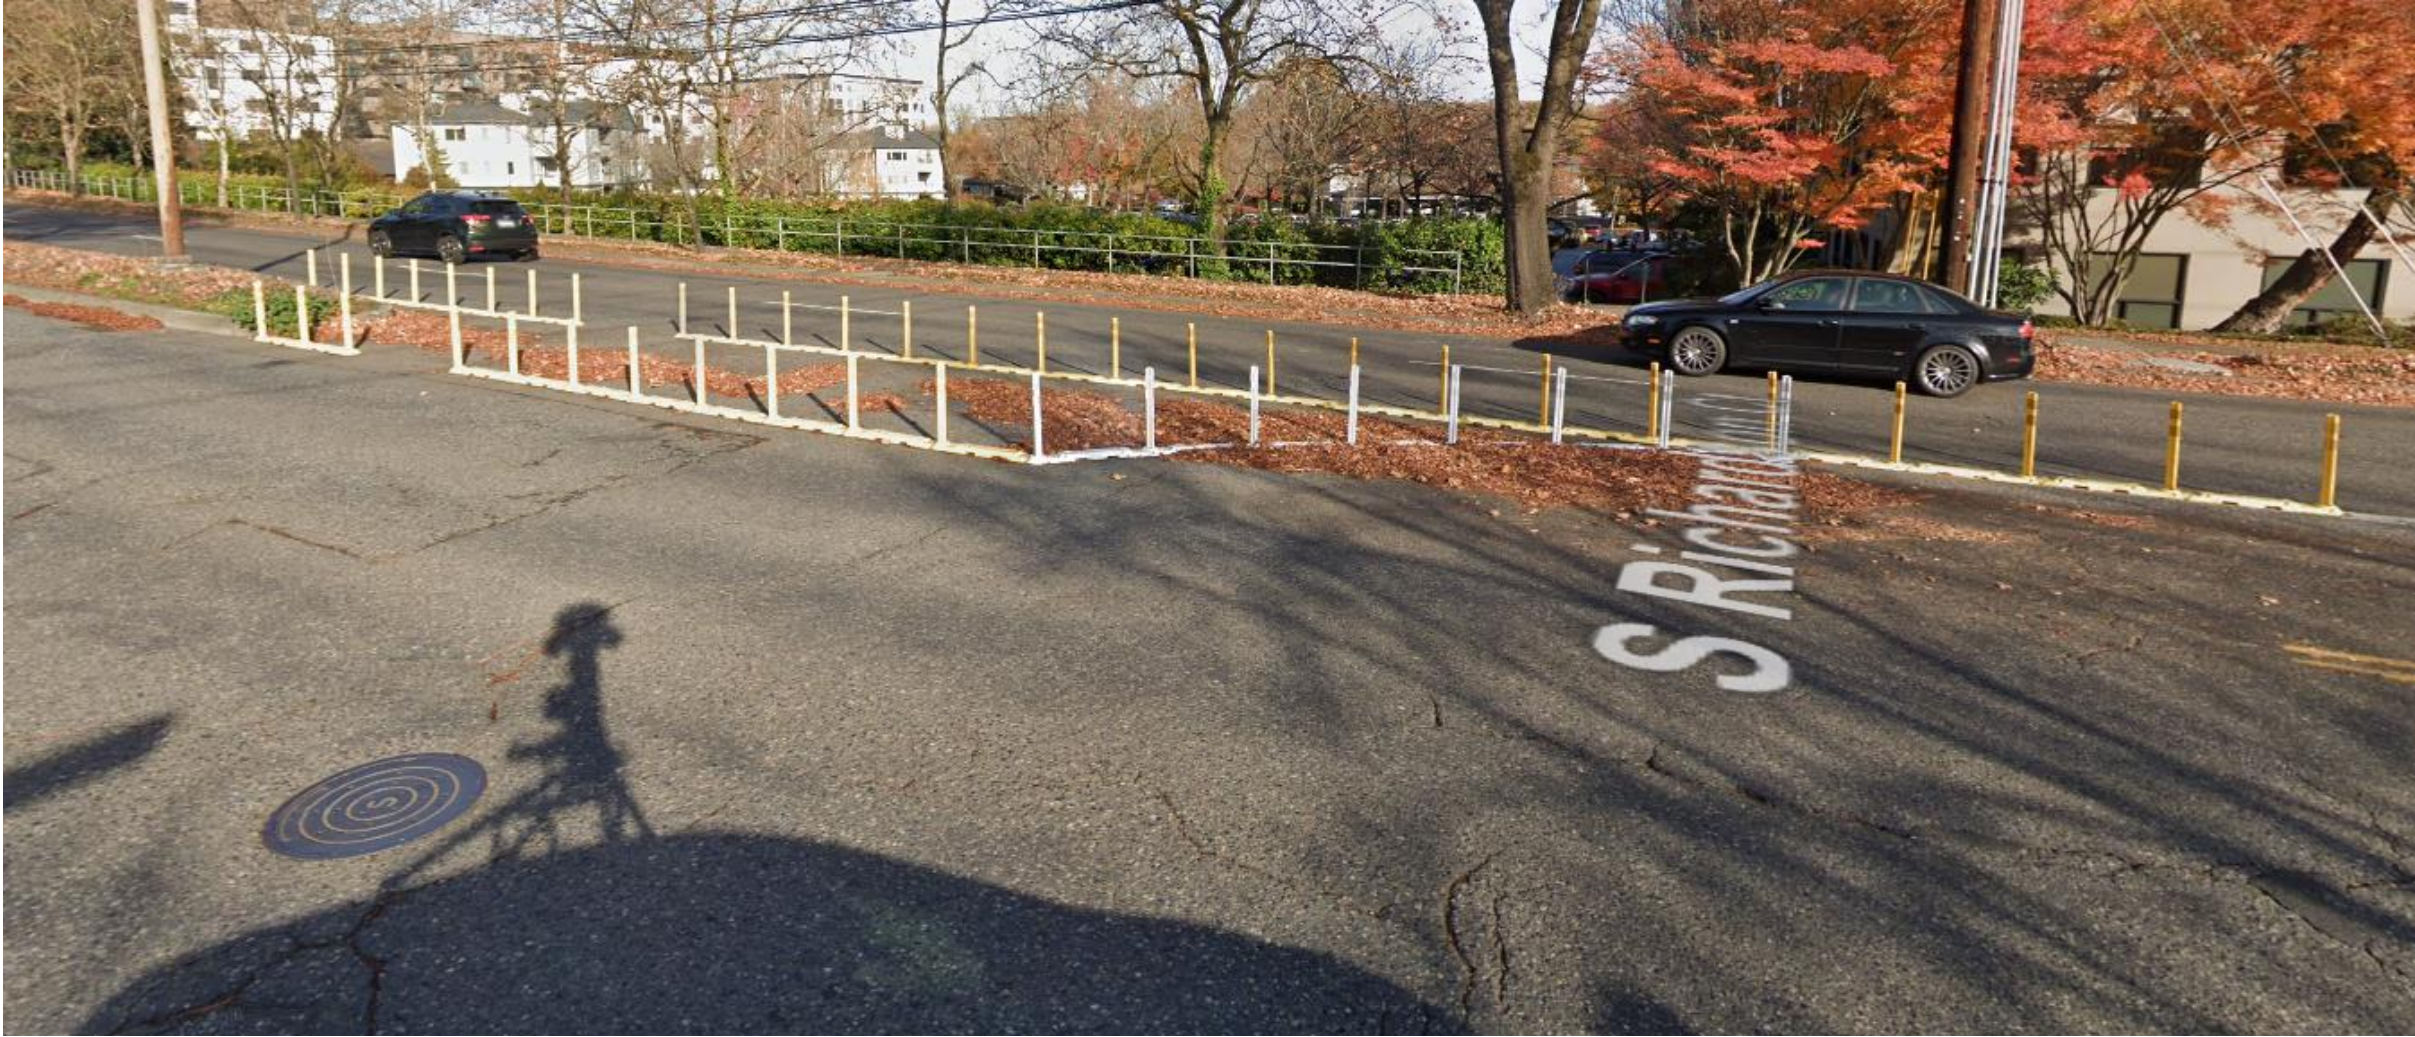
Step 6: Documentation and Implementation

- Implemented Solution
 - Two rows of polyethylene traffic separators across the intersection to extend the median island.
 - Restrict Richardson Ct. to right in, right out, and left in.
 - Selected to restrict left turns and the number of associated crashes.
 - Closed northerly crosswalk due to extension of median island.
