**RED LIGHT RUNNING CAMERA  
ASSESSMENT**

**Final Report**

**SPR 304-521**

Oregon Department of Transportation

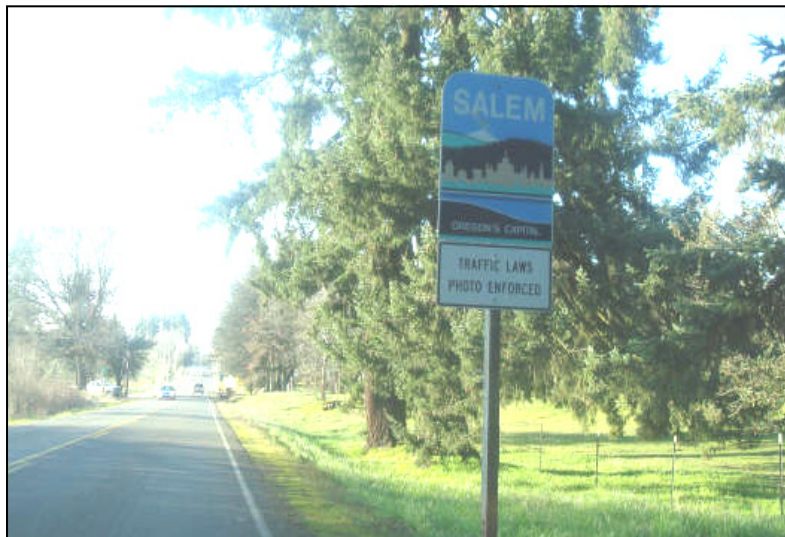
Figure 1.1: Photograph of photo enforcement sign installed at Salem city limits

Signs were installed at the city limits, alerting drivers that photo enforcement was being used in the city. A sign was installed on each approach where a camera would operate, alerting drivers that photo enforcement was in place. Figure 1.1 is an example of a sign installed at the city limits. Figure 1.2 is a photograph of the sign installed at the Mission and 25<sup>th</sup> intersection in the westbound direction.

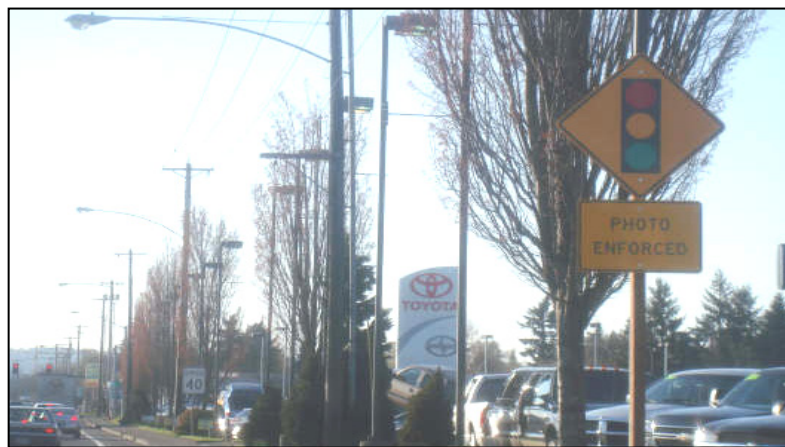
Figure 1.2: Photograph of photo enforcement sign installed on westbound approach of Mission Street SE and 25<sup>th</sup> Street SE intersection in Salem
