GROUND WATER ASSESSMENT

WEST SIDE QUARRY LLC

6655 SW Hergert Road
Cornelius, Oregon 97113
Washington County Tax Lot 1S3200000405

November 25, 2020
EVREN NORTHWEST, INC.
Project No. 1350-20001-05

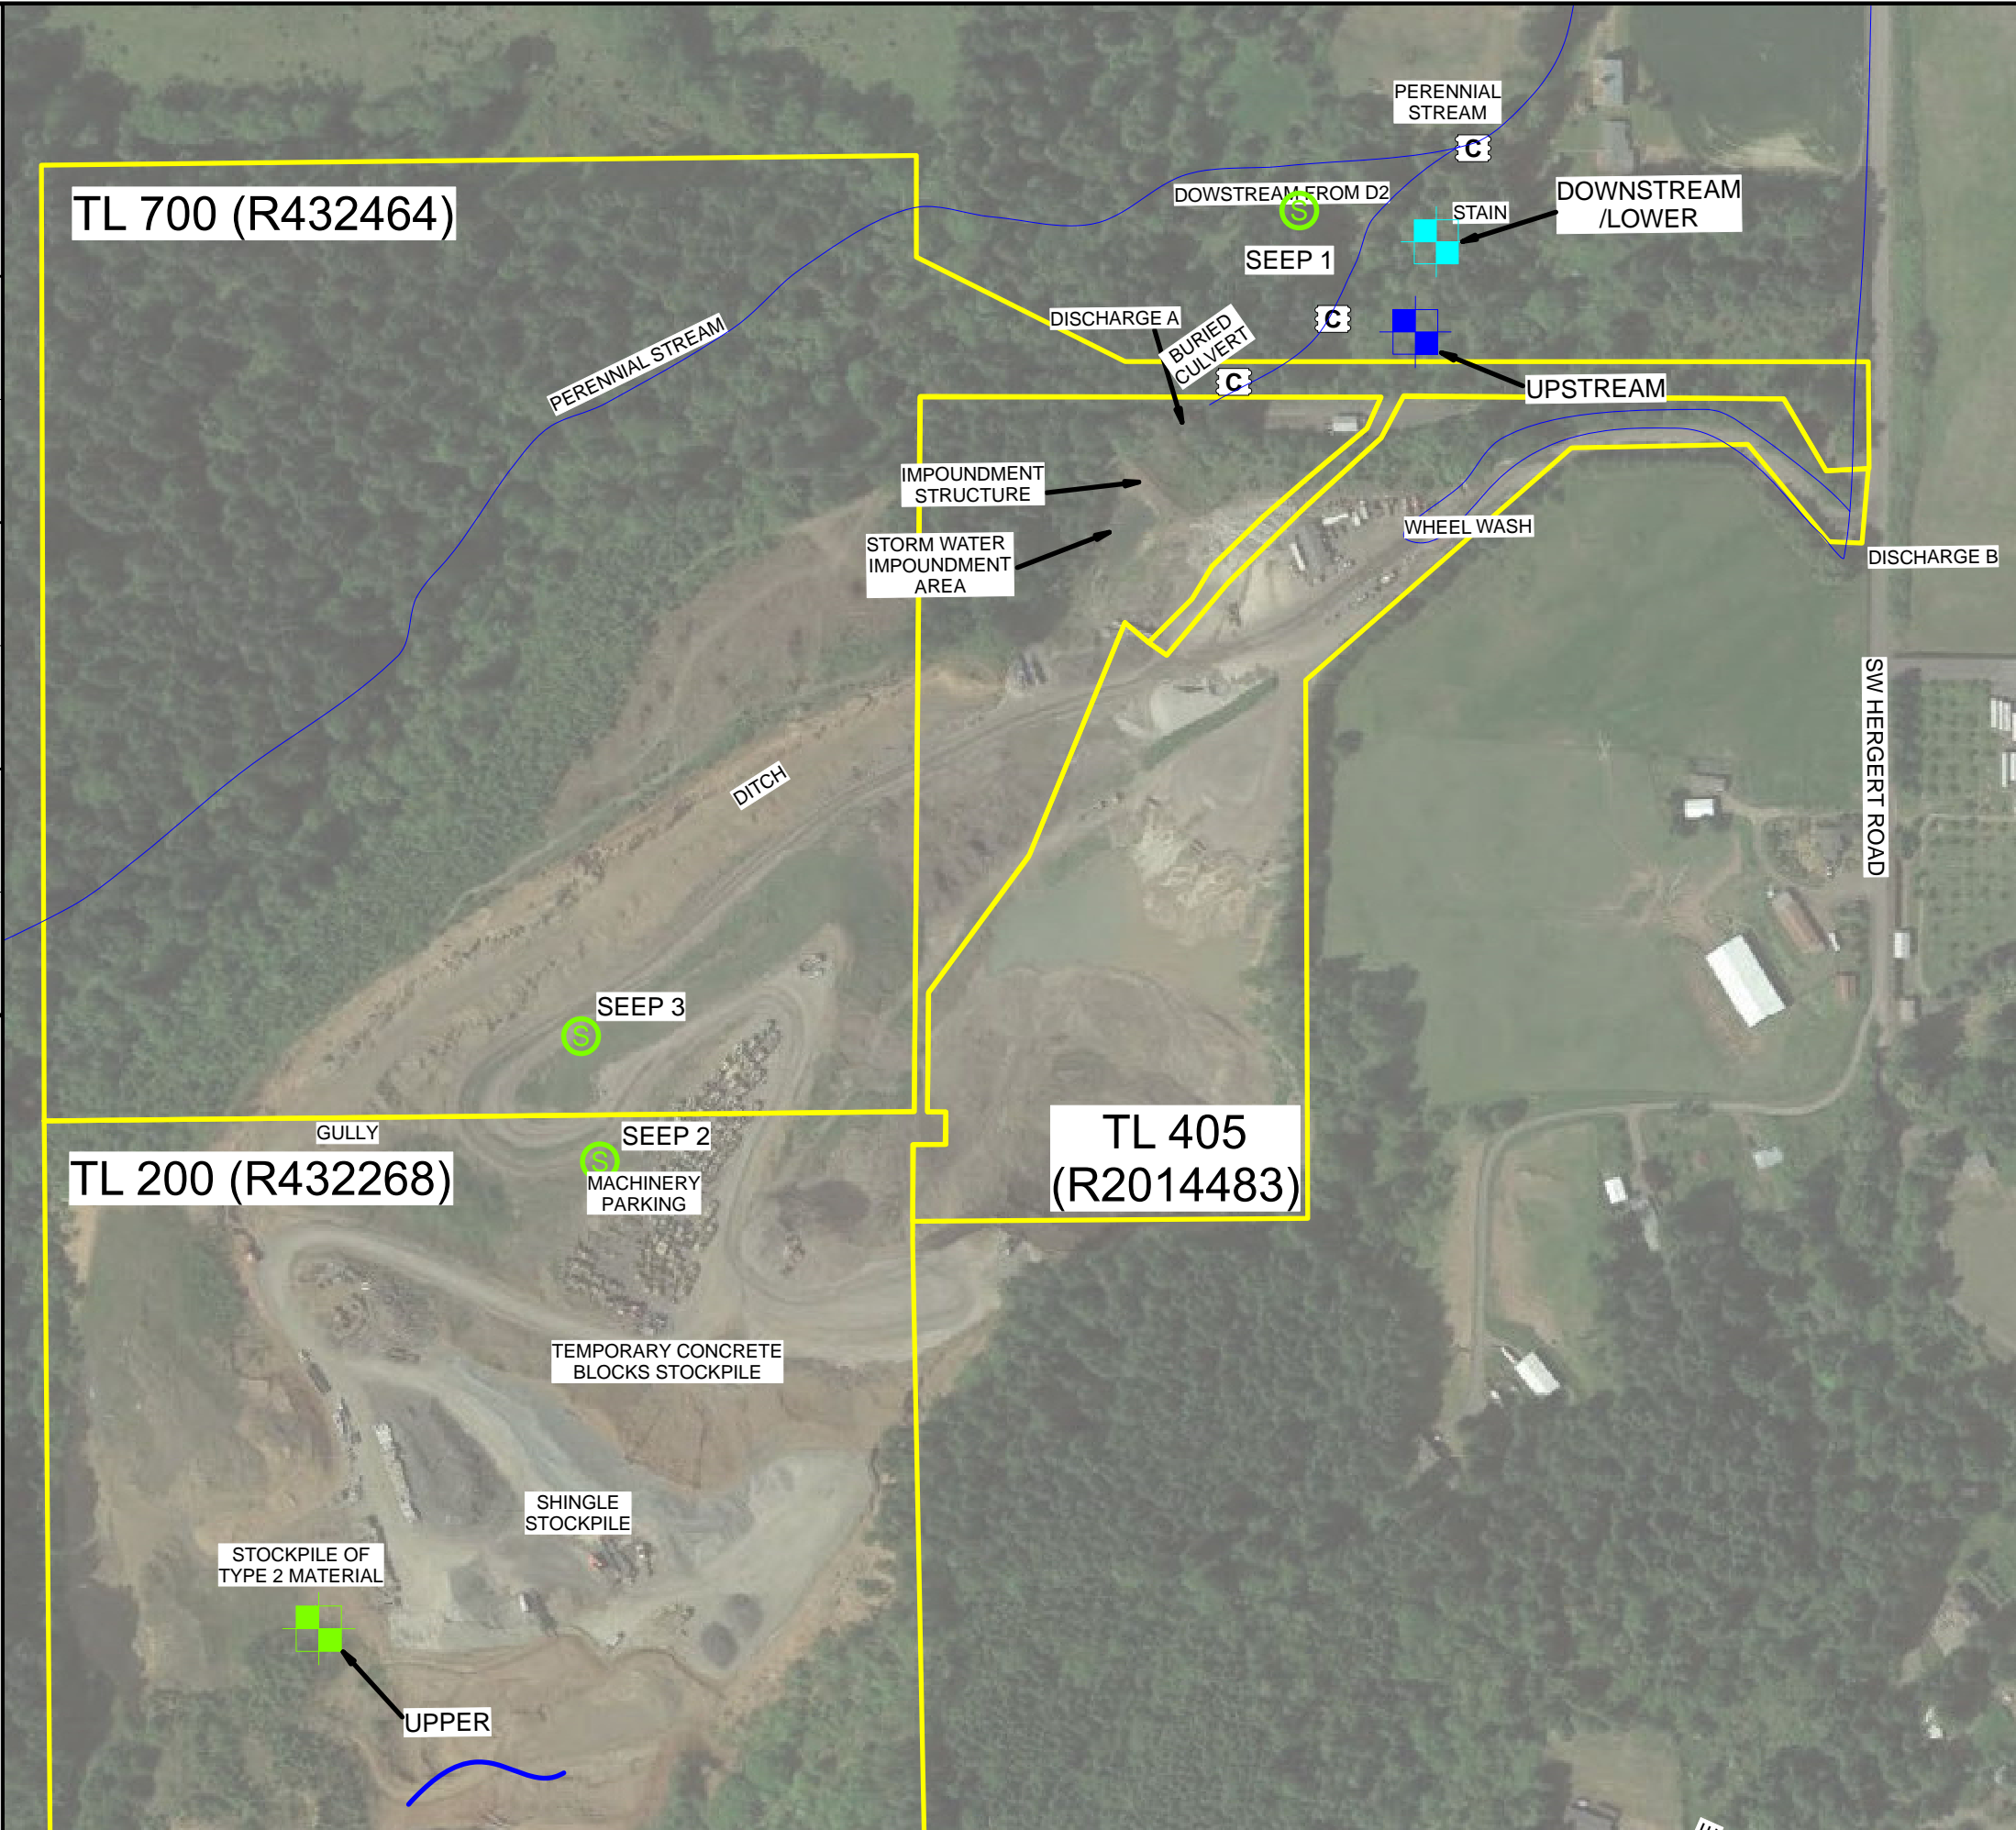
The drainage below the impoundment structure is a vegetated slope with a dry creek bed running in a northeast direction. The creek bed flows through two 3-foot diameter corrugated culverts (C1 and C3 on Figure 2), C1 running beneath a roadway on the VanAkin property, hydraulically down-gradient from the impoundment structure. No significant sediment or iron staining was observed in the creek bed; however, the bottom of the corrugated metal culvert pipe was deteriorated. The outlet of culvert C3 (reported by DOGAMI to be full of sediment) emerged at a vegetated hillside approximately 175 feet to the northeast. Counter to DOGAMI's report, the culvert was elevated above a rocky creek bed and neither the pipe nor creek bed had any visible sediment buildup.

Approximately 100 feet down slope of outfall C3 the embankment expanded into a broad swampy area covered by wetland vegetation. The area where DOGAMI had previously observed bubbling water coming from the ground was dry and stained (iron oxide); however, approximately 75 feet further northeast, ENW noted several active ground water seeps coming from the ground with associated rust-colored sediments. The channeled water from the quarry drainage joined the unnamed creek approximately 600 feet northeast of the impoundment structure. No evidence of oxidizing iron deposits was noted within the sediments of the unnamed creek bed.

During both visits, ENW observed two seeps (SEEP2 and SEEP3 on Figure 2) collecting in a shallow ditch along the haul road, below the middle bench. SEEP3 was on the lower switchback at an elevation of approximately 425 feet amsl, and SEEP2 was directly upslope of SEEP3 on the upper switchback of the main haul road at an elevation of approximately 450 feet amsl. A platy, iridescent film was noted on both seeps typical of organic residue from iron-oxidizing bacteria. No obvious source of water was found in the hydraulically up gradient direction above the seeps; therefore, ground water was the suspected origin.

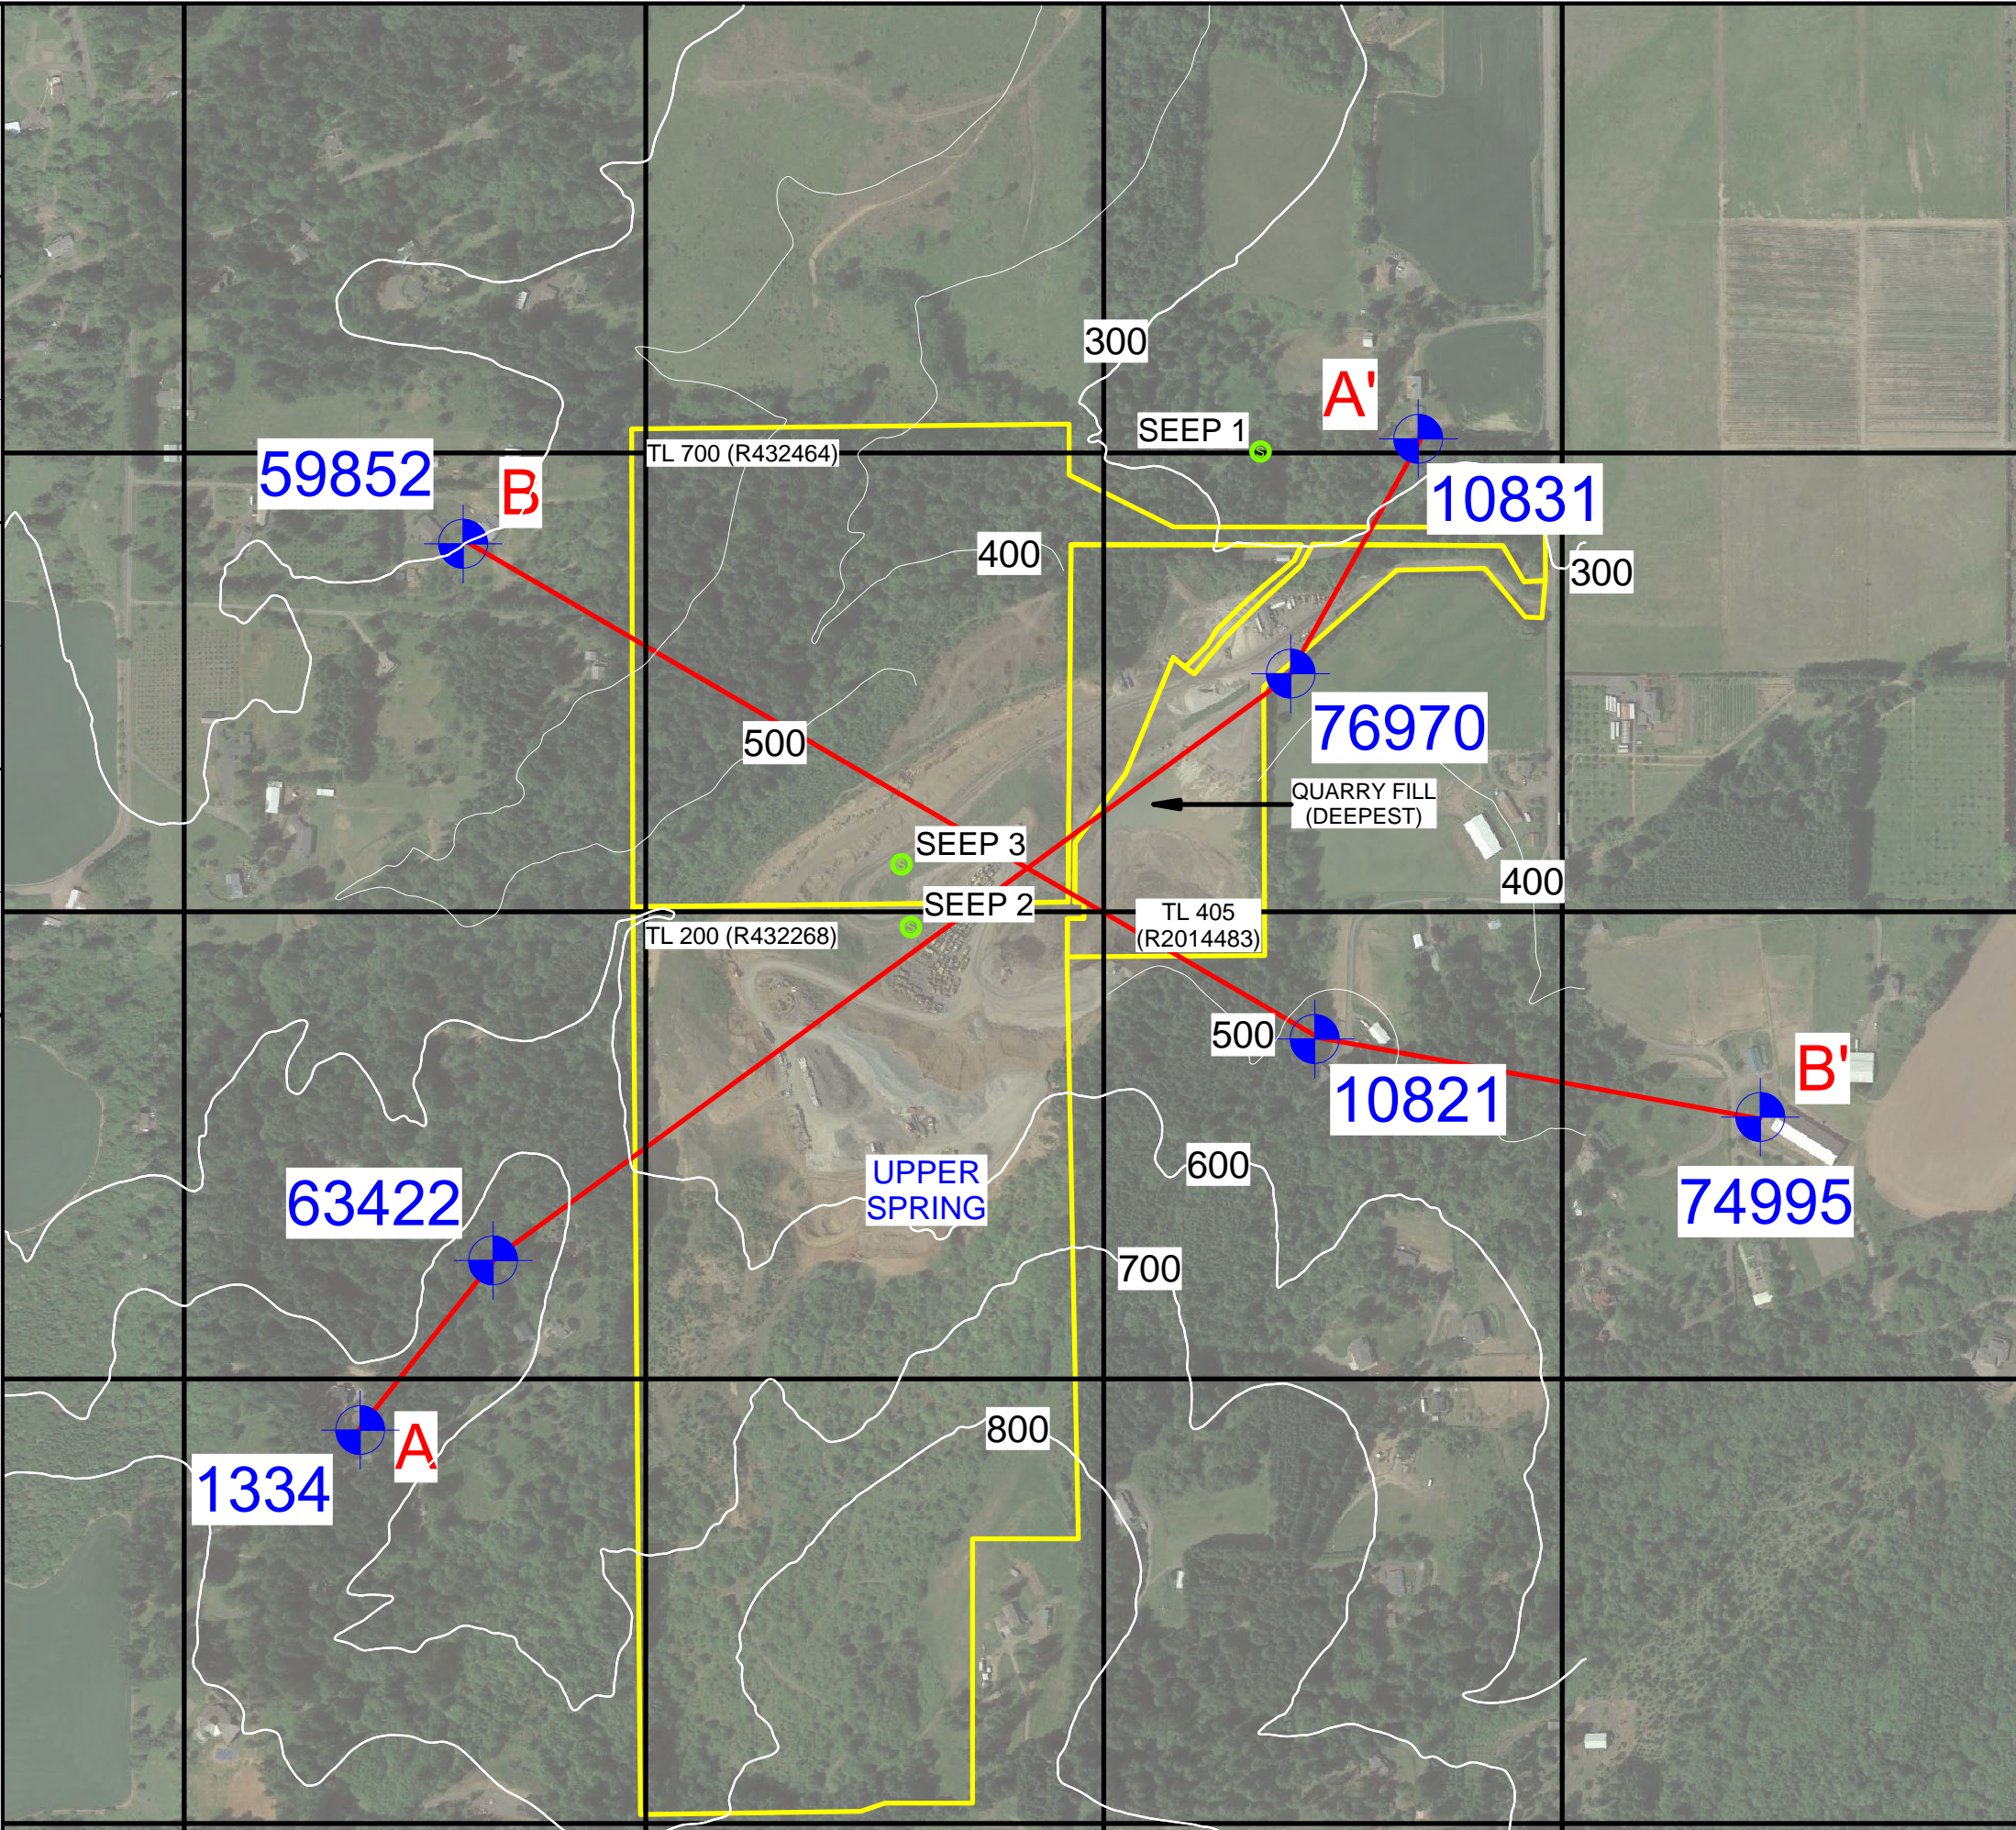
FIGURE 3
CROSS SECTIONS AND WELL LOCATIONS

An online search of the record of water wells of the Oregon Water Resources Department (OWRD) identifies 87 records of water wells in the same township/section/range as the subject site (T1S3R3W Sec 20). There are at least seven wells near the quarry based on available location information (wells logs attached as Appendix A). One well outside the immediate area (WASH633/Animal Farm Well) approximately 3 miles east of the quarry reportedly penetrates the entire CRB unit near the east margin of the Chehalem Mountains. Table 3-1 summarizes well depths, well completions, and water-bearing units encountered during drilling. The locations of nearby water wells are illustrated on the Cross Sections and Well Locations map on Figure 3. Generalized cross-sections compiled from well driller's descriptions are provided on Figures 4 and 5.
