# **Culvert Repair Programmatic Agreement 2019 Annual Report**

Oregon Department of Fish and Wildlife | Oregon Department of Transportation  
August 2021

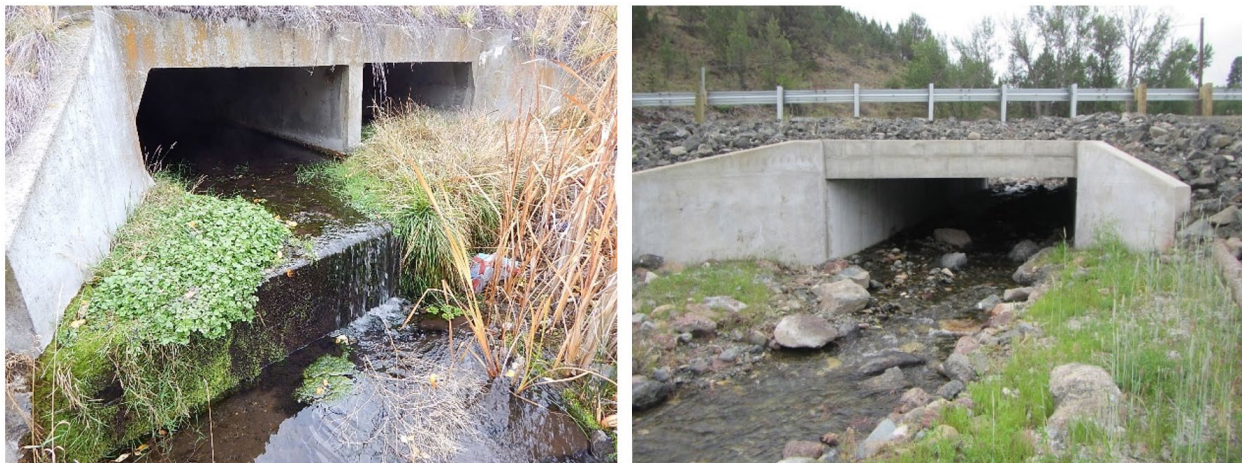
Figure 4: Little Pine Creek Culvert Replacement Project, Before and After, Completed in 2018

The Little Pine Creek culvert replacement project, Figure 4, completed by the ODOT Fish Passage Program, is one example of ODOT’s commitment to improving fish passage and supporting the Oregon Plan for Salmon and Watersheds. The project replaced an undersized double-cell concrete box culvert with a 14-foot wide single-span concrete box culvert. The old box culvert was constructed with a concrete apron on the downstream side, creating a
