LAVA BUTTE WILDLIFE CROSSING EFFECTIVENESS

**Final Report
2015-2017**

November 6, 2018

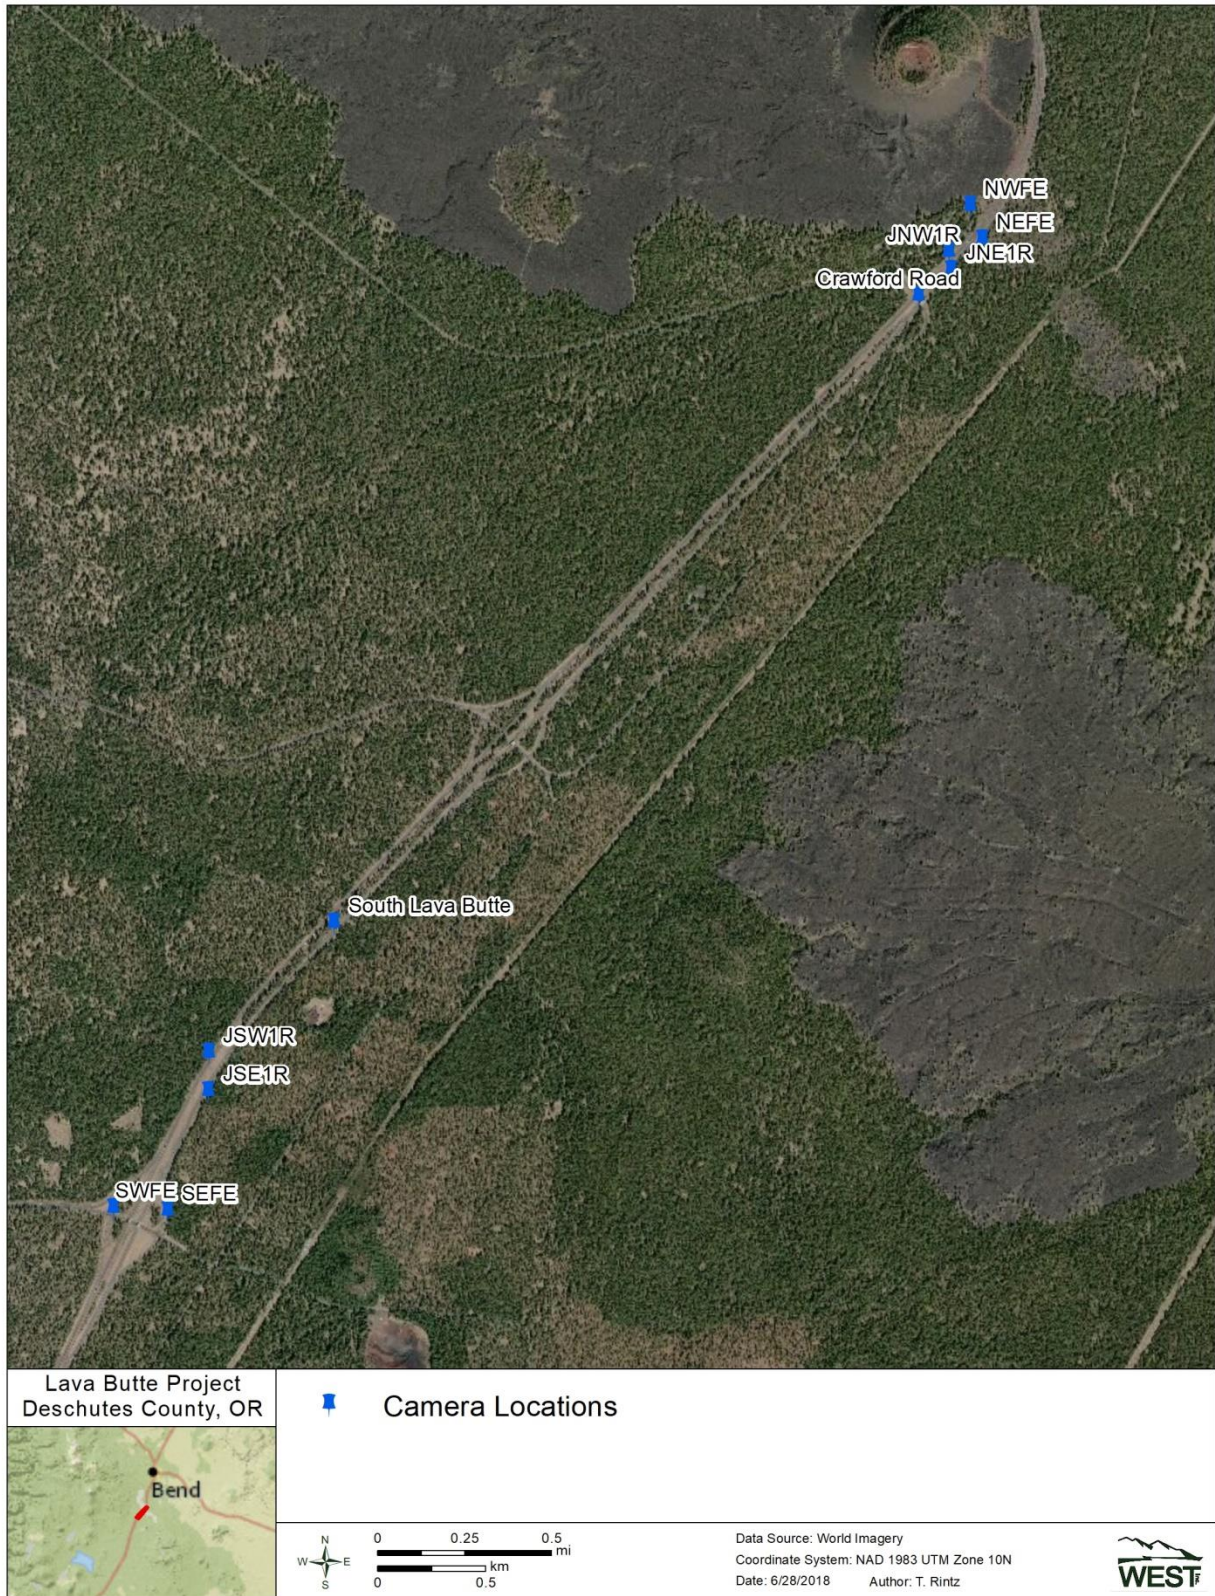
Figure 2.1. Location of wildlife crossing structures and exclusion fence ends along US Route 97 between Sunriver and Lava Butte, Deschutes County, Oregon.

The study area is located along Route 97 in the Deschutes National Forest, approximately 15 mi south of Bend, Oregon and immediately east of Sunriver, Oregon (Figure 1.1). More specifically, the north end of the fenced project area is located near Lava Butte within the Newberry National Volcanic Monument at milepost (MP) 149.3, and the south end of the fenced project area at MP 153.08, where it encompasses the South Century Drive exit to Sunriver (Figures 1.1 - 2.1). For purposes of a before-after control-impact (BACI) analysis (Green and Green 1979), we defined the 12-mi stretch of Route 97 from MP 143 – 155 as the Study Area. Within this 12-mi Study Area, the fenced treatment area was defined as the area between MP 149.3 and 153.08, while the sections from MP 143.0 – 149.3 and 153.09 – 155.0 were defined as the control area because they were outside the bounds of the fenced area and contained data on average annual daily traffic (AADT) consistent with the treatment area.

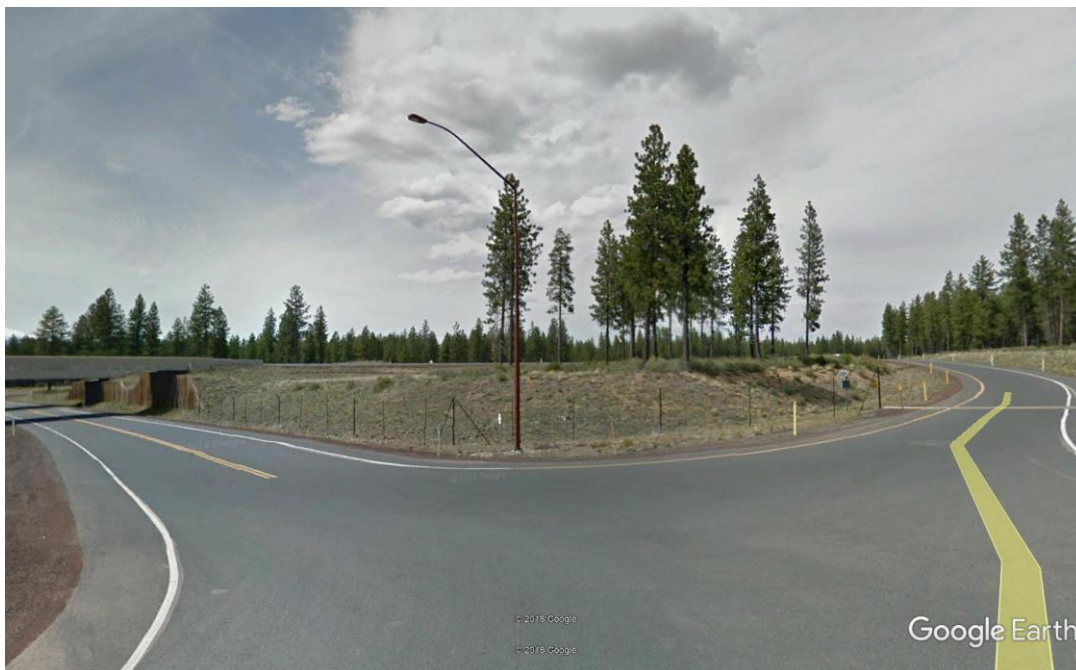
Figure 4.1. South end of exclusion fence as it crosses northbound onramp from South Century Drive and abuts the overpass abutment under U.S. Route 97.

The north fence-end cameras were positioned at true fence-ends and could capture whether an individual crossed from one side of the fence to the other (see Appendix A4). The south fence-end cameras were not on true ends; instead the southwest fence-end camera (SWFE) was positioned near the farthest southwest corner within the median between the southbound off-ramp to South Century Drive and Route 97, and the southeast fence-end camera (SEFE) was positioned along the exclusion fencing just north of the southeast corner on the outside of the northbound onramp from South Century Drive onto Route 97 (Figure 2.1; Appendix A4). In fact, at the southern end of the project, there are in fact no true fence ends, as the fencing abuts and crosses the on/off ramps to South Century Drive via electric wildlife mats (ElectroMat™) and then wraps along the northern side of South Century Drive to the South Lava Butte underpass abutments (see Figure 4.1). This essentially leaves no way for deer (or other large mammals) to exit the southern end of the fenced treatment area, unless they successfully navigate over the ElectroMats™ to escape via the on/off ramps, use the Route 97 overpass over South Century Drive to exit to the south, or return to the jump-outs approximately half a mile back to the north or beyond to the northern fence ends.

All but one of the 30 mule deer crossing events documented at fence-end cameras occurred at the northeast fence-end camera (NEFE), with 17 (56.7%) of the crossings being individuals travelling from the forest-side to the road-side of the exclusion fencing (Table 4.3; Appendix A4). However, although mule deer actually crossing the fence-end were more often entering the road corridor than exiting the corridor, the NEFE camera documented more individuals travelling along the forest-side of the fence than the road-side of the fence, suggesting the majority of deer are remaining on the forest-side of the fence outside of the roadway. Only one crossing was detected at the northwest fence-end camera (NWFE; Table 4.3). This fence-end is also the location of high human-activity with hikers and vehicles actively moving through the area (see Appendix A4). Additionally, this fence-end terminates next to a large lava flow which likely further serves as a barrier. This human activity and relative position to the lava flow may deter deer from crossing at this junction, as would be suggested by the low overall number of deer detections at this camera. The majority (93%) of trigger events at the SEFE camera were of mule deer travelling on the forest side of the exclusion fencing whereas the SWFE camera documented similar occurrences of individuals inside and outside of the fencing (Table 4.3). This result is not surprising given the position of the cameras relative to roads and off- and on-ramps for Route 97. The SEFE camera documented the only elk observed at the fence-end cameras, which was moving south on the inside of the exclusion fence. Unfortunately, it was not possible to evaluate if this or other individuals on the road-side of the fence were able to exit via the ElectroMat™ setup across the on/off-ramps on the south end of the project, as there were no cameras setup to document activity at the ElectroMat™ locations. As noted above, these animals on the road-side of the fence at the SEFE and SWFE had no clear way to exit the roadway without returning north to the jump-outs or north fence-ends, crossing the overpass over South Century Drive, or navigating over the ElectroMat™ to escape via the on/off-ramps.

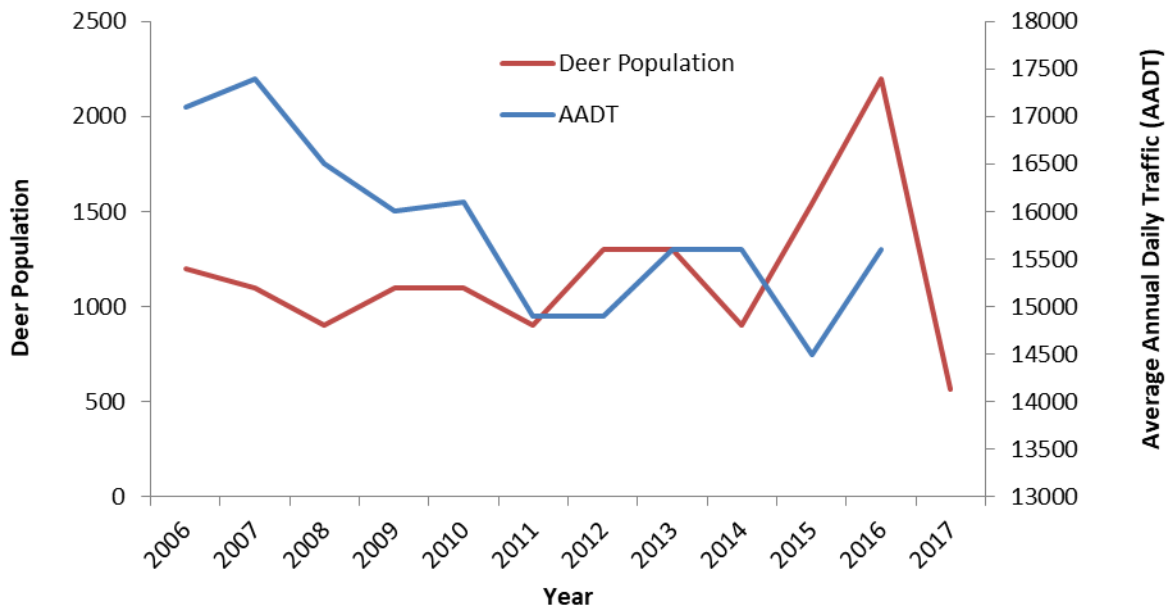
Figure 4.4. Average Annual Daily Traffic (AADT) from mileposts 143.46 to 153.08 on U.S. Route 97, Deschutes County, Oregon and Upper Deschutes District mule deer population estimates from 2006 to 2017. AADT were divided by 10 for scaling purposes.

A total of 273 mule deer and 15 elk carcasses were collected by ODOT in the 12-mi Study Area from 2006 to 2017 (Figure 4.2), with the number of DVC generally increasing over time while elk-vehicle collisions remained low (Figure 4.3). During the 10-year period from 2006 to 2016, AADT counts on this same 12-mi stretch of Route 97 generally declined from a high of over 17,000 vehicles per day in 2006-2007 to a slightly lower level of about 15,000 to 16,000 vehicles per day over most of the remainder of the period (Figure 4.4). Mule deer population estimates for the Upper Deschutes District generally fluctuated between about 900 and 1,500 animals from 2006 – 2017, with a bit of a spike in 2016 (2,200 animals) followed by a sharp decline in 2017 (565 animals) and generally tracked with DVC during the study period (Figure 4.4).

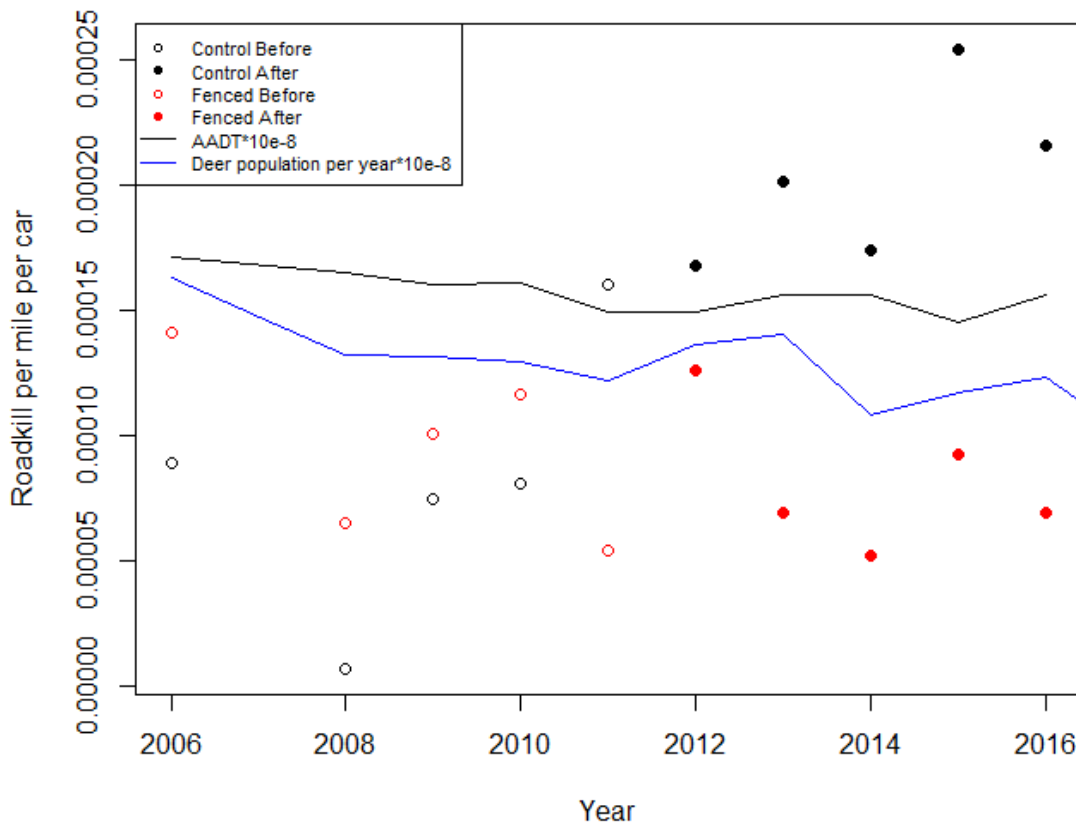
Figure 4.5. Deer-vehicle collisions (DVC) per mile per car by year, period (before or after), and stretch (control or fenced), Deschutes County, Oregon, 2006-2016.

Linear models were constructed to account for a BACI design (Green and Green 1979) to examine relationships between DVC in fenced (i.e., treatment) and control areas before (2006-2011) and after (2012-2017) construction was completed, and whether traffic numbers influenced DVC. These models included main effects for stretch (e.g., fenced or control) and period (before or after construction) as well as an interaction term. Using this approach, a significant interaction effect between the stretch and the period would indicate a significant effect in the fenced treatment in the period after construction. Several models were examined, including those incorporating the two density outcomes of interest described above for deer/elk and for deer (DVC) only. Log transformations and random effects for year were considered but not needed. All statistical analyses were conducted using R (R Core Team 2013) and Statistix (Analytical Software 2013).

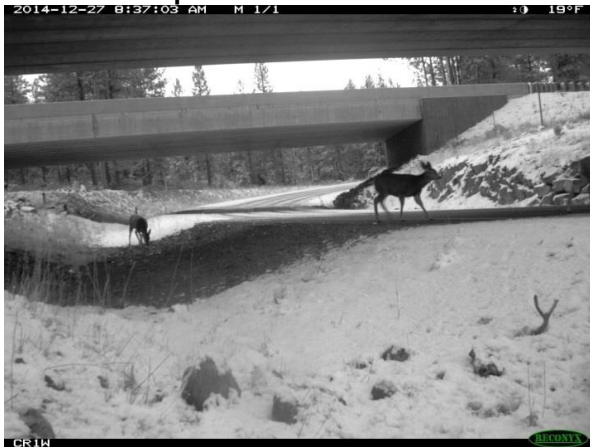
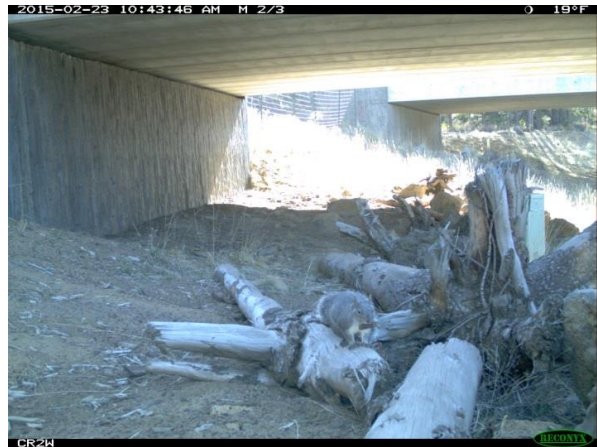
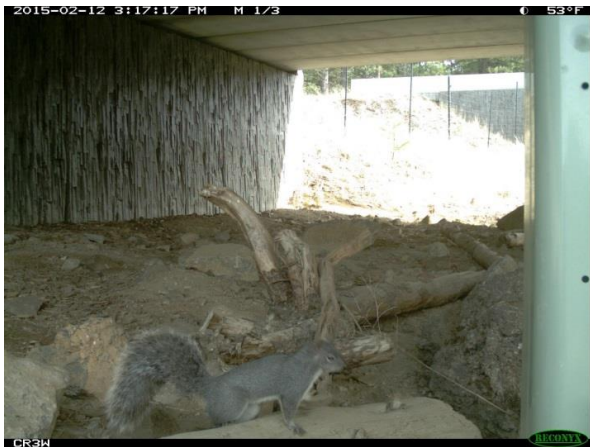
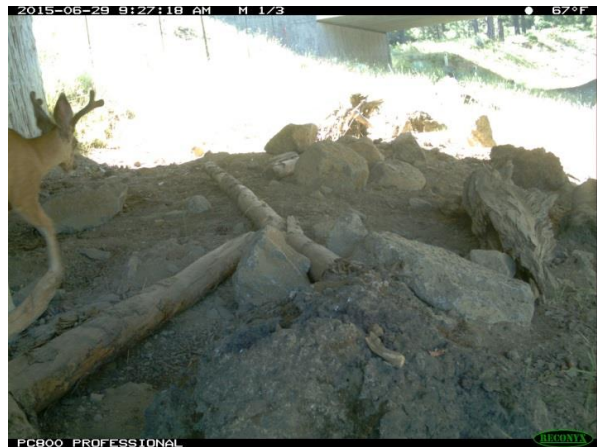
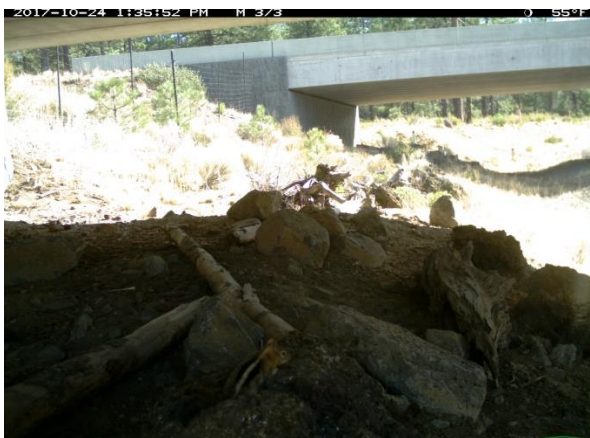
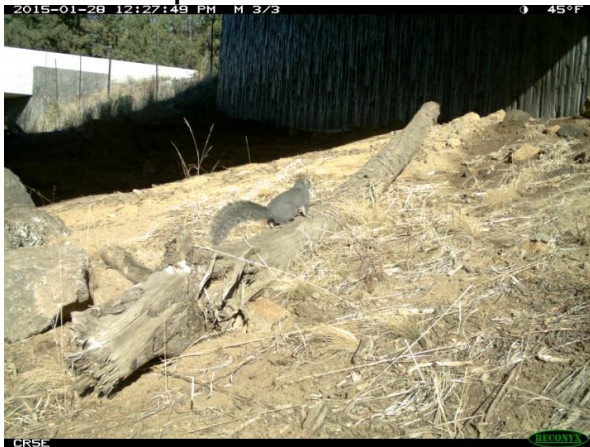
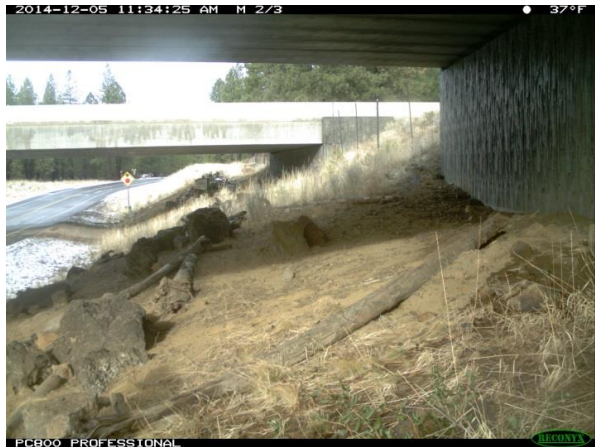
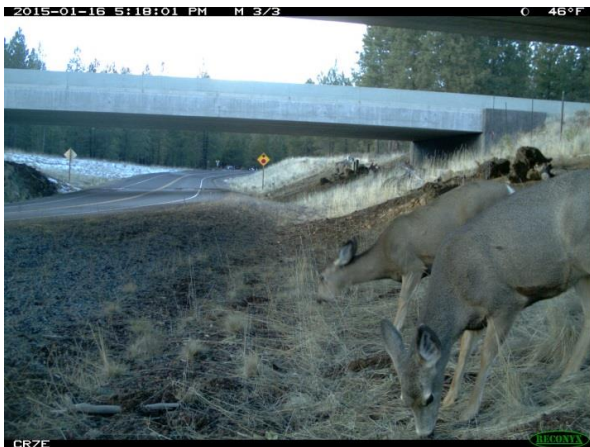
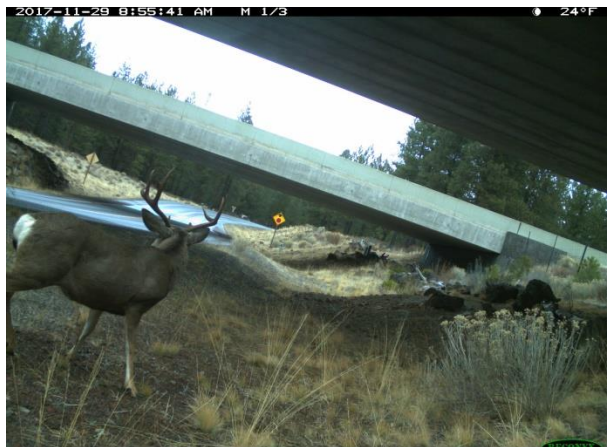
Appendix A1. Views from remote cameras at the multi-use Crawford Road (CR) wildlife underpass on U.S. Route 97. Photos are labeled with the camera ID. Photos 1a-e represent views from cameras situated on the west side and 1f-i represent cameras on the east side of the underpass.

majority of detections at Crawford Road, mule deer were consistently detected using the Crawford Road underpass, suggesting that the underpass is successfully being used by mule deer. Wildlife detections at South Lava Butte were dominated by mule deer, followed by coyotes (*Canis latrans*), indicating this structure is also functioning successfully for other large mammal species. Based on the data (304 detections at South Lava Butte compared to 34 at Crawford Road), it appears that coyotes may prefer to use the wildlife-specific crossing structure as opposed to one alongside a road (i.e., Crawford Road). Bobcats (*Lynx rufus*) were relatively common at Crawford Road ($n = 26$), but rarely documented at other locations. The only large carnivore detected during this study was a cougar (*Puma concolor*) on the forest side of a jump-out (Table 4.2; Appendix A3).

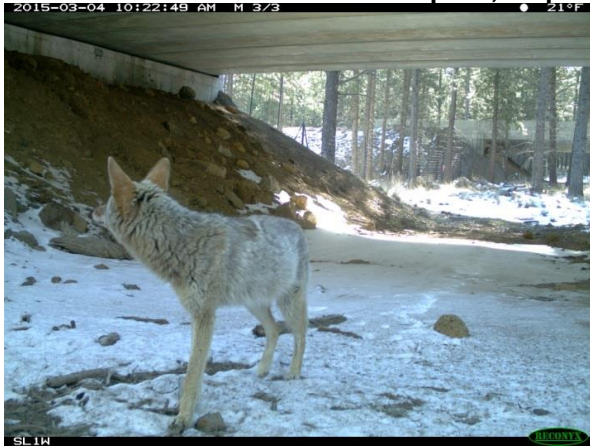
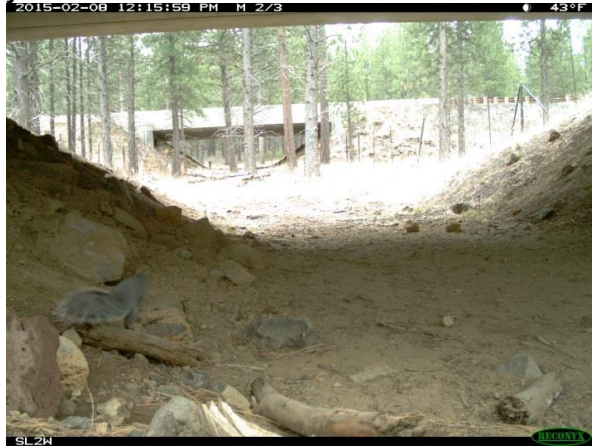
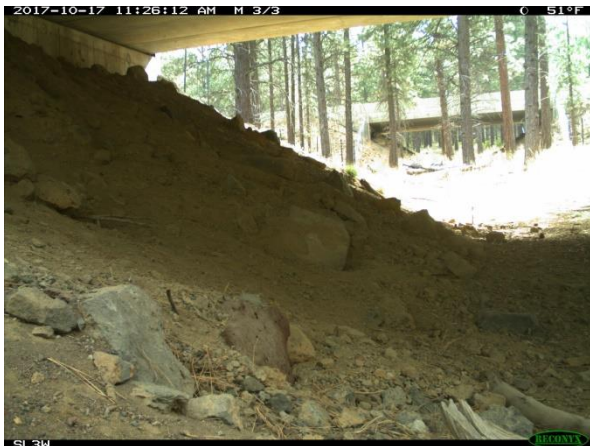
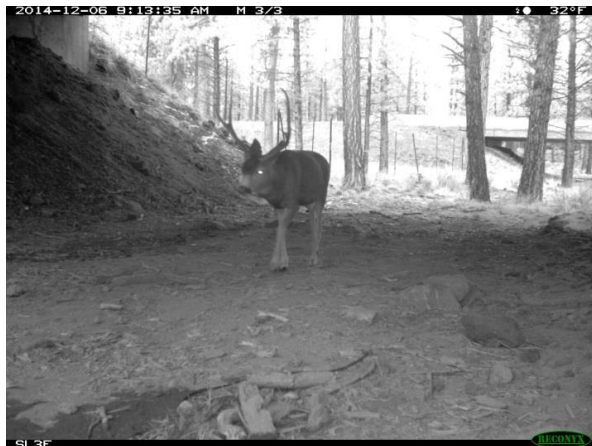
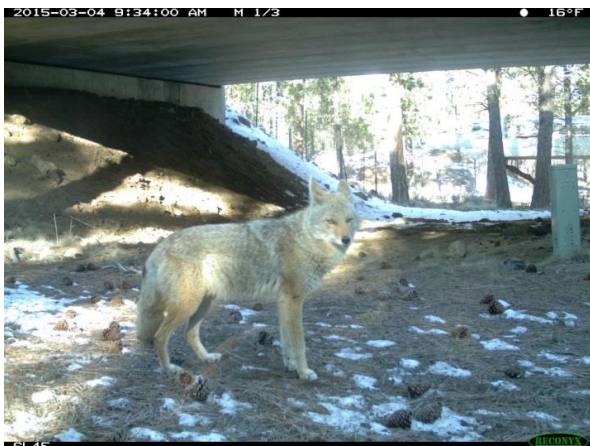
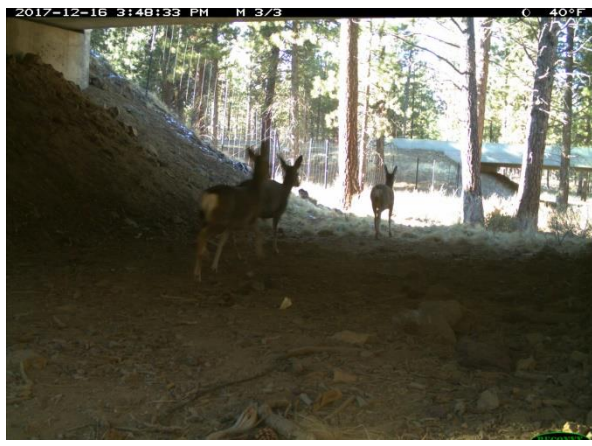
Appendix A2. Views from remote cameras at the South Lava Butte (SL) wildlife underpass on U.S. Route 97. Photos 2a-c and 2d-f represent views from cameras situated on the west side and east side of the underpass, respectively.

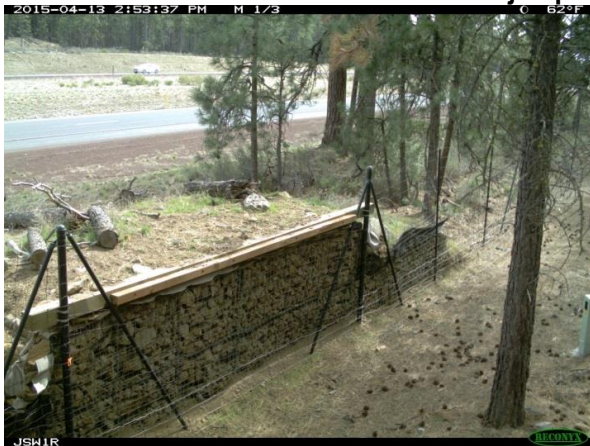
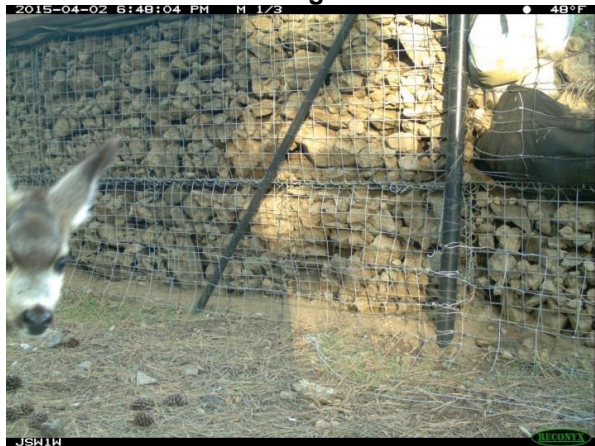
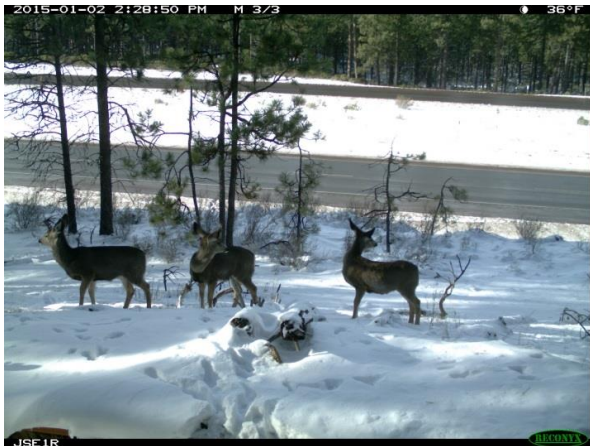
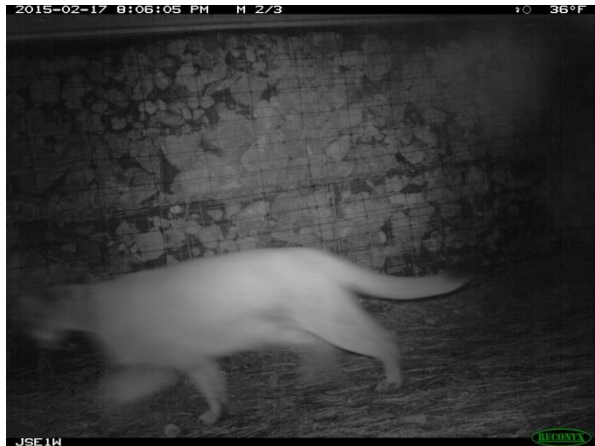
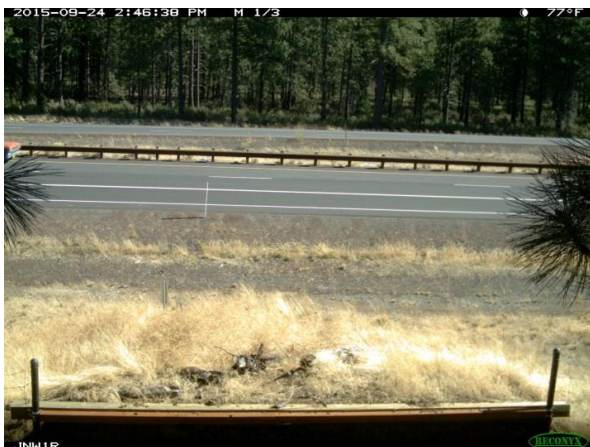
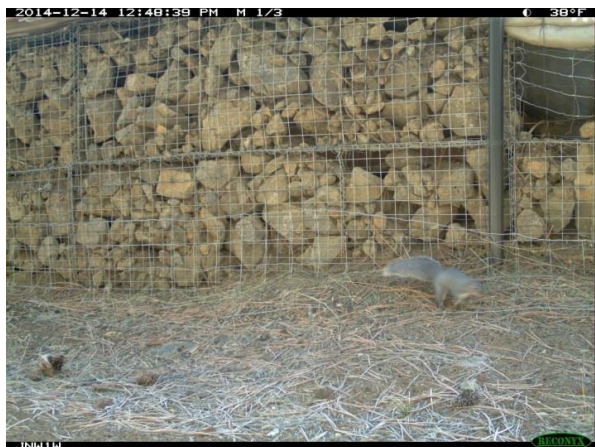
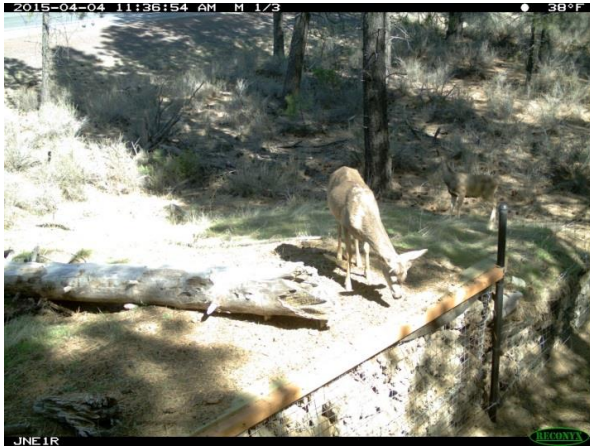
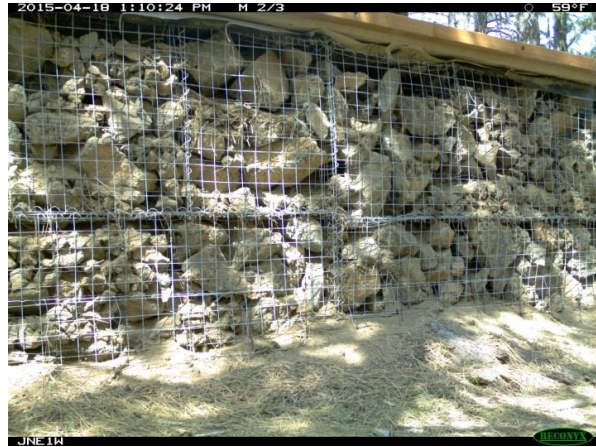
**Appendix A3. Views from remote cameras at the jump-outs in the exclusion fencing along U.S. 97.
There are two cameras for each jump-out; one tree-based and one ground-based camera.**

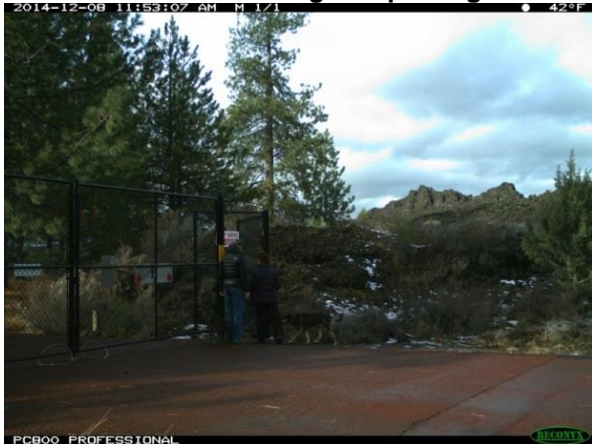
1a. NWFE. Northwest fence-end that terminates at a lava mound.

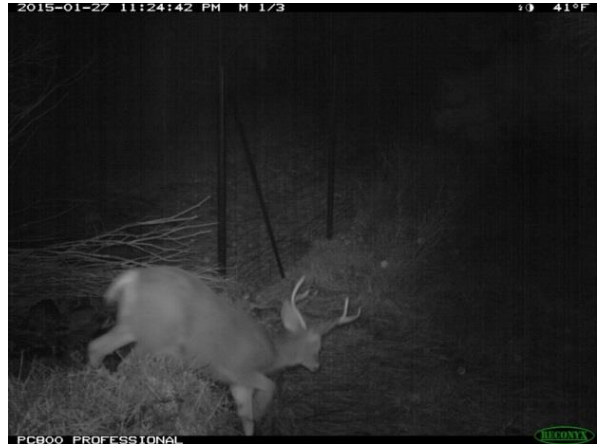
1b. NEFE. Northeast fence-end that terminates at lava mound.

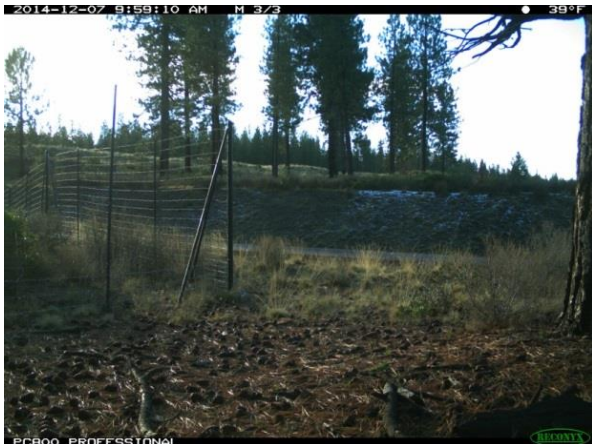
1c. SWFE. Southwest fence corner near U.S. 97 south-bound off-ramp and Hwy 42.

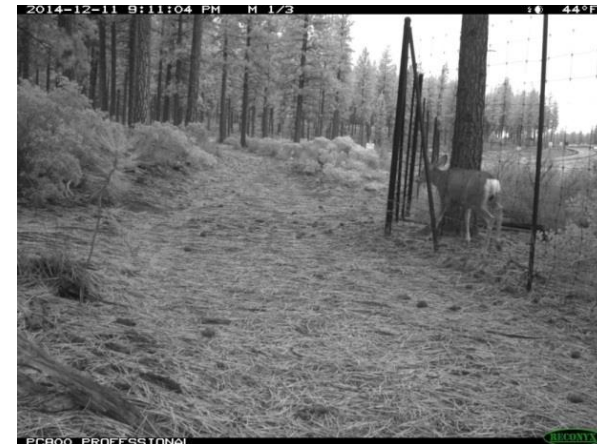
1d. SEFE. Southeast fence line near U.S. 97 north-bound on-ramp along fence.
