# EXHIBIT H GEOLOGY AND SEISMICITY

**Response:** Section H.1 defines the analysis area of the Madras Solar Energy Facility (Facility). Sections H.2 through H.9 provide information from reasonably available sources regarding the geological and soil stability within the analysis area. Section H.10 provides a summary of Exhibit H findings.

**Figure H-1**  
**Geology Map**  
 Application for Site Certificate  
 Madras Solar Energy Facility  
 Jefferson County, OR

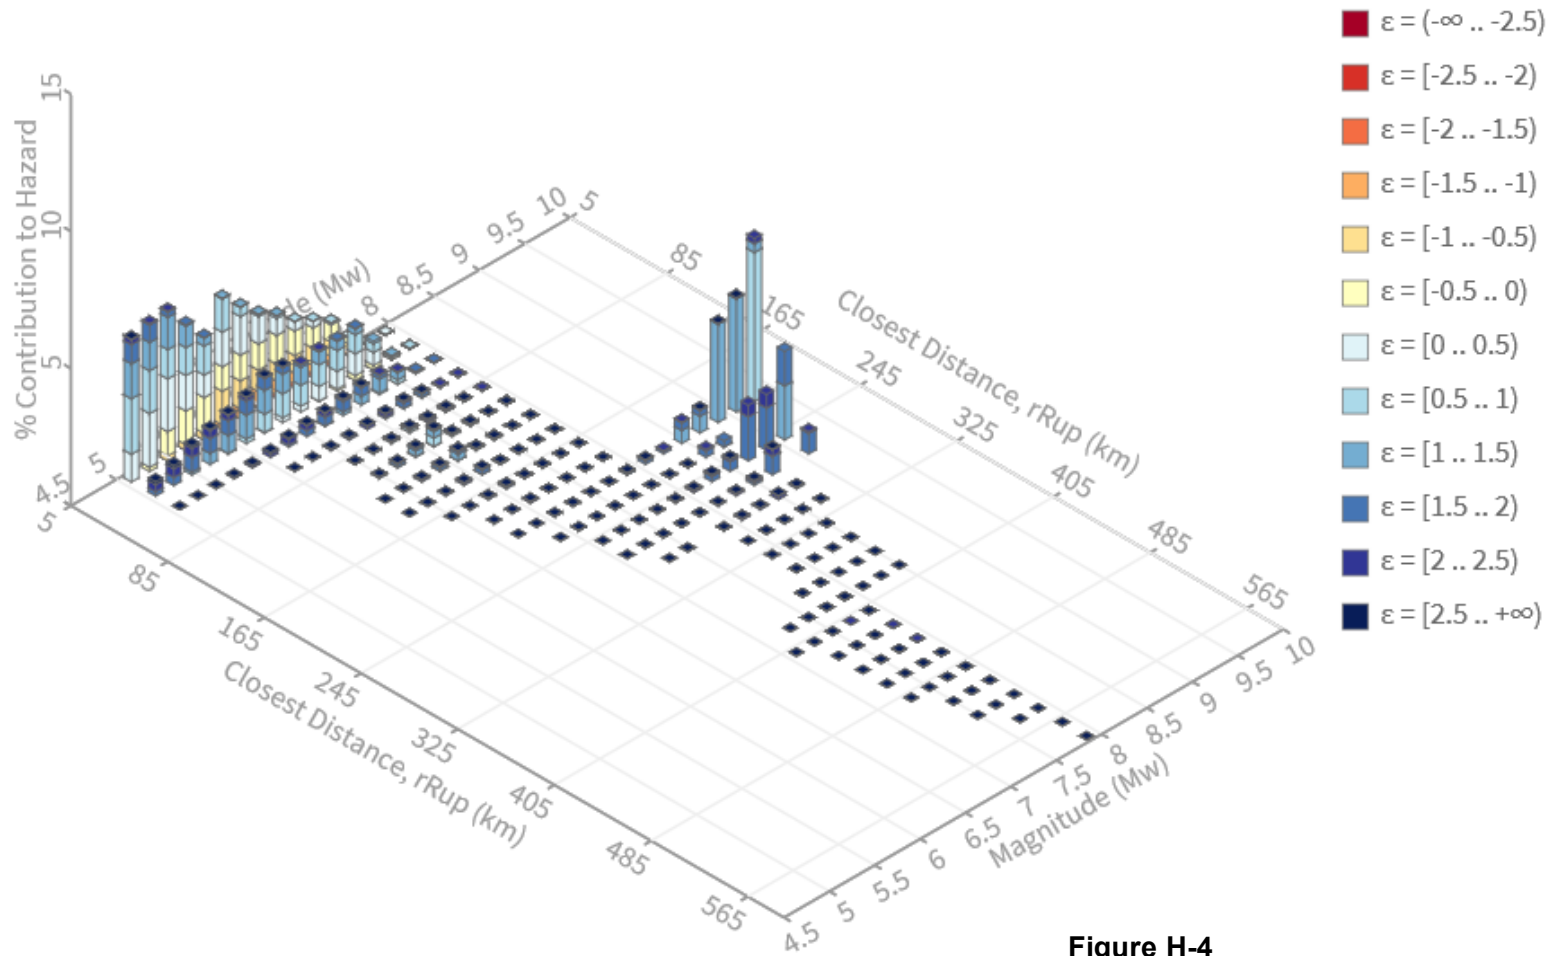
**Figure H-4**  
 Probabilistic Seismic Hazard Deaggregation for  
 the Maximum Considered Earthquake Event  
 Application for Site Certificate  
 Madras Solar Energy Facility  
 Jefferson County, OR

The Maximum Probable Earthquake (MPE) is considered to be an earthquake that has a 10 -percent probability of exceedance in 50 years (a nominal 475-year recurrence interval). The MConE is considered to be an earthquake with a nominal 2,475-year recurrence interval (a 2-percent probability of exceedance in 50 years). Figures H-3 and H-4 show the probabilistic seismic hazard deaggregation for the MPE and MConE events, respectively.

PSH Deaggregation  
 NEHRP BC Rock  
 44.662853° N, 121.229395° W  
 Peak Horizontal Ground Acceleration  $\geq 0.18$  g  
 Mean Return Time 2,475 Years

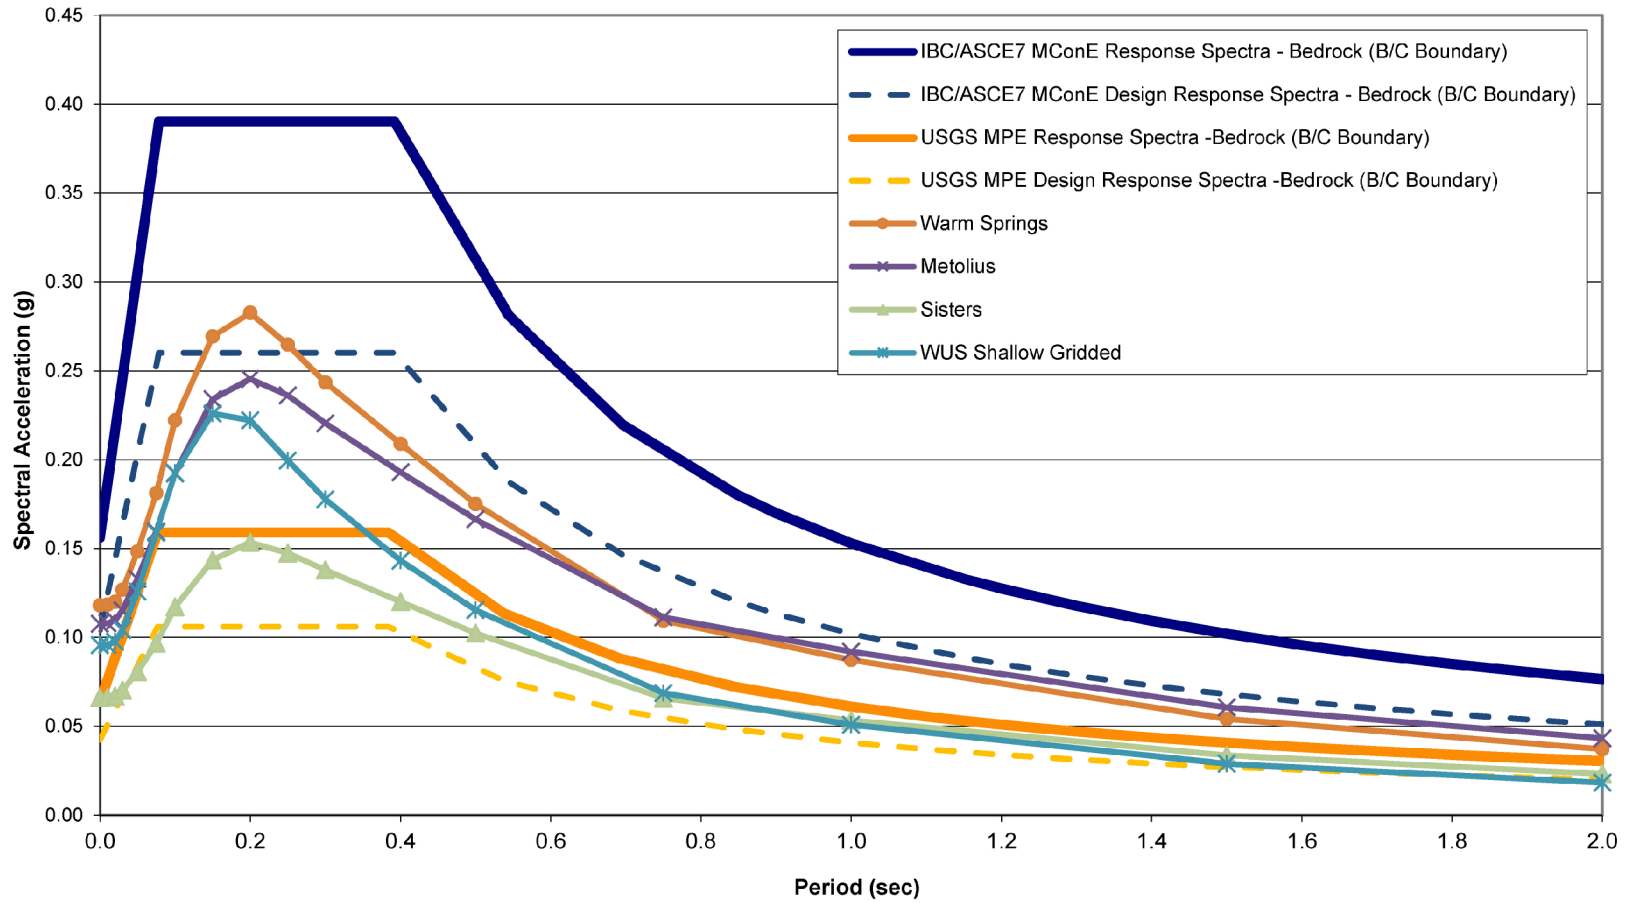
**Figure H-5**  
 Median Ground Response Spectra Plots  
 Application for Site Certificate  
 Madras Solar Energy Facility  
 Jefferson County, OR

**Response:** Figure H-5 compares the USGS-derived, IBC 2012/American Society of Civil Engineers 7 design spectral response accelerations for the MConE and MPE (for Site Class B), with the MCE spectral response occurring on the crustal fault source mechanisms identified in Table H-2. The NGA modal inputs for the crustal fault sources are summarized in Table H-3. The CSZ interplate and intraslab sources are not included in Figure H-5 because they are too distant from the Facility to exceed the design spectra. Weighting of each of these models follows the 2014 USGS National Seismic Hazards Mapping guidance (USGS, 2014). Figure H-5 compares the response on the bedrock surface between the design spectra and the median response spectra from the principal crustal sources. Therefore, all plots in Figure H-5 are presented at the bedrock surface (or the B/C Site Class boundary identified within the IBC, where no site-specific amplification is applied to spectral accelerations).

**5%-Damped Pseudo-Absolute Acceleration Response Spectrum**  
 [(Crustal sources modeled after NGA (2014 USGS Update))]

Because of the potential for seismic-induced hazards within the Facility site boundary, mitigation measures to address these hazards in the siting, design, and construction of the Facility are necessary in order to protect against ground shaking and instability. The design of the Facility components can readily accommodate the level of seismic energy described in Section H.6.4, Median Ground Response Spectrum.
